the **play inspection** company

Annual Inspection

Copdock and Washbrook Parish Council - Fen View

Inspected: 16-February-2026 - 15:00 by James Law (RPII Annual Inspector)

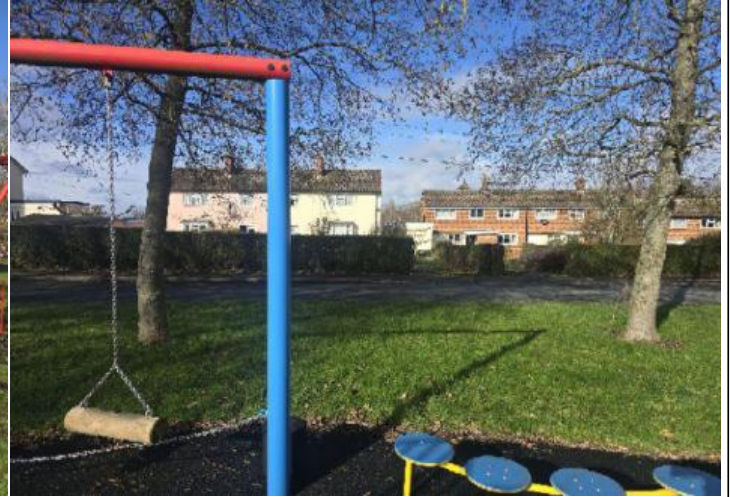
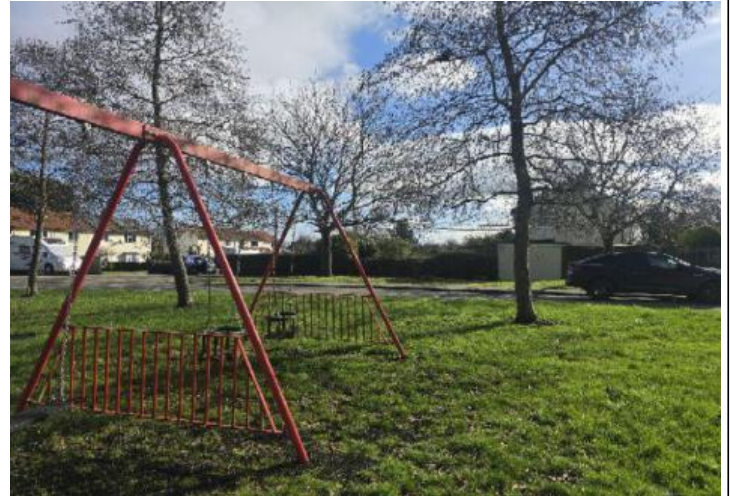
Item: Ancillary Items - Site General
Manufacturer: Owner/Operator

Finding: There is no physical barrier between the road and the play area

Action: Ensure a full and sufficient risk assessment is in place and review regularly

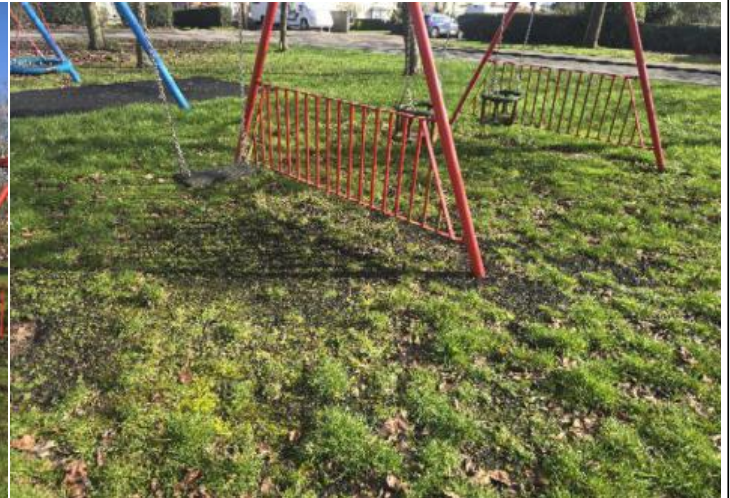
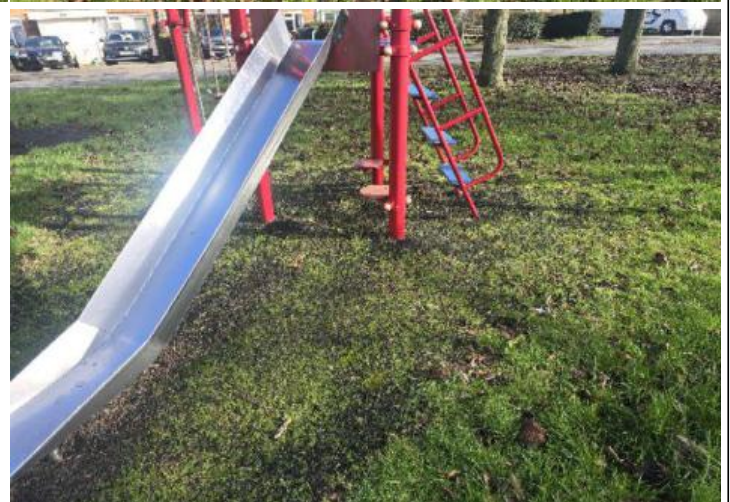
Item: Ancillary Items - Site General
Manufacturer: Owner/Operator

Finding: There is weed / vegetation growth within the surface

Action: Remove weed / vegetation growth

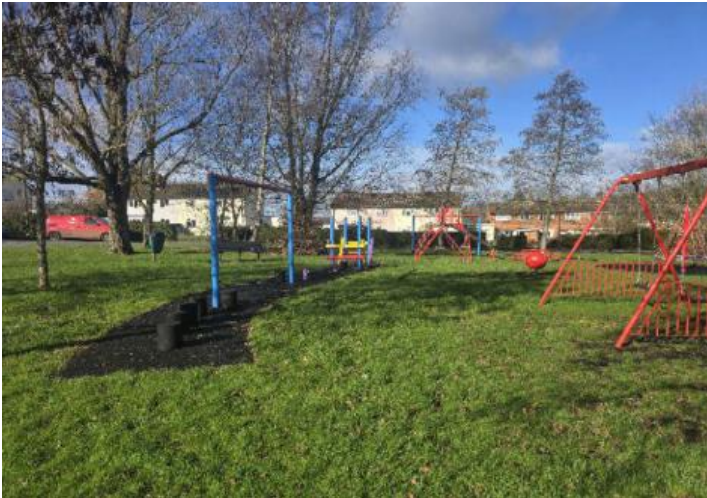
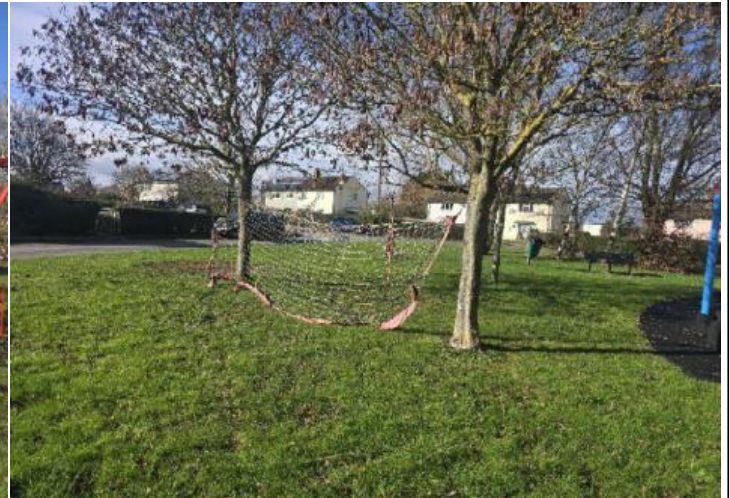
Item: Ancillary Items - Site General
Manufacturer: Owner/Operator

Finding: There is a damaged and unsecured domestic football goal present on site

Action: Remove

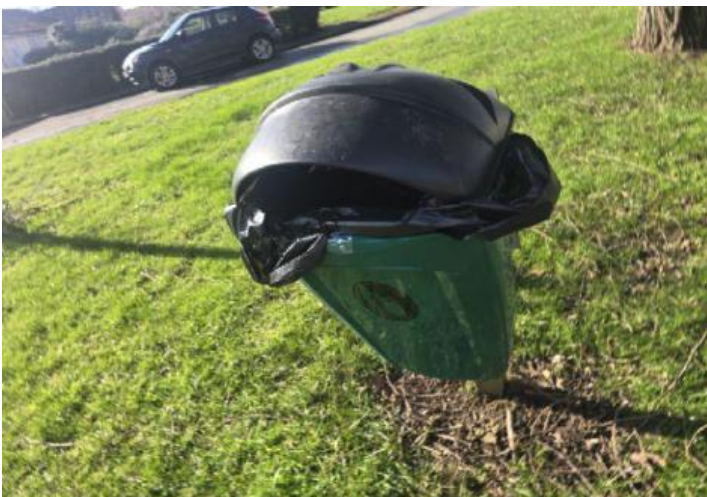
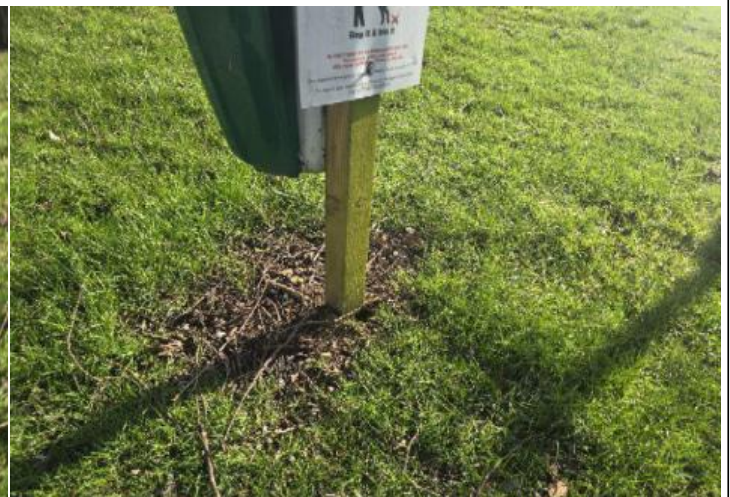
Item: Ancillary Items - Litter Bin
Manufacturer: Not Identified

Finding: The post is loose in its foundations

Action: Reinstall item to secure

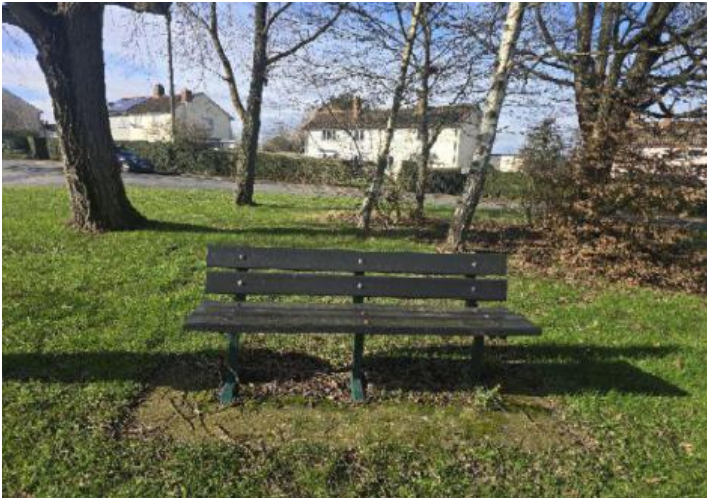
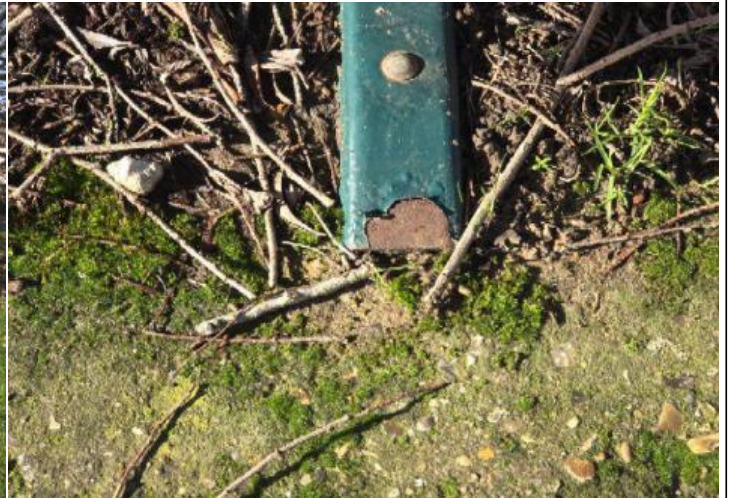
Item: Ancillary Items - Bench
Manufacturer: Not Identified

Finding: The paintwork on this item has been damaged or worn exposing the metal underneath which is rusting / corroding

Action: Treat affected areas and repaint

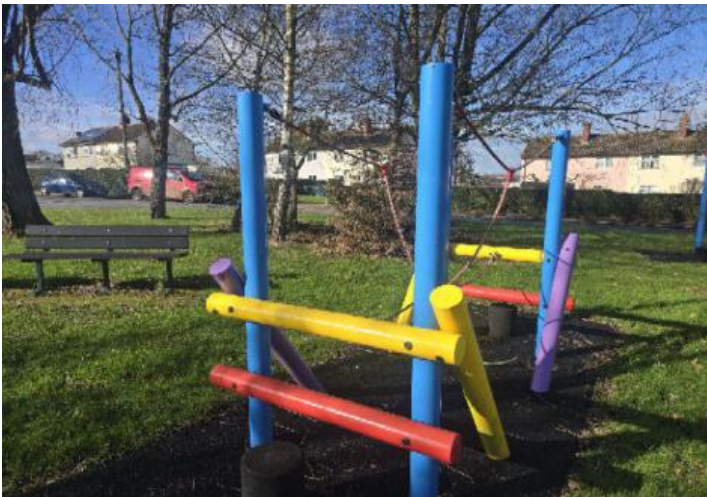
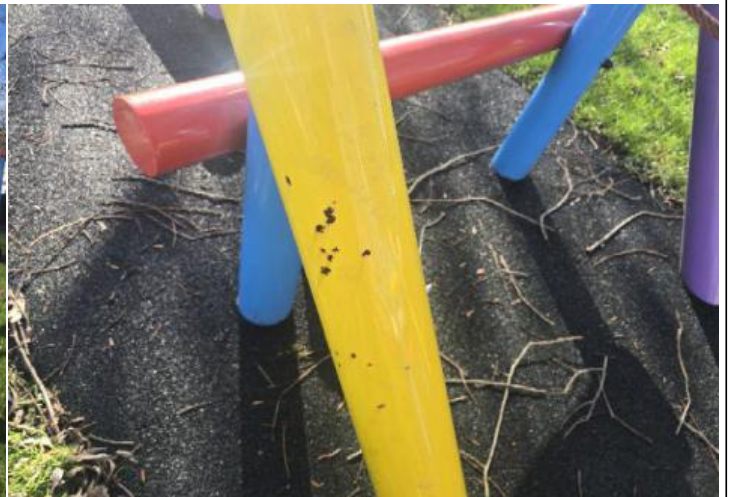
Item: Activity Equipment - Rope Bridge
Manufacturer: Not Identified

Finding: The paintwork on this item has been damaged or worn exposing the metal underneath which is rusting / corroding

Action: Treat affected areas and repaint

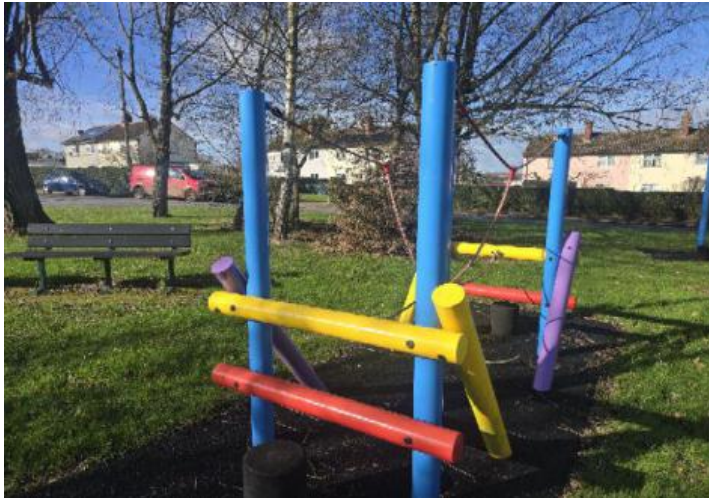
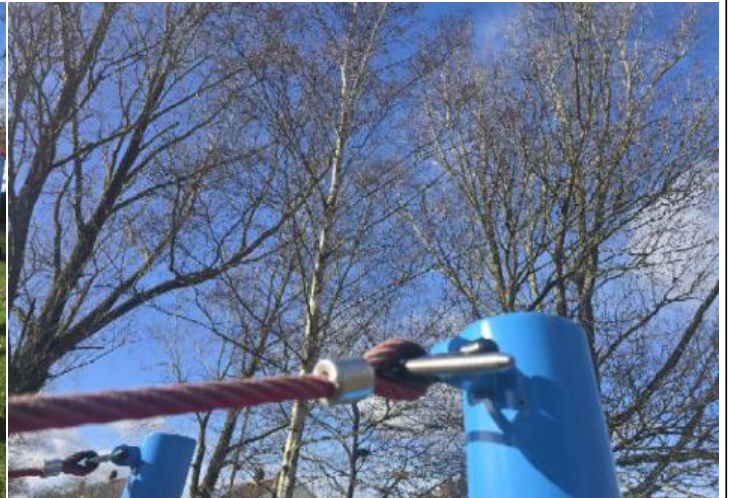
Item: Activity Equipment - Rope Bridge
Manufacturer: Not Identified

Finding: The connecting links are in excess of 8.6mm and less than 12mm and fail the requirements of BS EN 1176 Part 1; clause 4.2.13, Chains

Action: Monitor use and replace with compliant links at the next maintenance cycle

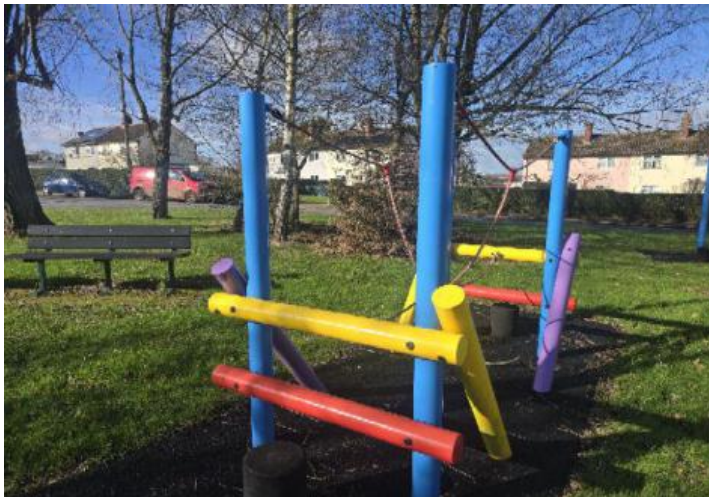
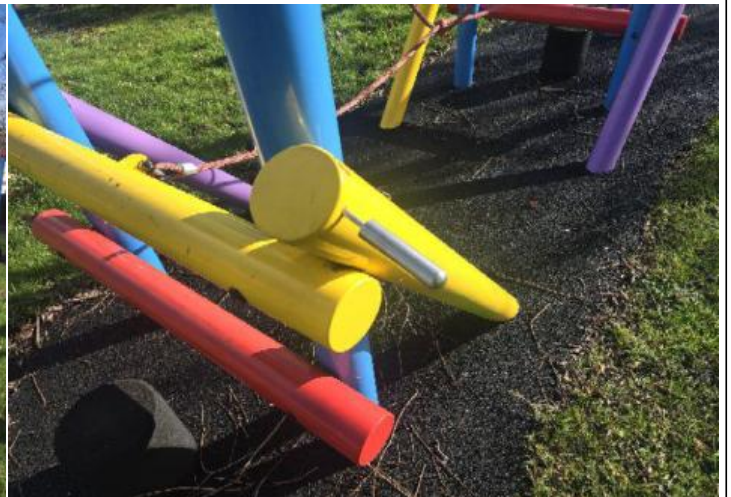
Item: Activity Equipment - Rope Bridge
Manufacturer: Not Identified

Finding: There are missing inserts creating finger entrapment/s in the framework and the item fails to meet the requirements of BS EN 1176 Part 1 4.2.7.6 Entrapment of fingers

Action: Replace the missing inserts to remove the entrapment

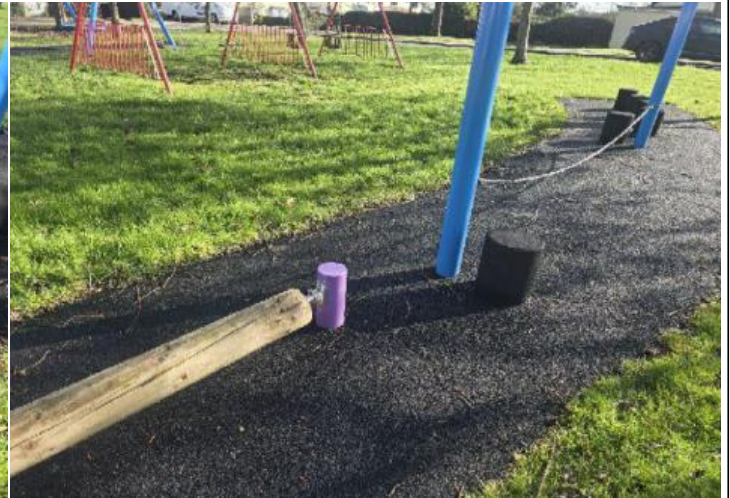
Item: Activity Equipment - Rubber Steps
Manufacturer: Not Identified

Finding: The step between the items is quite large and users may not be able to complete the step without touching ground, the items could therefore be considered to be within the falling space of each other, however the intention of the play activity continuity is easily apparent and foreseeable to the user

Action: Monitor - No action given the risk assessment

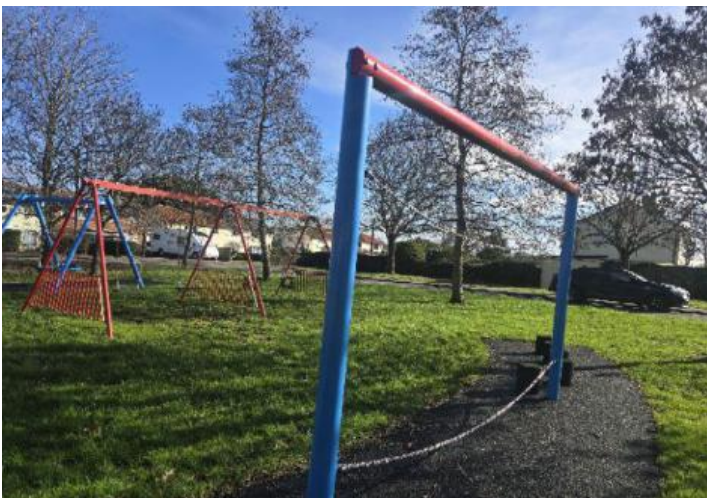
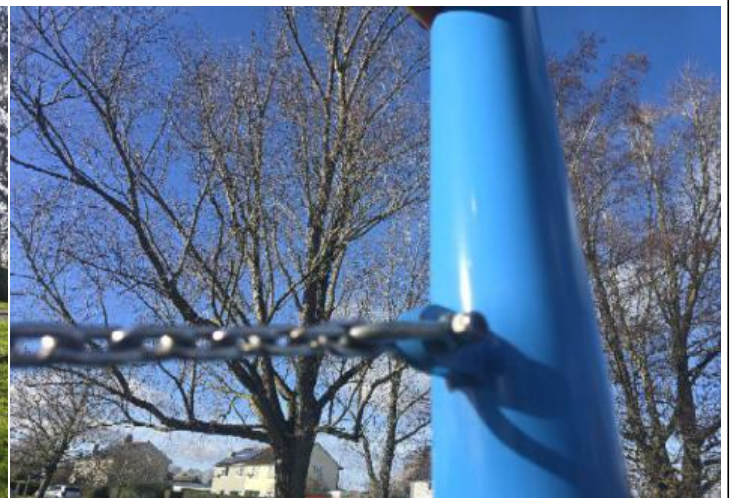
Item: Activity Equipment - Chain Traverse
Manufacturer: Not Identified

Finding: There is/are bolt cap covers missing or damaged on the item

Action: Replace missing or damaged bolt cap covers

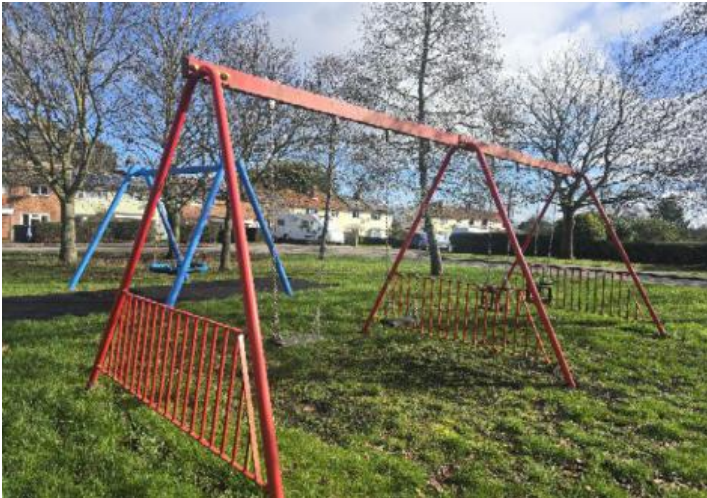
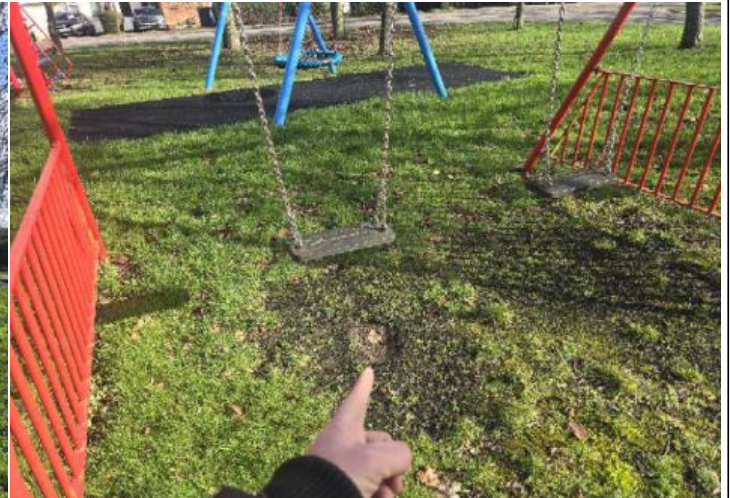
Item: Swings - 2 Bay (2 Flat, 2 Cradle)
Manufacturer: Not Identified

Finding: There is moderate damage to the surface

Action: Repair the damaged areas of surfacing

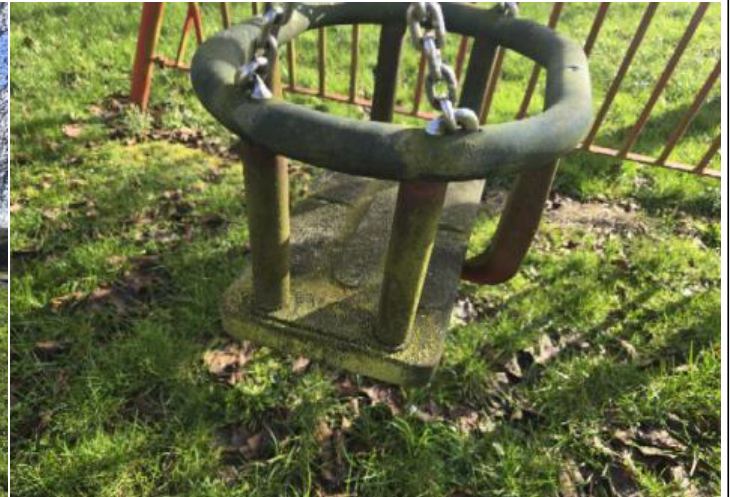
Item: Swings - 2 Bay (2 Flat, 2 Cradle)
Manufacturer: Not Identified

Finding: There is algae or moss on the surface of the seats

Action: Clean and treat appropriately

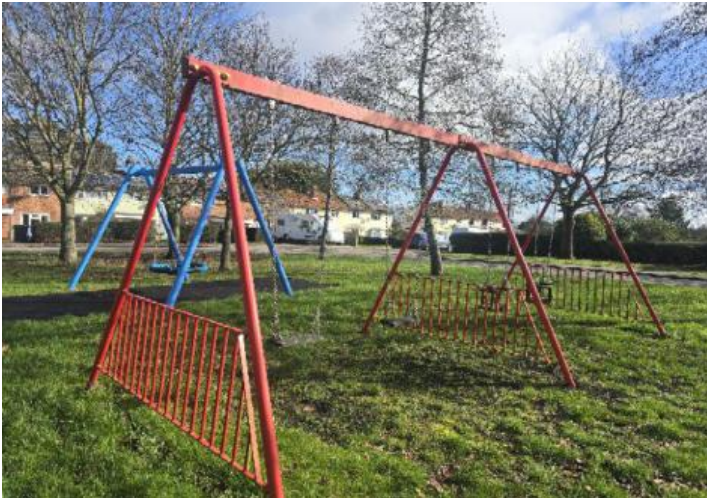
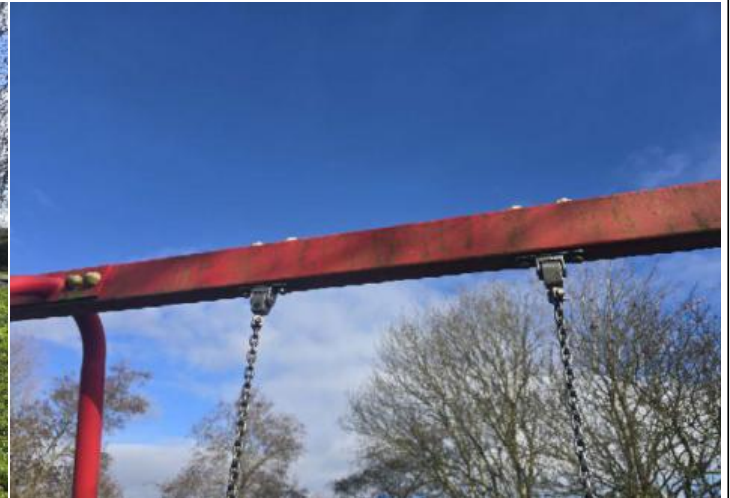
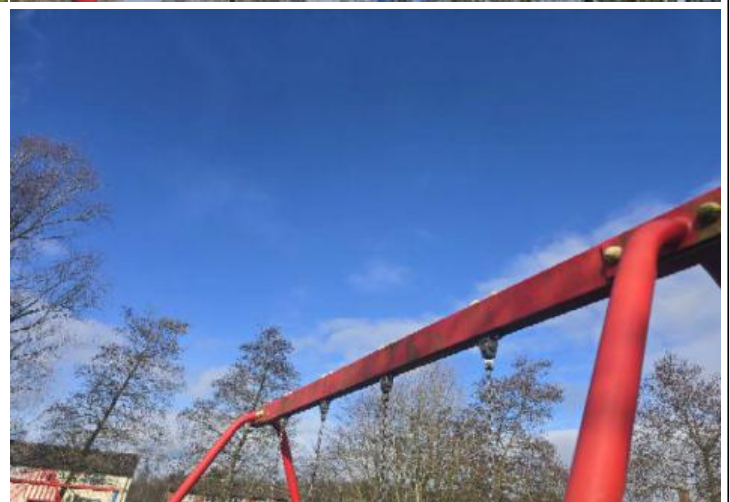
Item: Swings - 2 Bay (2 Flat, 2 Cradle)
Manufacturer: Not Identified

Finding: The bushes are showing signs of wear

Action: Monitor for any further deterioration and replace as required

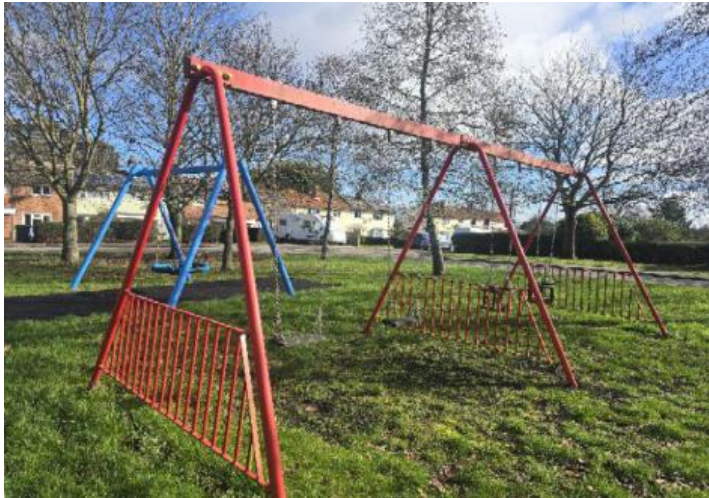
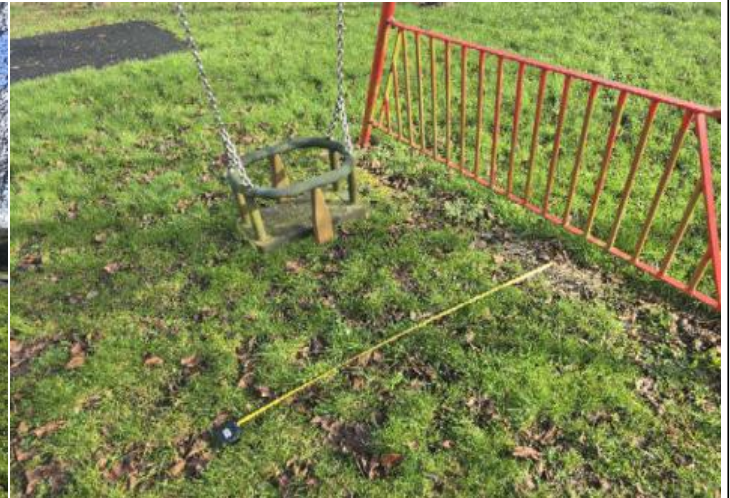
Item: Swings - 2 Bay (2 Flat, 2 Cradle)
Manufacturer: Not Identified

Finding: BS EN 1176 Part 2: Annex A makes a recommendation that fences or enclosures should be 1.50m from the edges of the swing seat to the sides, and subject to risk assessment, from the edge of the impact area. This is however, a low risk finding and no remedial action is recommended.

Action: Monitor - No action given the risk assessment

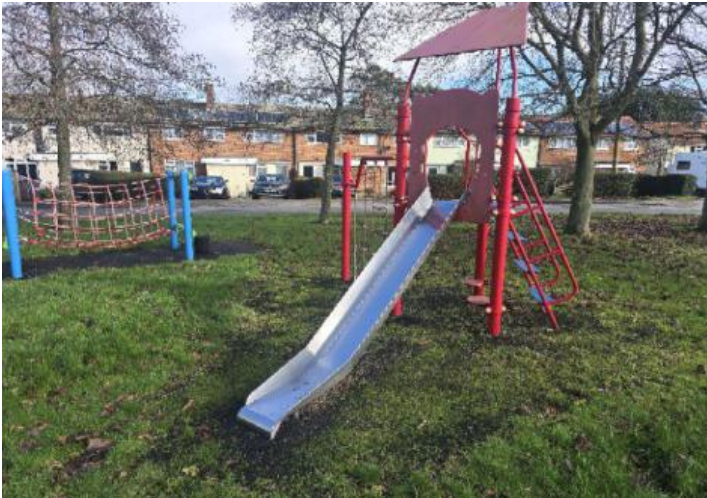
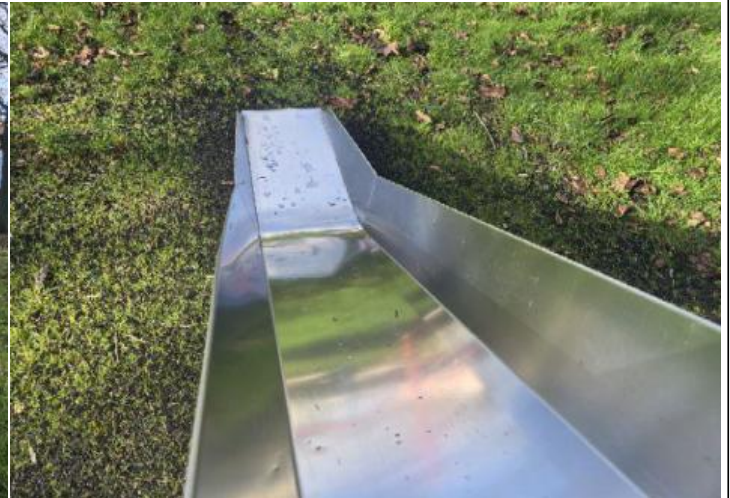
Item: Activity Equipment - Multi Play (Junior)
Manufacturer: Not Identified

Finding: There are a number of dents in the slide surface

Action: Monitor for any further deterioration and repair as required

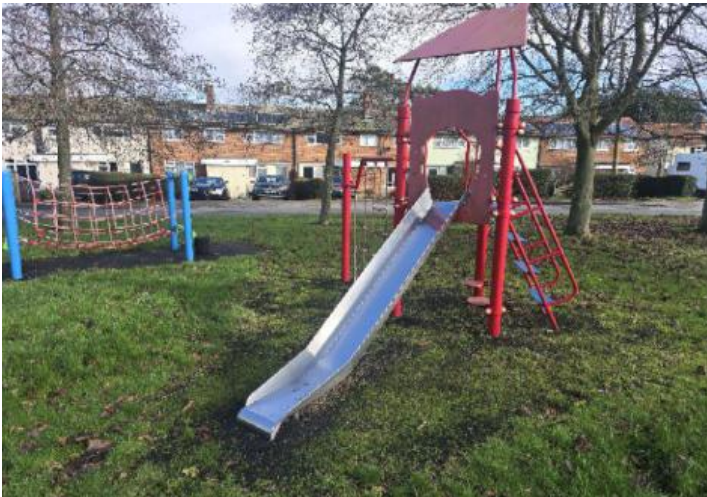
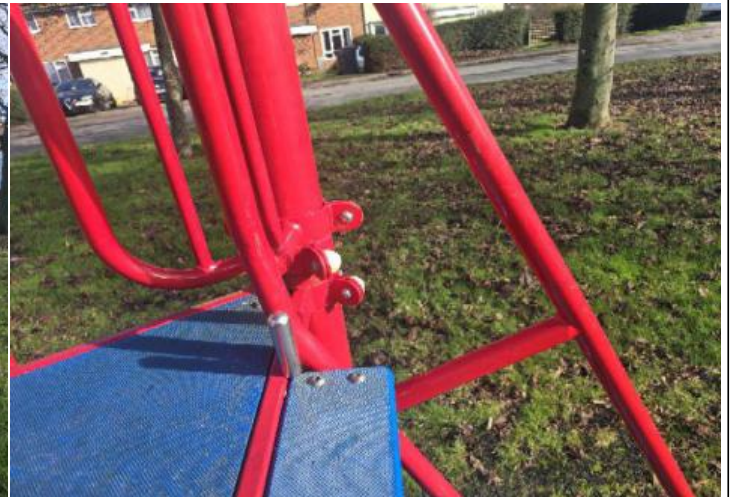
Item: Activity Equipment - Multi Play (Junior)
Manufacturer: Not Identified

Finding: There is/are finger entrapment/s in the framework and the item fails to meet the requirements of BS EN 1176 Part 1 4.2.7.6 Entrapment of fingers

Action: Monitor - No action given the risk assessment

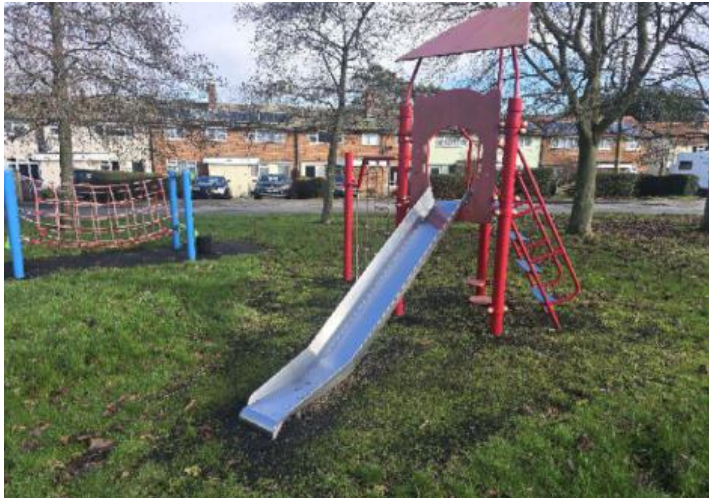
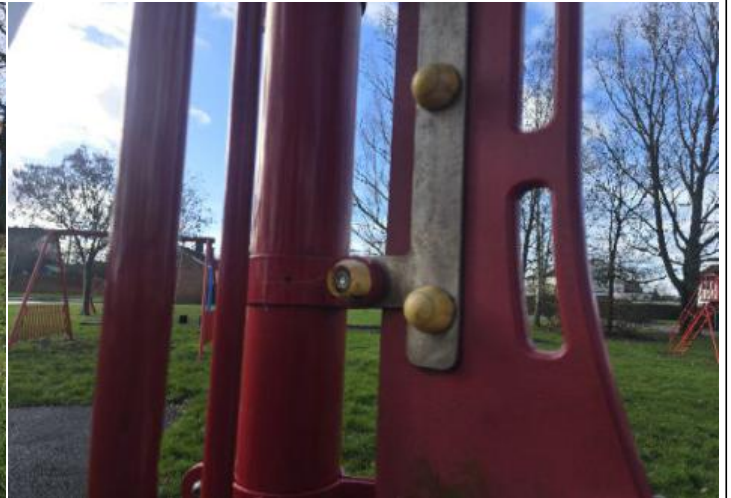
Item: Activity Equipment - Multi Play (Junior)
Manufacturer: Not Identified

Finding: There is/are bolt cap covers missing or damaged on the item

Action: Replace missing or damaged bolt cap covers

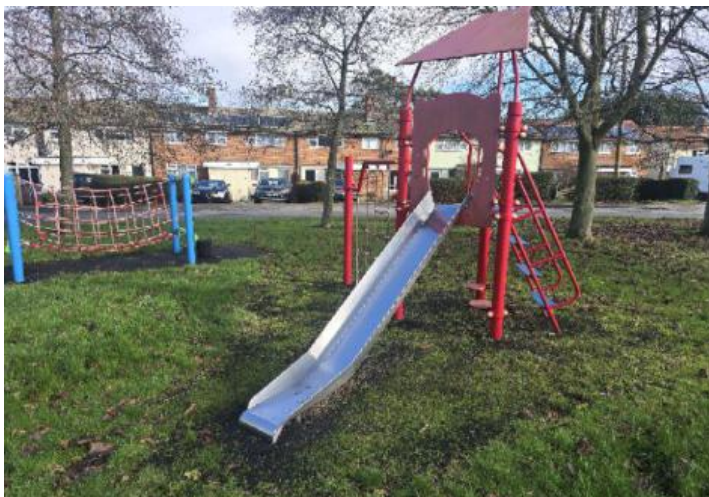
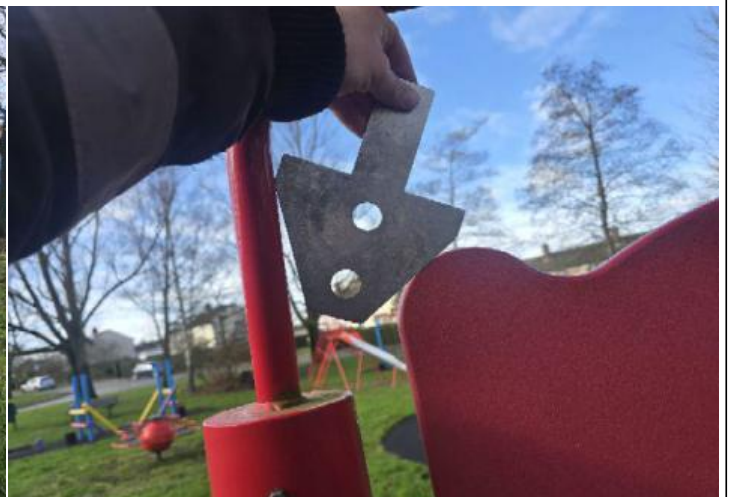
Item: Activity Equipment - Multi Play (Junior)
Manufacturer: Not Identified

Finding: The item fails to meet the requirements of BS EN 1176 Part 1 4.2.7.2 head and neck entrapment in the barriers and/or steps

Action: Monitor - No action given the risk assessment

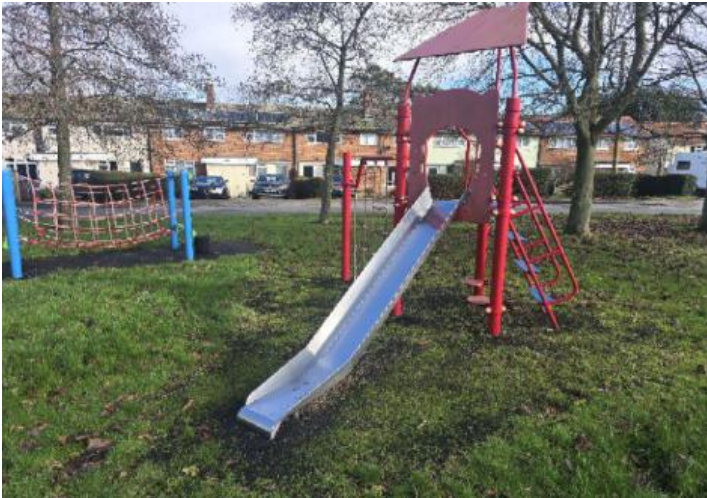
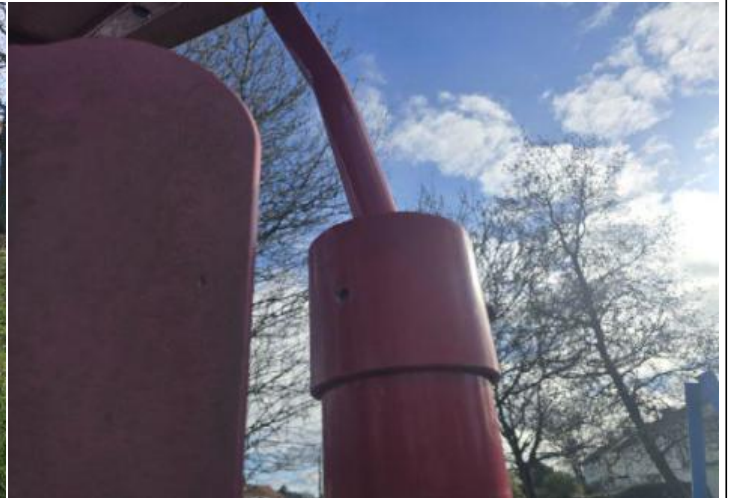
Item: Activity Equipment - Multi Play (Junior)
Manufacturer: Not Identified

Finding: There is or are fixings missing on the post

Action: Replace all missing fixings

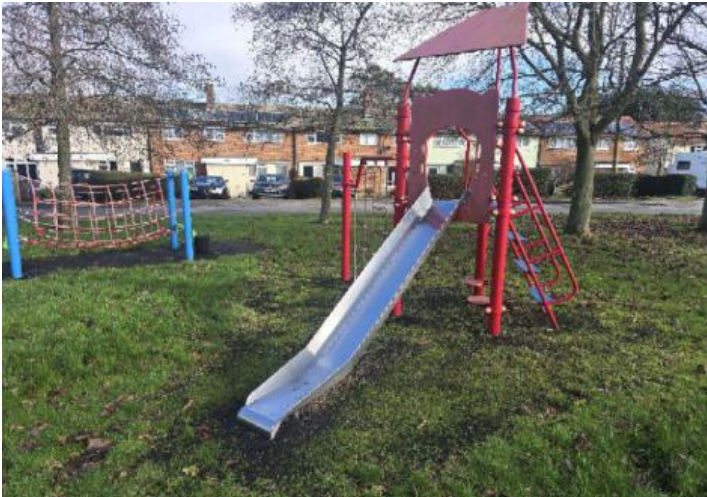
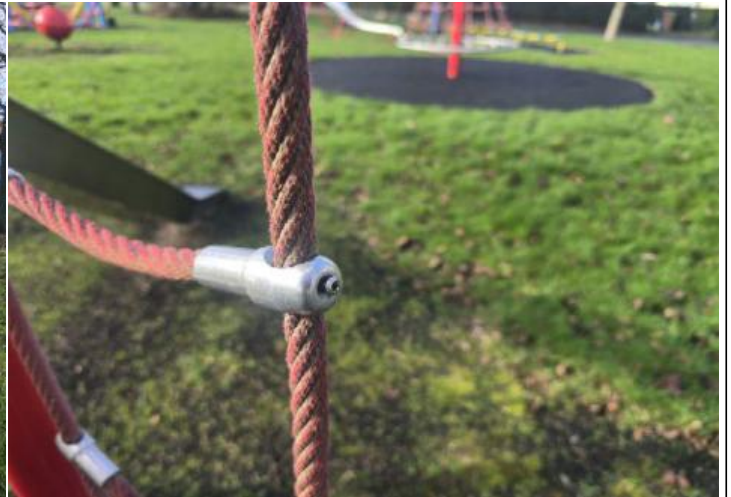
Item: Activity Equipment - Multi Play (Junior)
Manufacturer: Not Identified

Finding: A number of fixing(s) have worked loose

Action: Secure all loose fixings

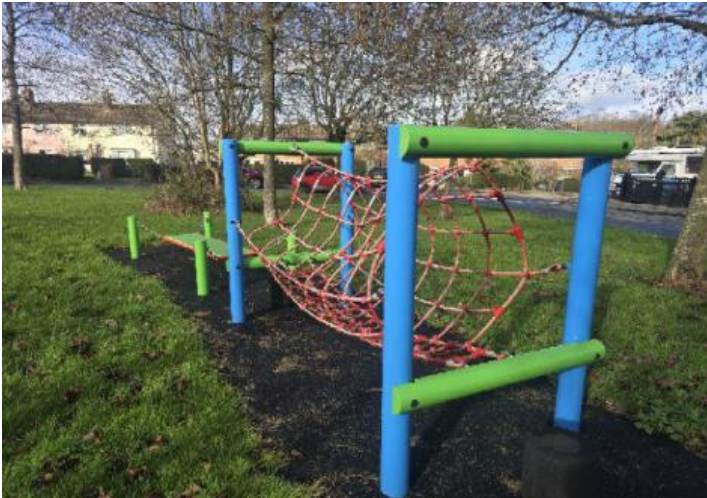
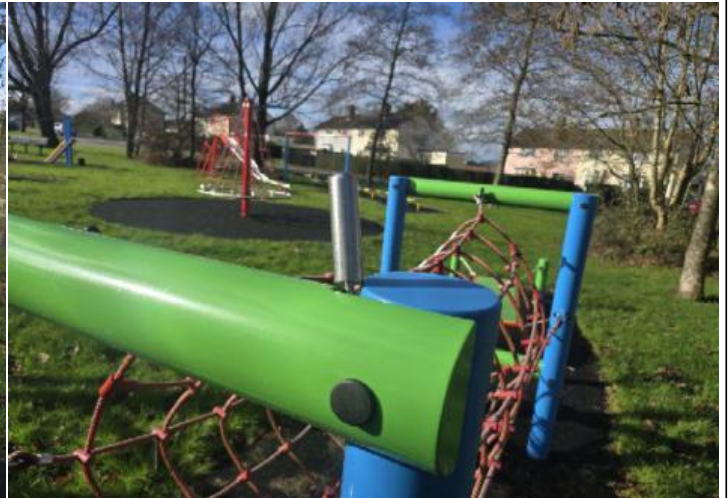
Item: Activity Equipment - Rope Tunnel
Manufacturer: Not Identified

Finding: There is/are finger entrapment/s in the frame and the item fails to meet the requirements of BS EN 1176 Part 1 4.2.7.6 Entrapment of fingers

Action: Monitor - No action given the risk assessment

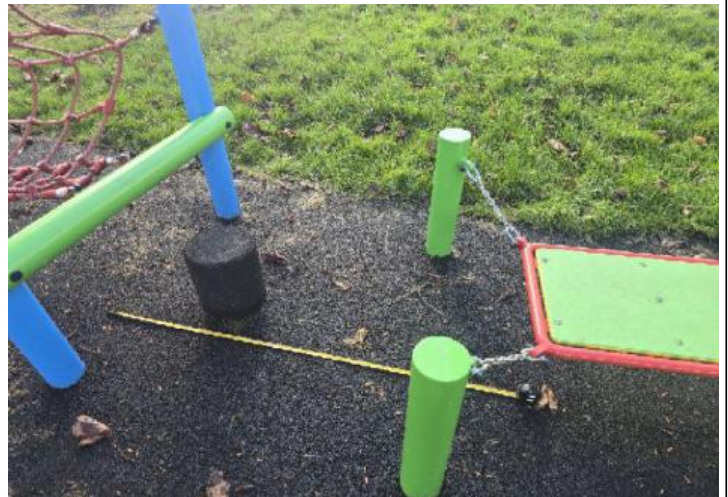
Item: Activity Equipment - Wobble Board
Manufacturer: Not Identified

Finding: The adjacent items forms a projecting obstacle / hard object within the falling space of the equipment, in contravention of the requirements of BS EN 1176 Part 1

Action: Monitor - No action given the risk assessment

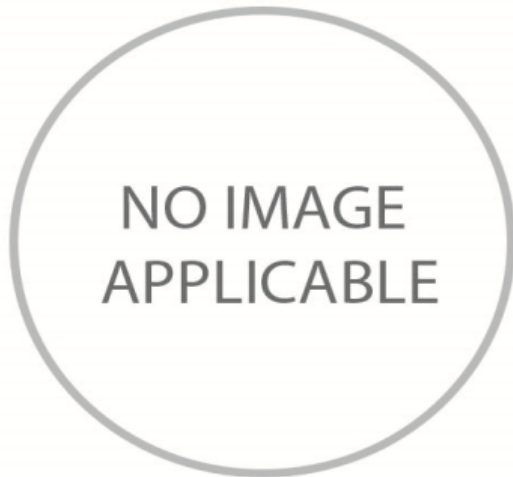
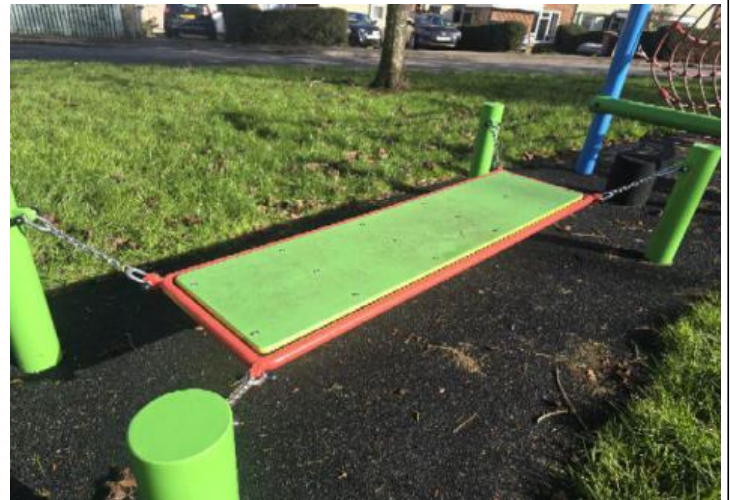
Item: Activity Equipment - Wobble Board
Manufacturer: Not Identified

Finding: The clearance to the underside of the wobble board is less than 400mm and fails the requirements of BS EN 1176 Part 1

Action: Monitor - No action given the risk assessment

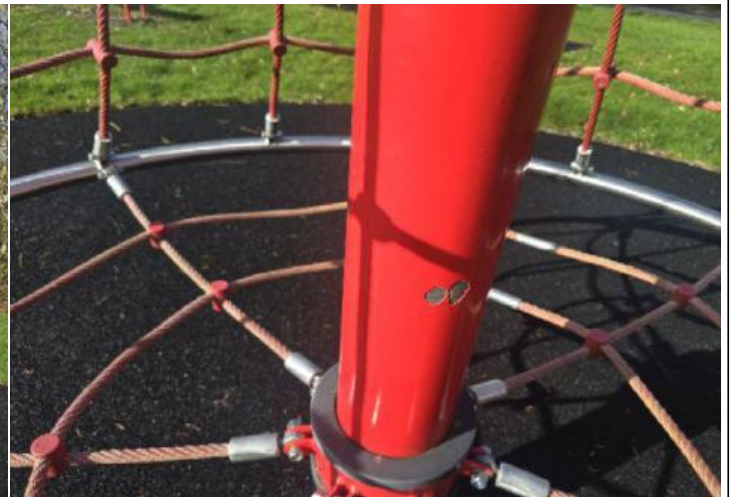
Item: Rotor Play - Rotating Net
Manufacturer: Not Identified

Finding: The paint is flaking off the metalwork

Action: Rub down and re-paint

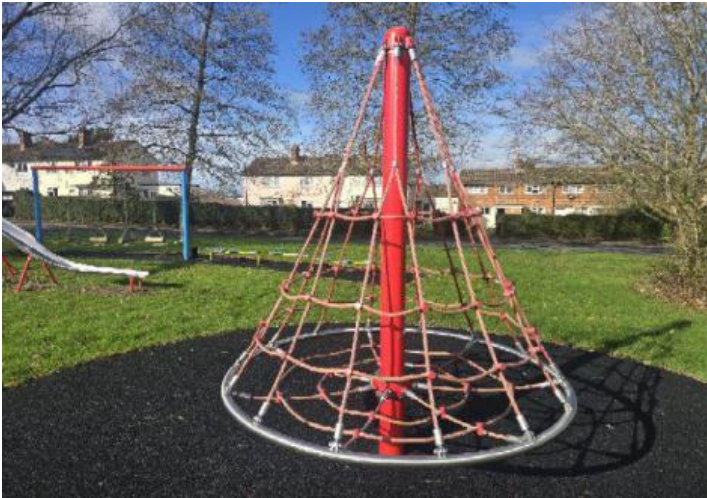
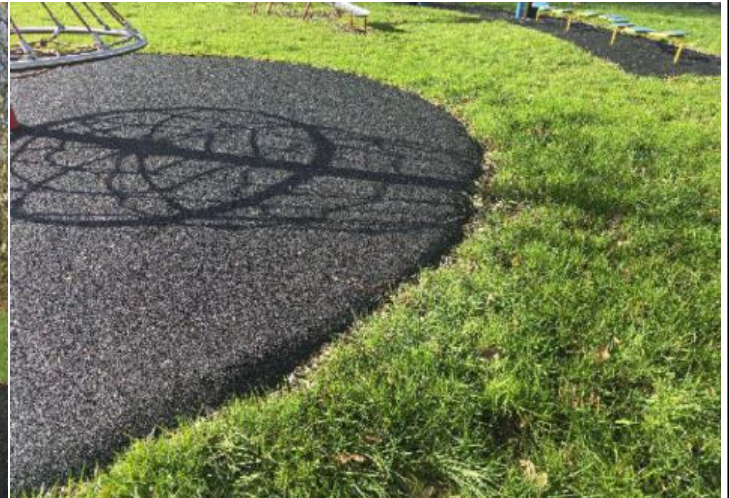
Item: Rotor Play - Rotating Net
Manufacturer: Not Identified

Finding: There is / are steep gradients along the edges of the synthetic surface that may cause users to trip or roll ankles

Action: Build up surrounding surface levels to remove

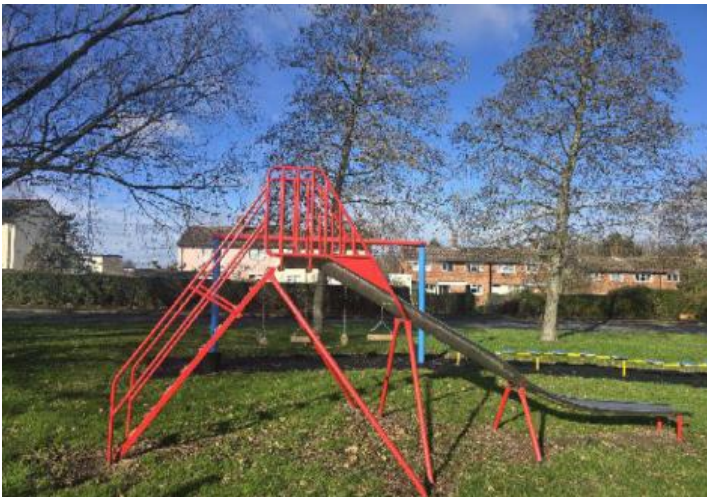
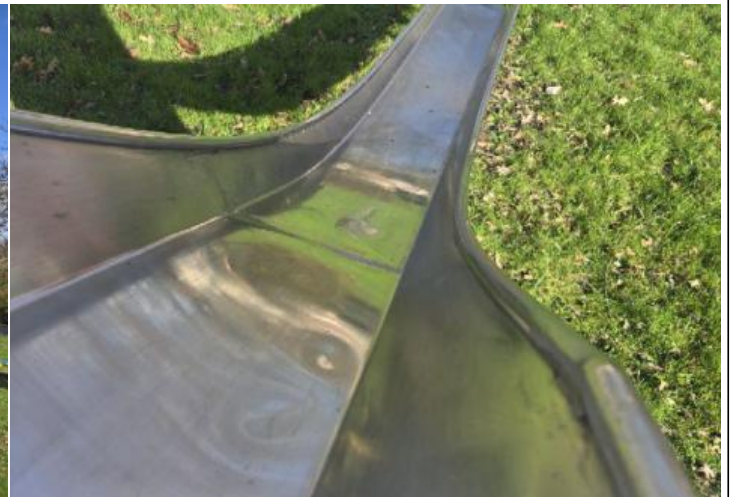
Item: Other - Free Standing Slide
Manufacturer: Not Identified

Finding: There are a number of dents in the slide surface

Action: Monitor for any further deterioration and repair as required

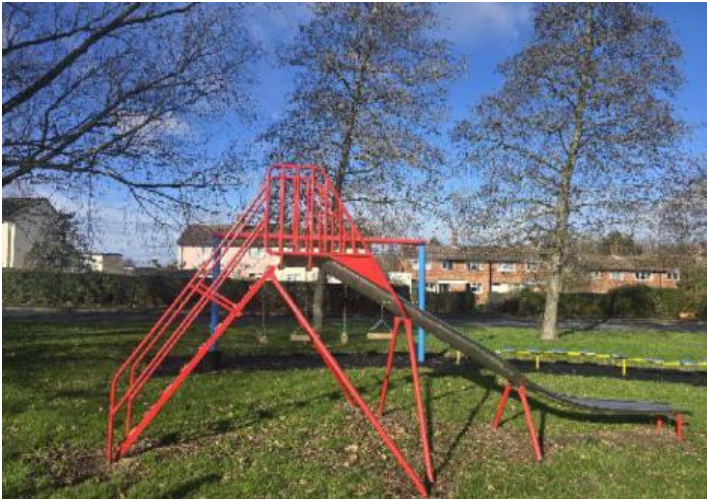
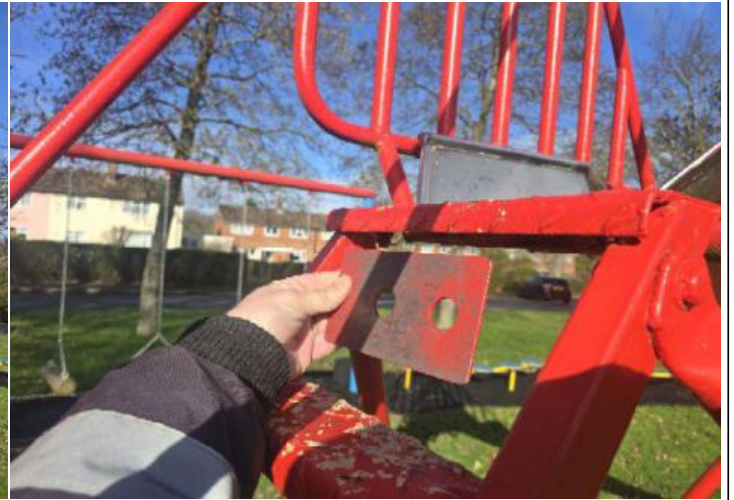
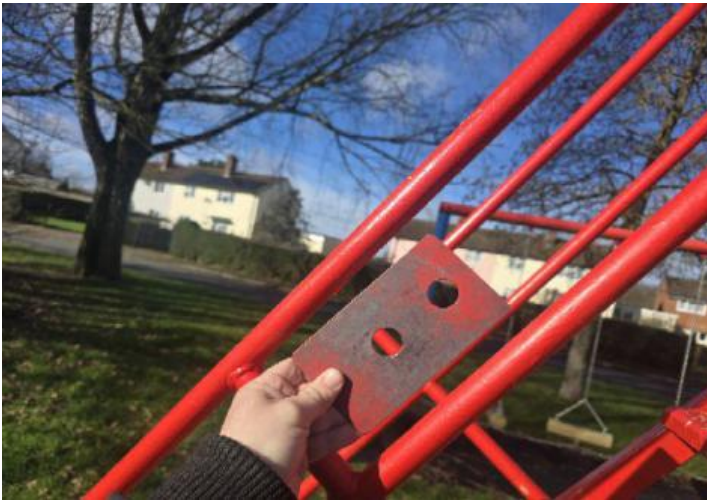
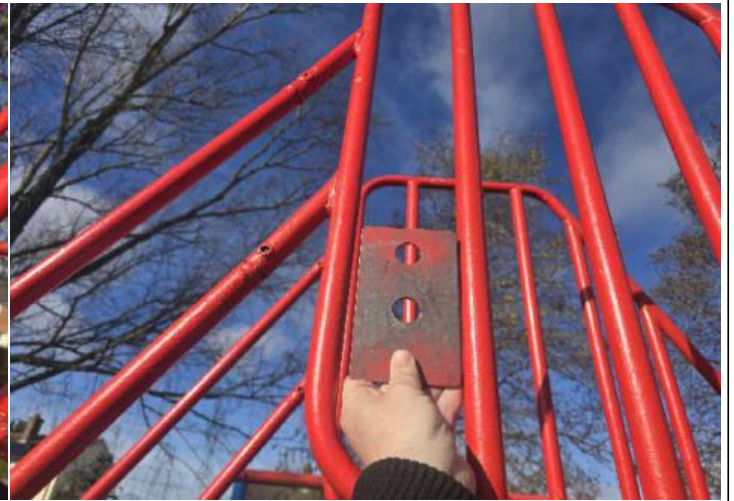
Item: Other - Free Standing Slide
Manufacturer: Not Identified

Finding: The item fails to meet the requirements of BS EN 1176 Part 1 4.2.7.2 head and neck entrapment in the barriers and/or steps

Action: Monitor - No action given the risk assessment

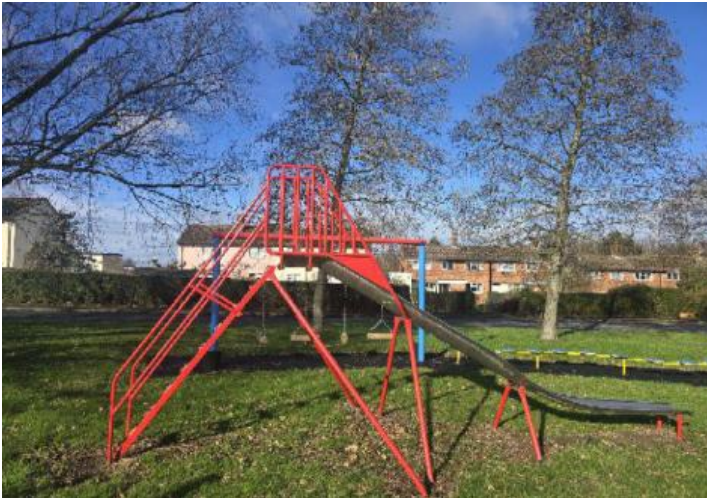
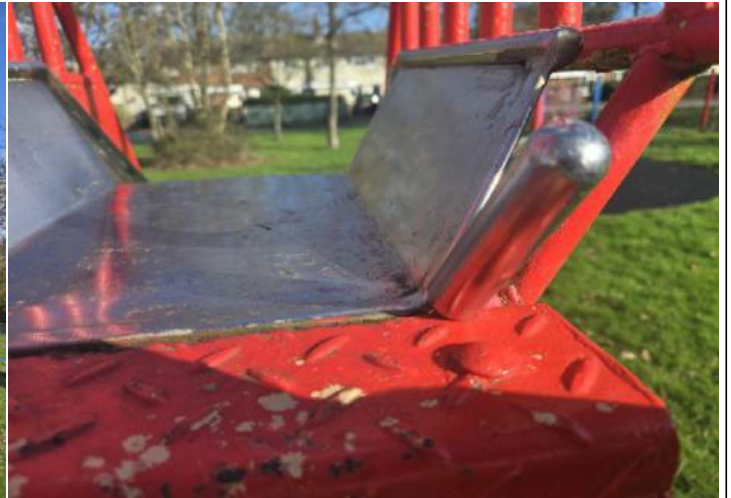
Item: Other - Free Standing Slide
Manufacturer: Not Identified

Finding: There is/are finger entrapment/s in the framework and the item fails to meet the requirements of BS EN 1176 Part 1 4.2.7.6 Entrapment of fingers

Action: Monitor - No action given the risk assessment

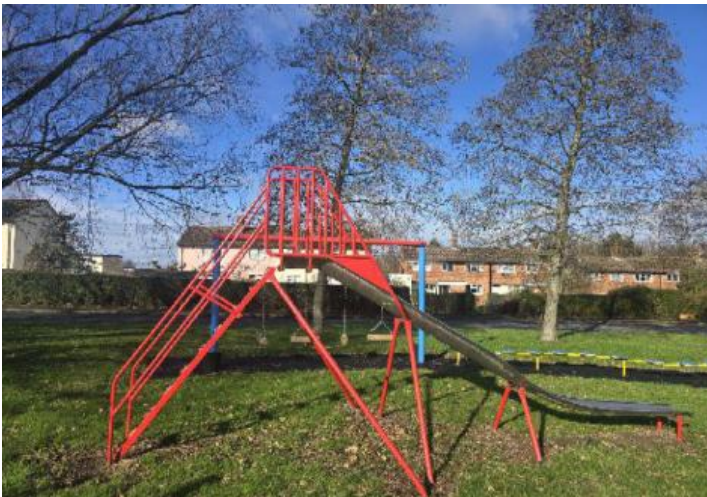
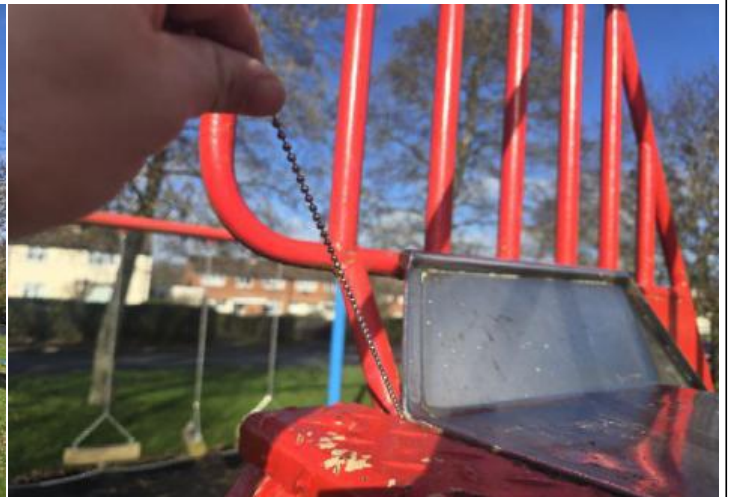
Item: Other - Free Standing Slide
Manufacturer: Not Identified

Finding: There is / are toggle entrapment/s present in contravention of the recommendations set out in BS EN 1176 Part 1

Action: Monitor - No action given the risk assessment

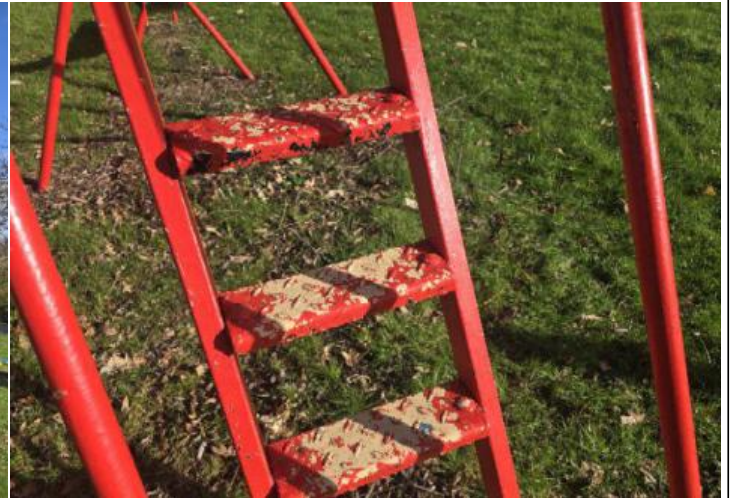
Item: Other - Free Standing Slide
Manufacturer: Not Identified

Finding: The paint is flaking off the metalwork

Action: Rub down and re-paint

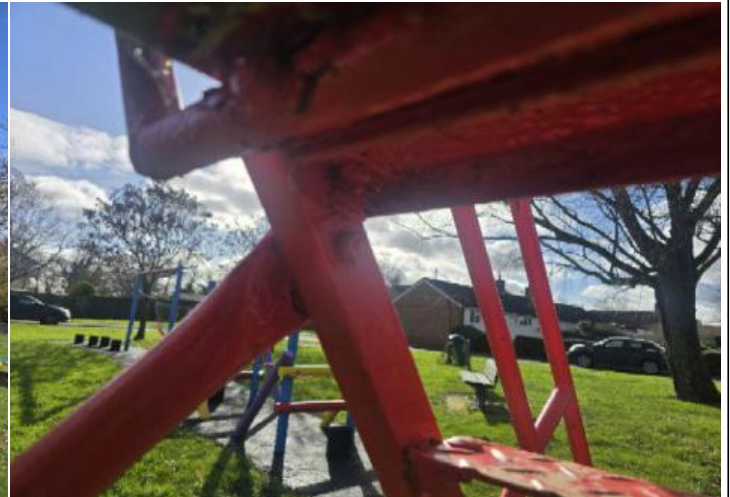
Item: Other - Free Standing Slide
Manufacturer: Not Identified

Finding: There are projecting bolt thread(s) present

Action: Remove excess thread length and deburr or provide cap
