the **play inspection** company

Annual Inspection

Copdock and Washbrook Parish Council - Fen View

Inspected: 16-February-2026 - 15:00 by James Law (RPII Annual Inspector)

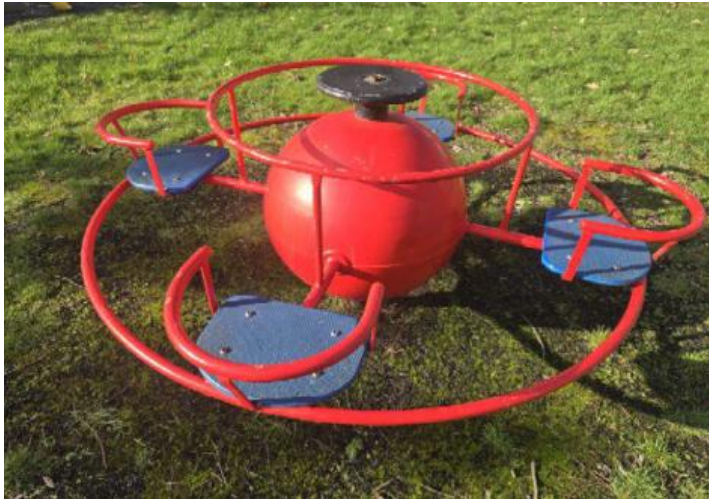
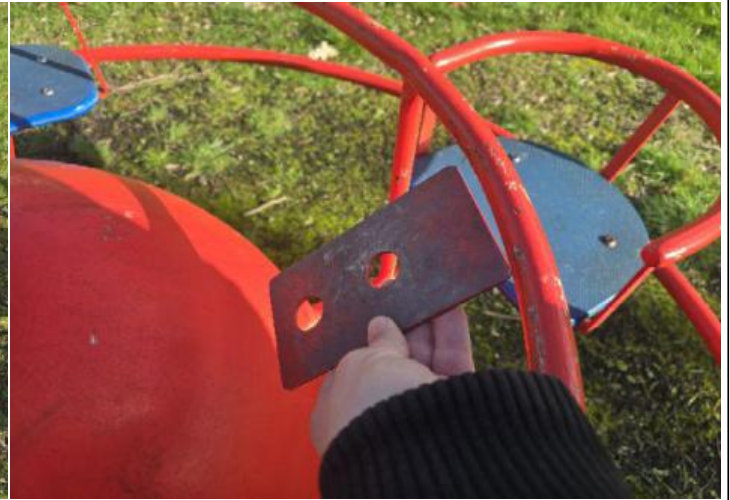
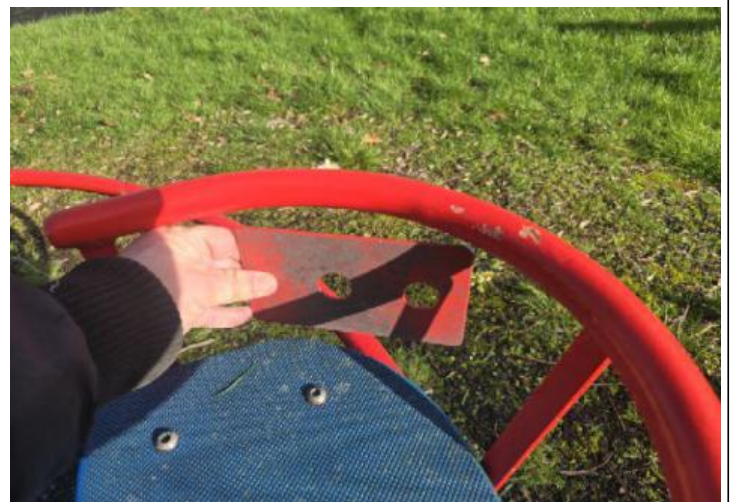
Item: Rotor Play - Roundabout
Manufacturer: Not Identified

Finding: The item fails to meet the requirements of BS EN 1176 Part 1 4.2.7.2 for head and neck entrapment in the framework

Action: Monitor - No action given the risk assessment

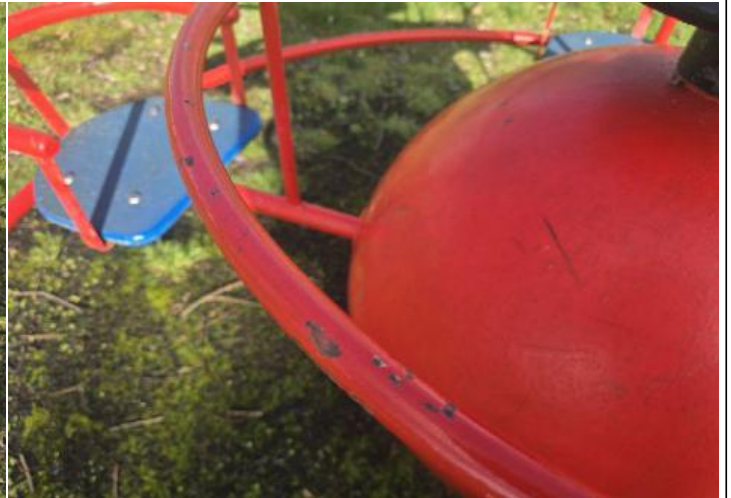
Item: Rotor Play - Roundabout
Manufacturer: Not Identified

Finding: The paint is flaking off the metalwork

Action: Rub down and re-paint

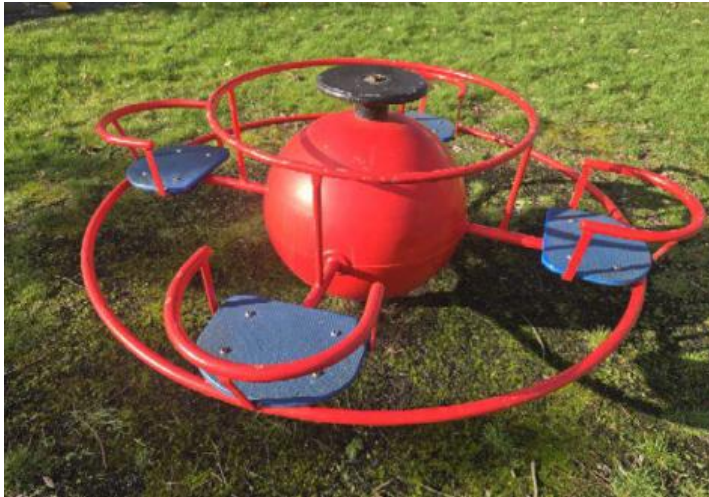
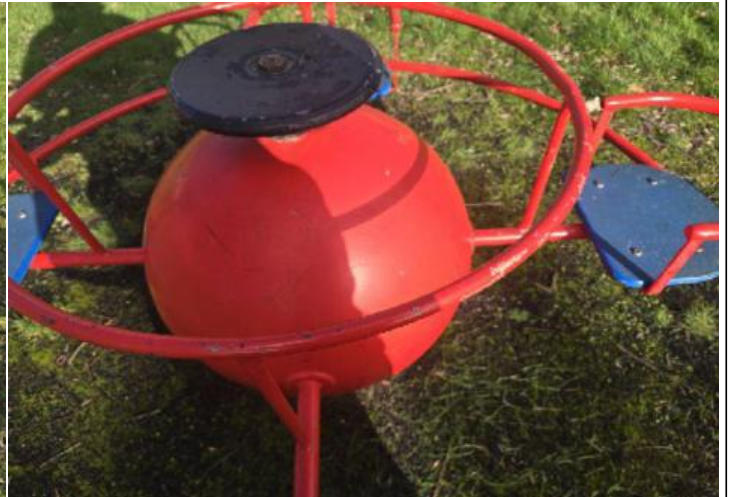
Item: Rotor Play - Roundabout
Manufacturer: Not Identified

Finding: The bearing is worn / damaged and the item is not operating correctly

Action: Repair / replace
