# the **play inspection** company

## Annual Inspection

Babergh District Council

Copdock and Washbrook Parish Council - Mill Lane

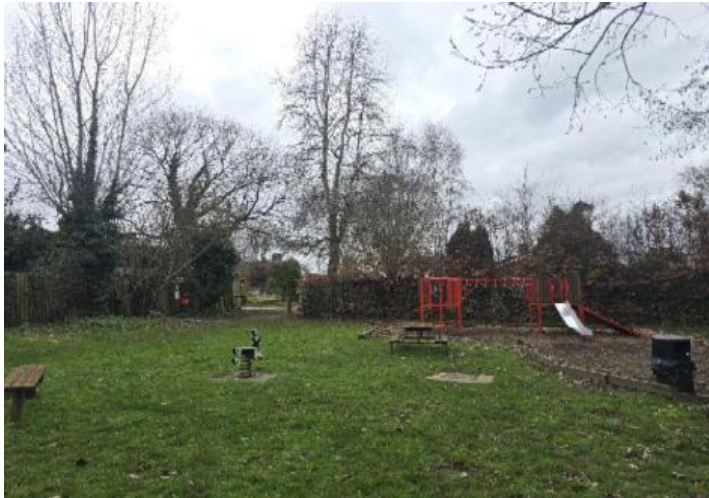
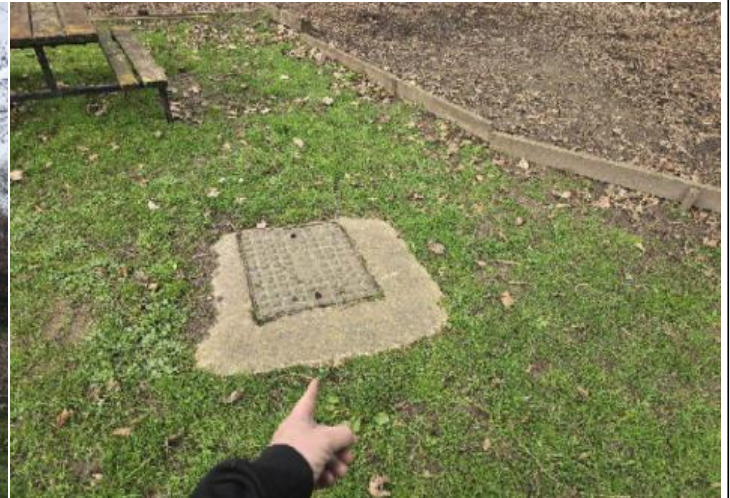
**Finding:** There are trip hazards at the edges of the surface **Action:** Remove trip hazard

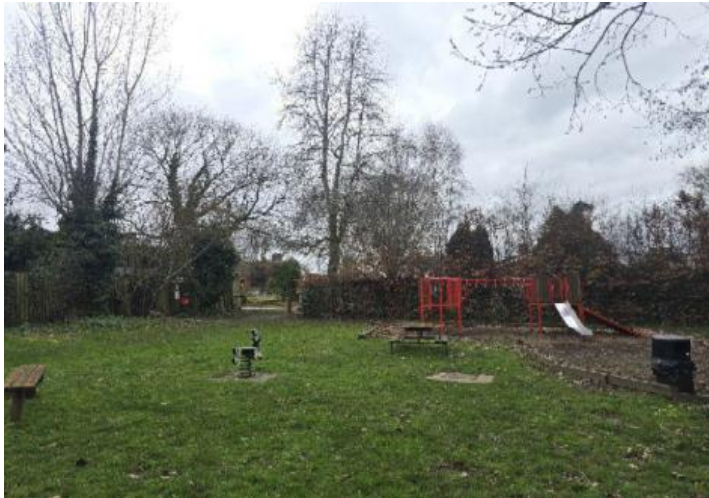
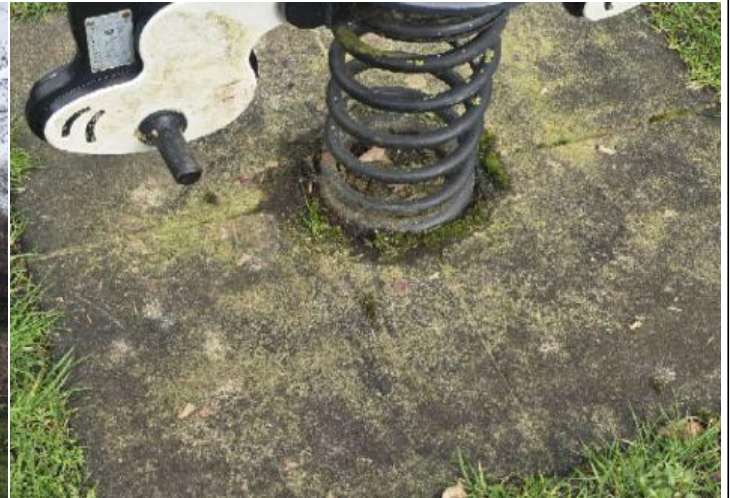
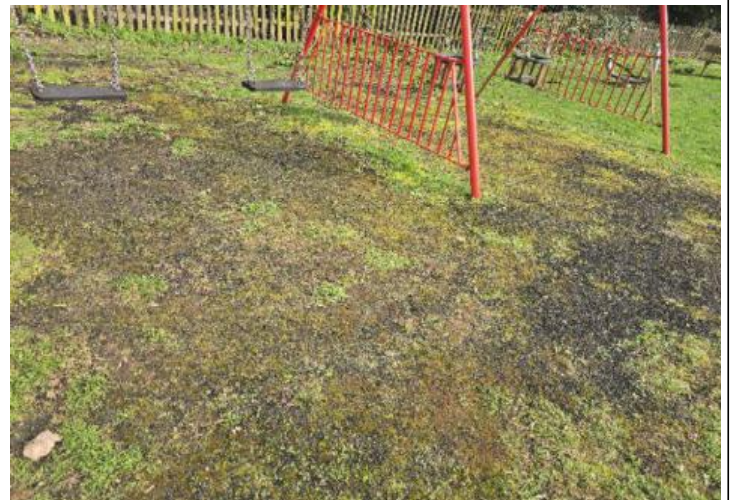
**Finding:** There is algae, silt or moss growth on the surface resulting in slippery conditions

**Action:** Clean and treat appropriately

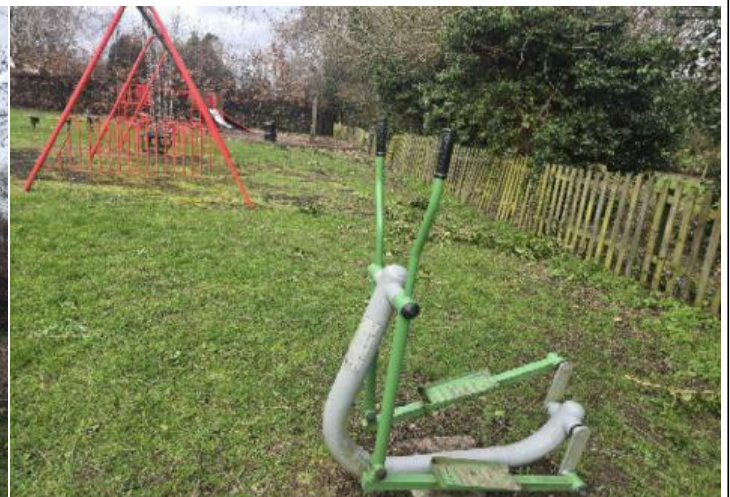
**Finding:** It is recommended that Adult Outdoor Fitness equipment is installed a minimum of 25m away from a childrens playground or separated and screened to discourage access by younger children

**Action:** Monitor use and review risk assessment regularly

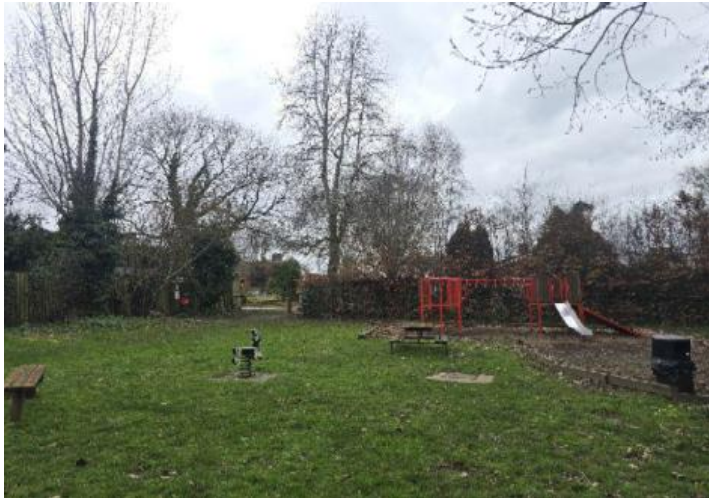
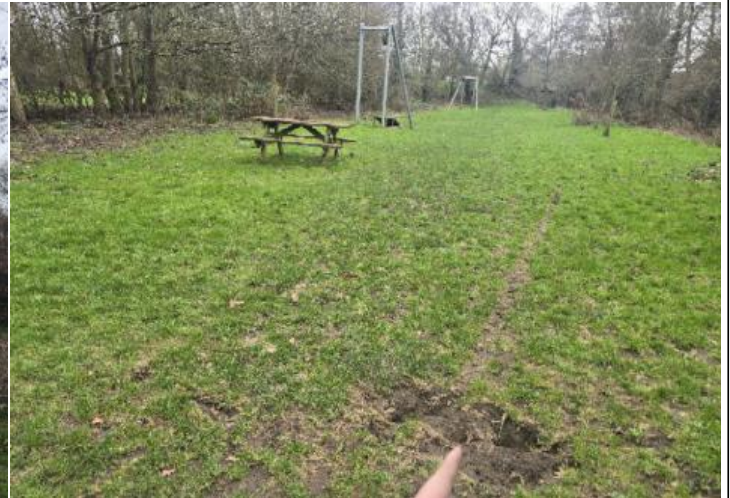
**Finding:** There are holes in the surface that may cause users to trip or roll ankles

**Action:** Infill to provide a sound reasonably level surface.

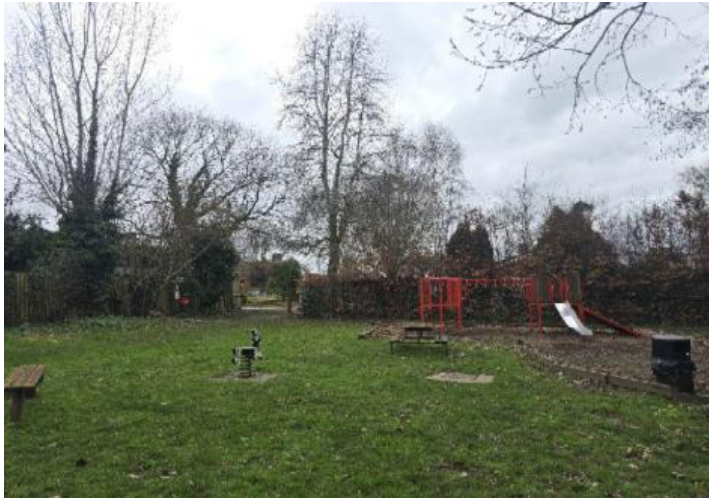
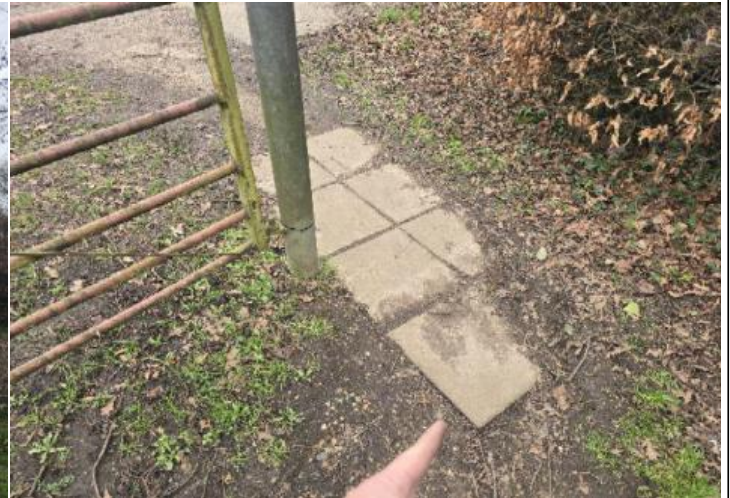
**Finding:** There are trip hazards at the edges of the surface **Action:** Remove trip hazard

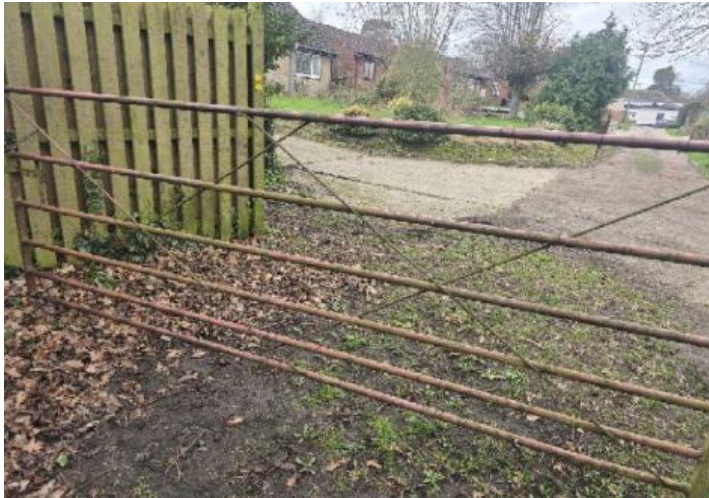
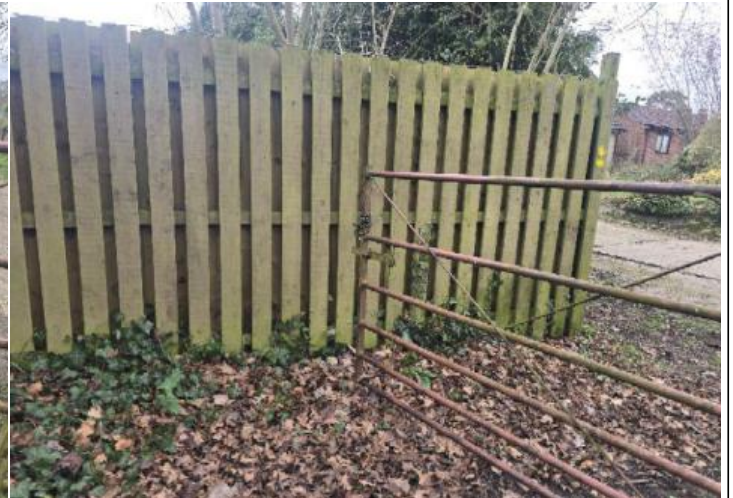
**Finding:** The gate latch is damaged and gate post is missing

**Action:** Repair or replace post

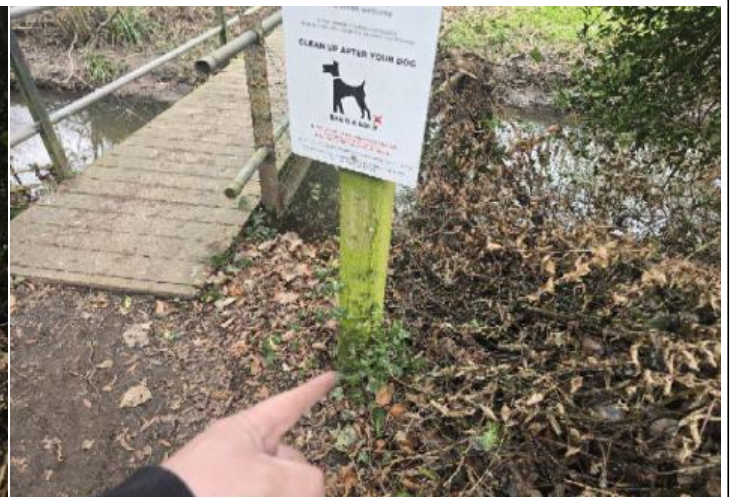
**Finding:** The item is slightly loose in its foundations

**Action:** Monitor for any further deterioration and repair as required

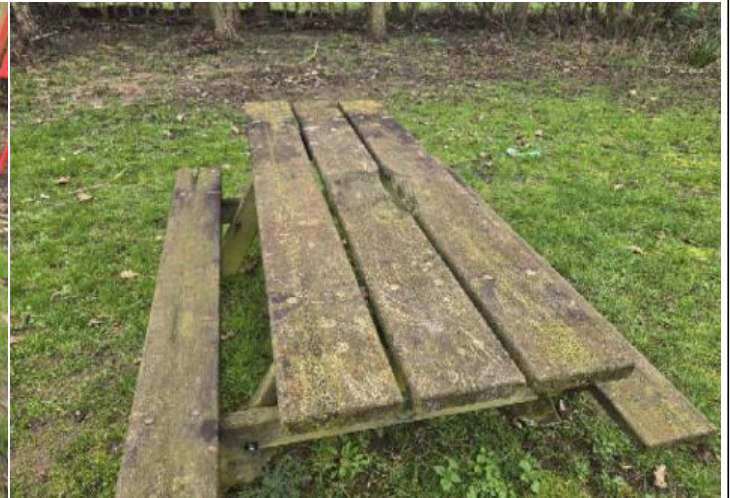
**Finding:** There is some evidence of fire damage to the item **Action:** Monitor for any further deterioration and repair as required

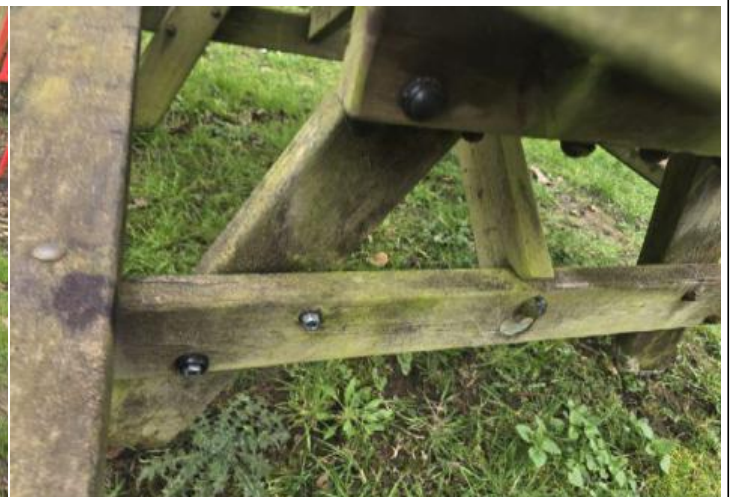
**Finding:** There is/are bolt cap covers missing or damaged on the item **Action:** Replace missing or damaged bolt cap covers

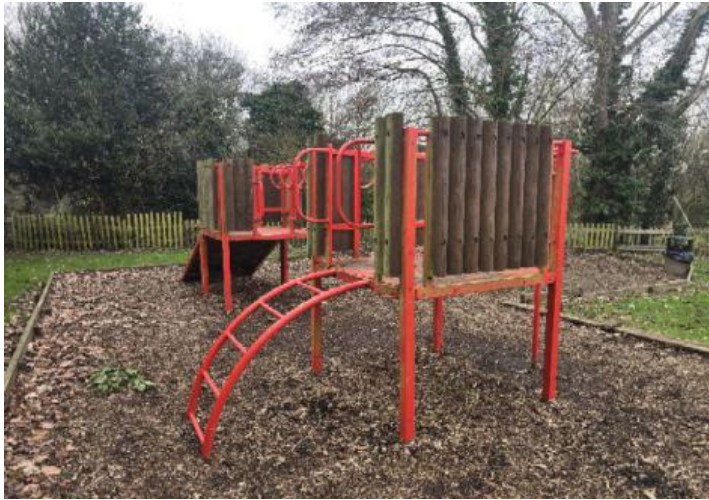
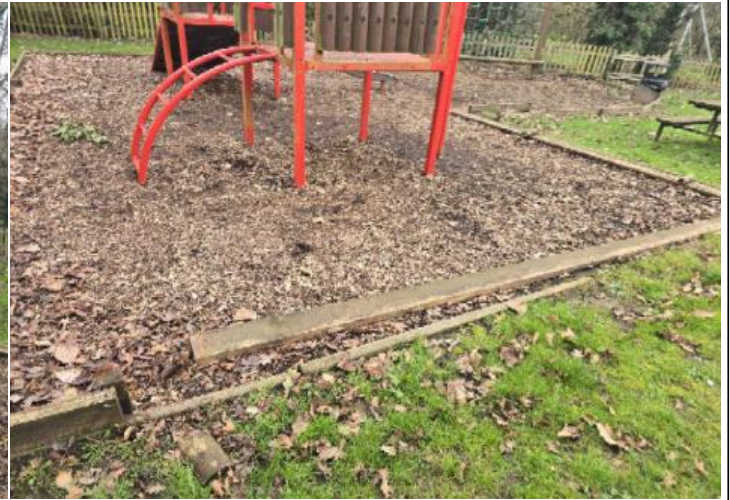
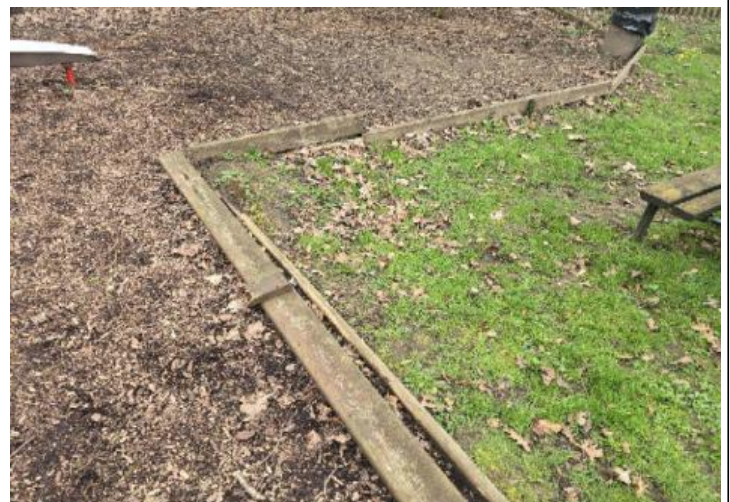
**Finding:** There are areas or parts of the timber edging that have rotted and are unsecured

**Action:** Replace all affected timbers

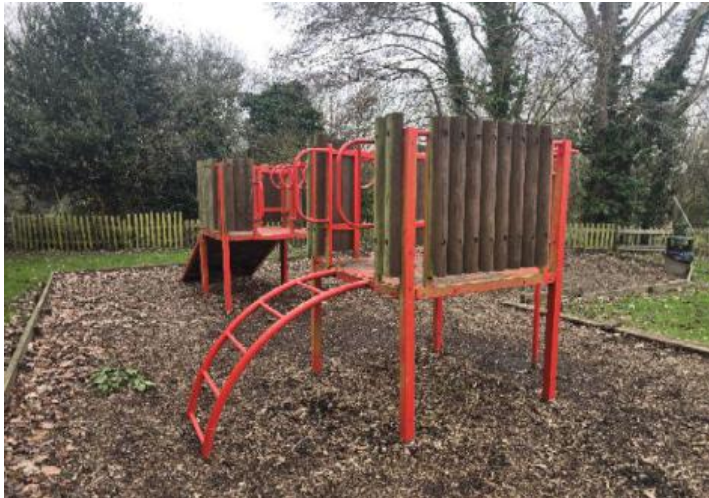
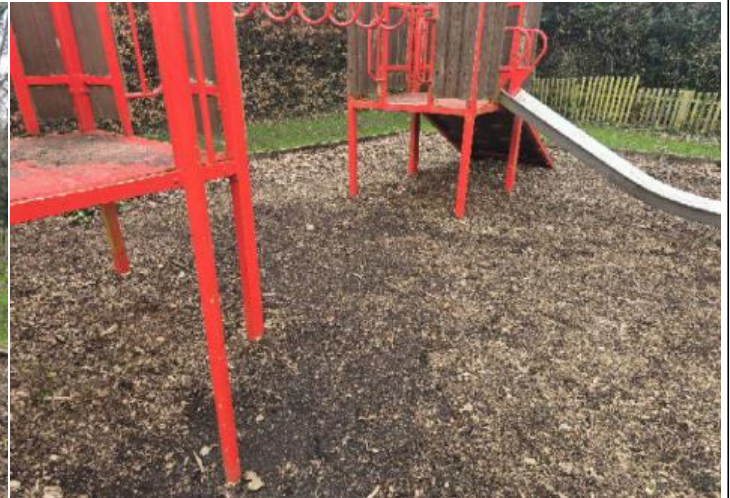
**Finding:** The depth of the loose fill surfacing is lower than the recommended depth specified in BS EN 1176; the free height of fall of the equipment is less than 2.0m and a minimum of 300mm depth should be provided (including an extra 100mm to allow for compaction and displacement as per BS EN 1176 Part 1 - Table 4)

**Action:** Top up loose fill surfacing to recommended levels

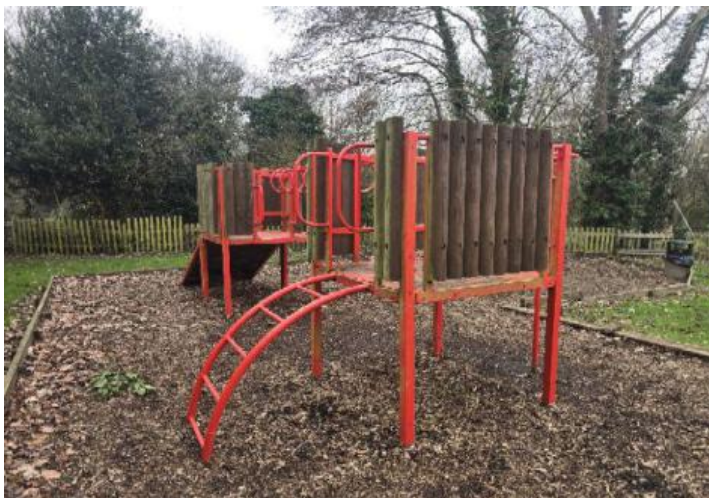
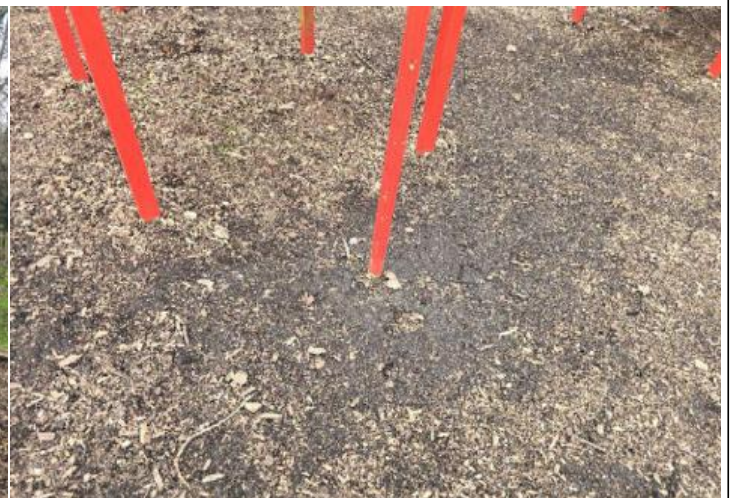
**Finding:** The loose fill safety surfacing has become compacted and degraded to mulch

**Action:** Top up with fresh material

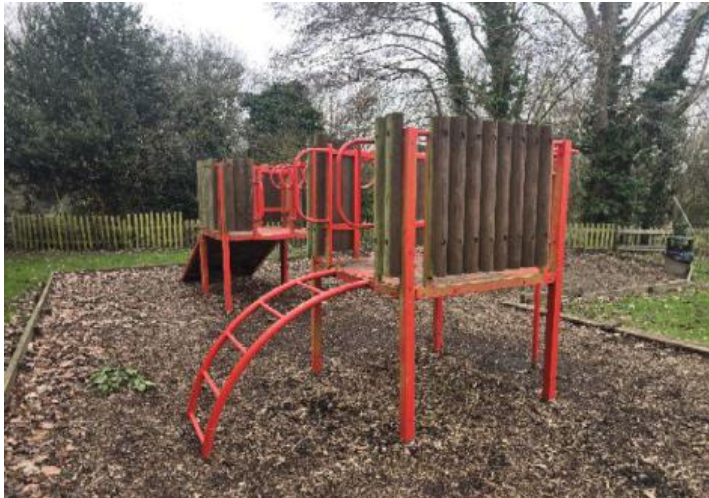
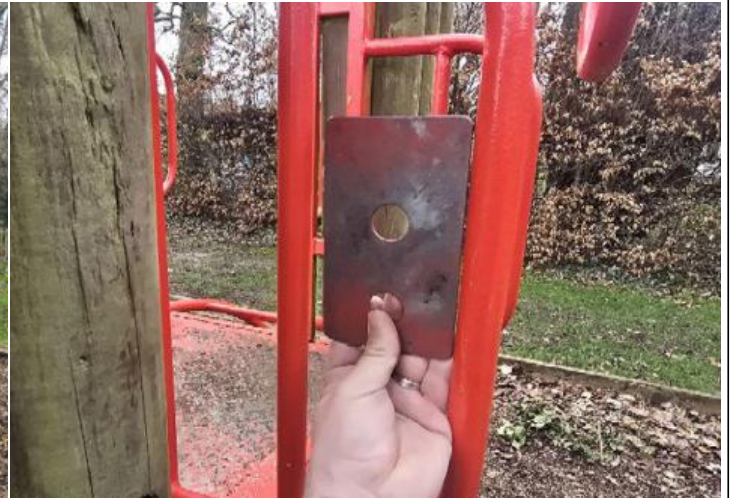
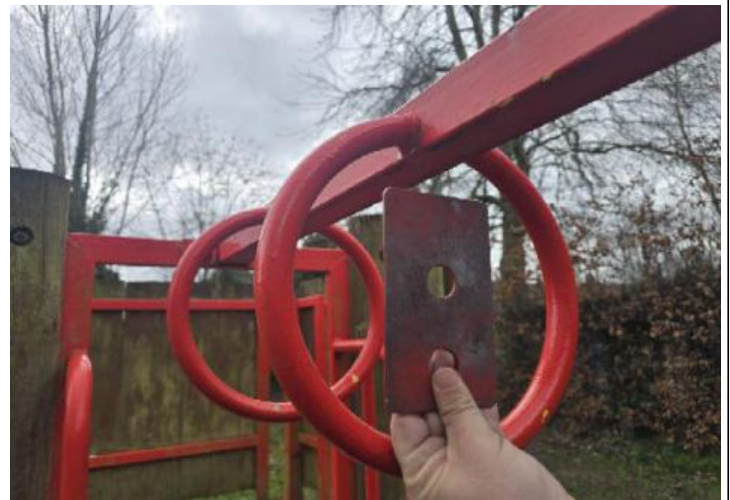
**Finding:** The item fails to meet the requirements of BS EN 1176 Part 1 4.2.7.2 for head and neck entrapment in the framework

**Action:** Monitor - No action given the risk assessment

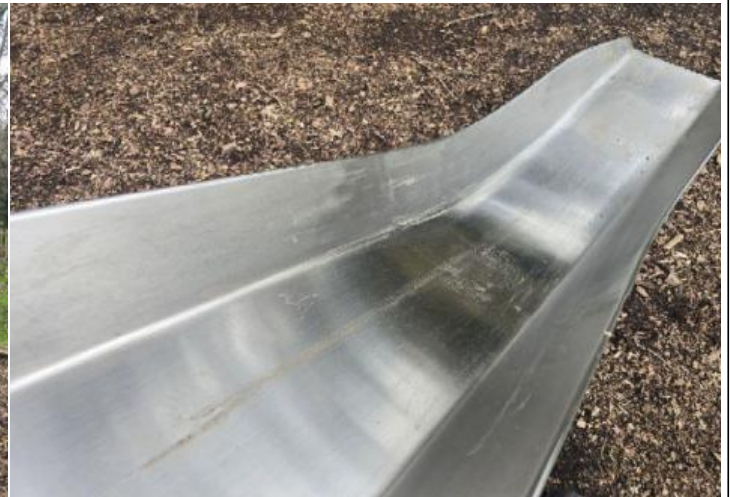
**Finding:** There are a number of dents in the slide surface  
**Action:** Monitor for any further deterioration and repair as required

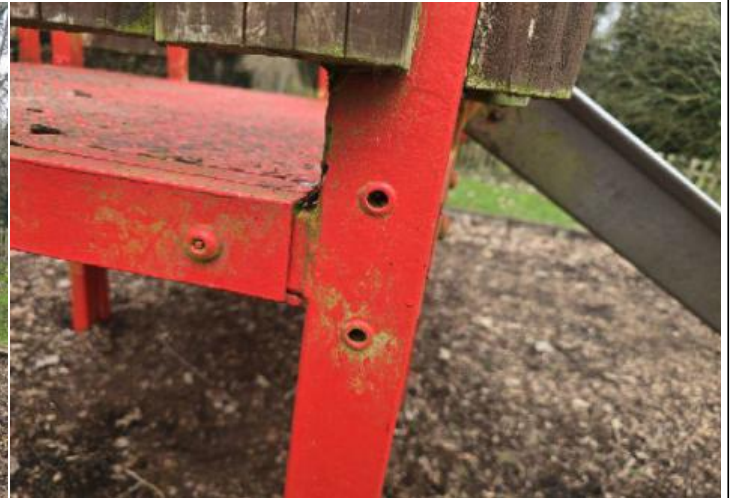
**Finding:** There is/are inserts missing

**Action:** Replace missing inserts

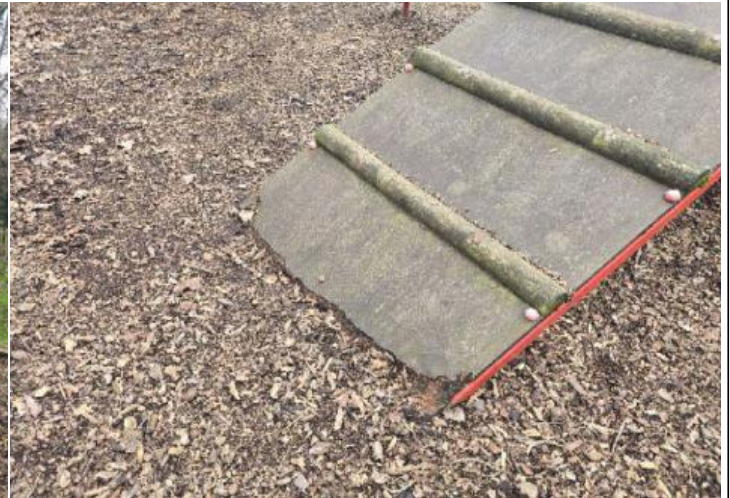
**Finding:** There are areas or parts of the timber ramp that have rotted

**Action:** Replace all affected timbers

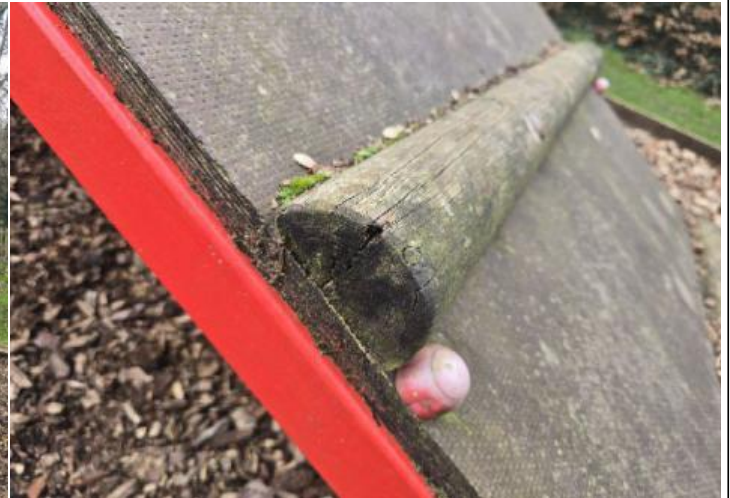
**Finding:** There is some evidence of rot in the timber

**Action:** Monitor for any further deterioration and replace as required

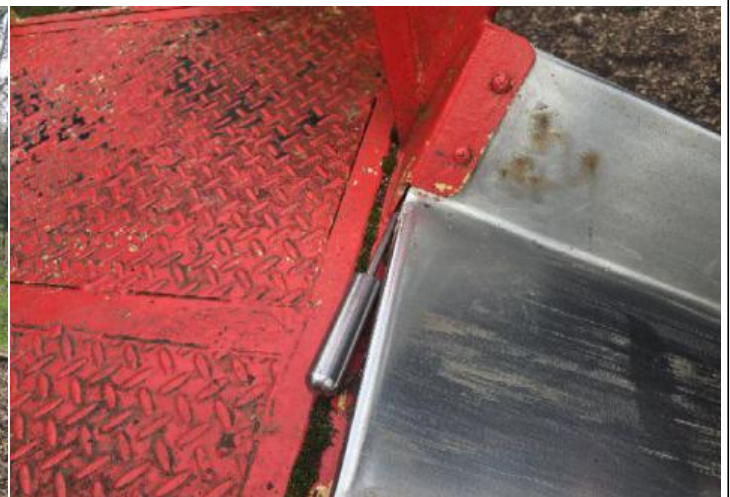
**Finding:** There is/are finger entrapment/s in the starting section of the slide and the item fails to meet the requirements of BS EN 1176 Part 1 4.2.7.6 Entrapment of fingers

**Action:** Monitor - No action given the risk assessment

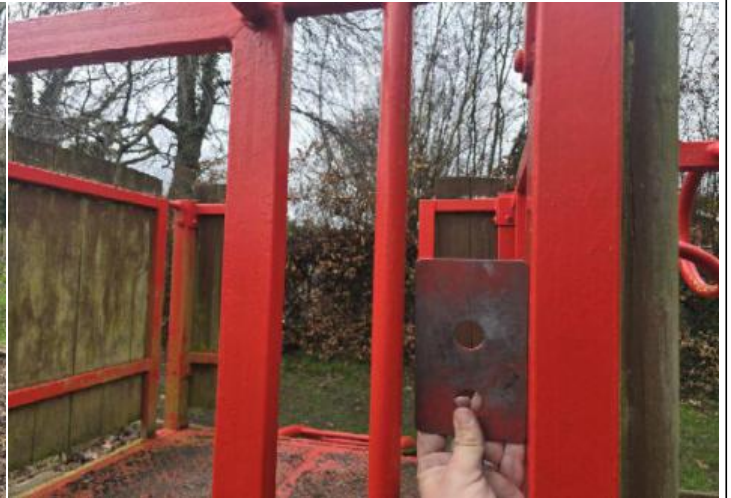
**Finding:** The item fails to meet the requirements of BS EN 1176 Part 1 4.2.7.2 head and neck entrapment in the barriers and/or steps

**Action:** Monitor - No action given the risk assessment

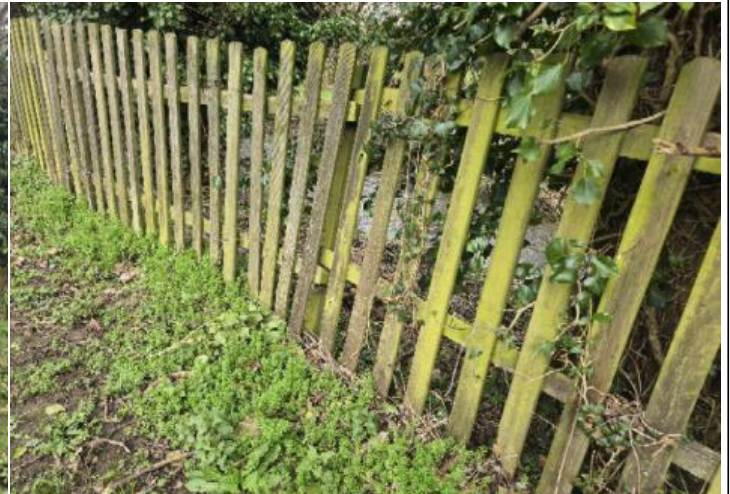
**Finding:** There are areas or parts of the timber fencing that have rotted

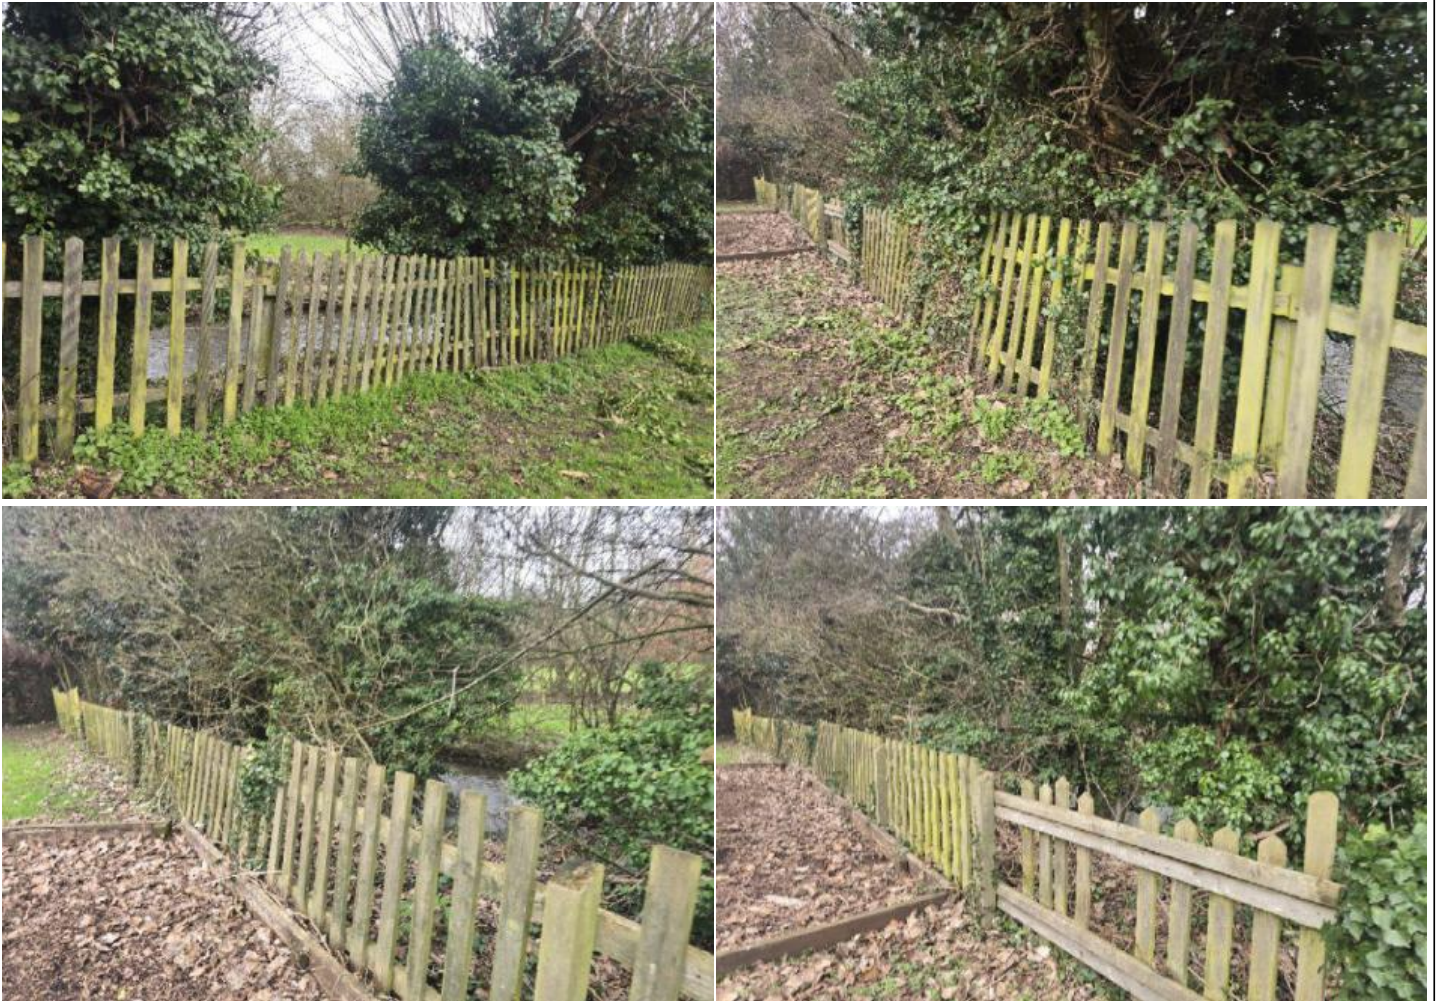
**Finding:** The fence is damaged and is leaning in places

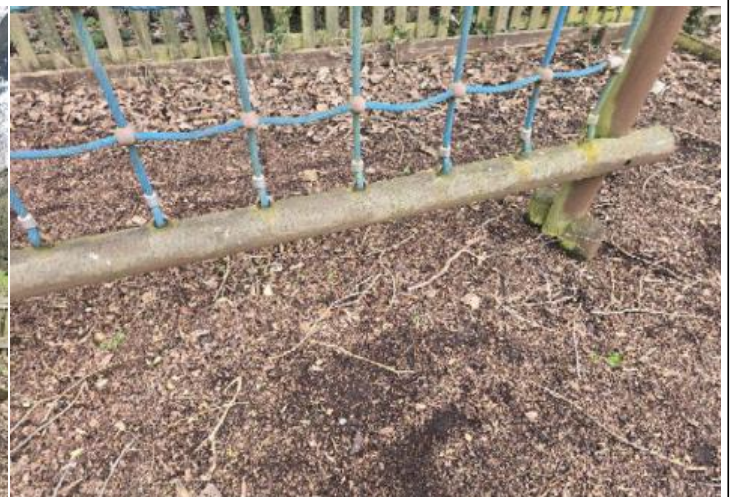
**Finding:** The loose fill safety surfacing has become compacted and degraded to mulch

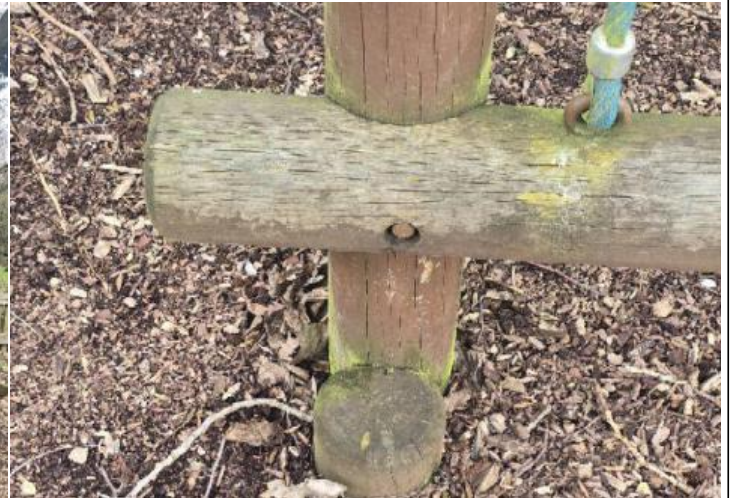
**Finding:** There is/are bolt cap covers missing or damaged on the item

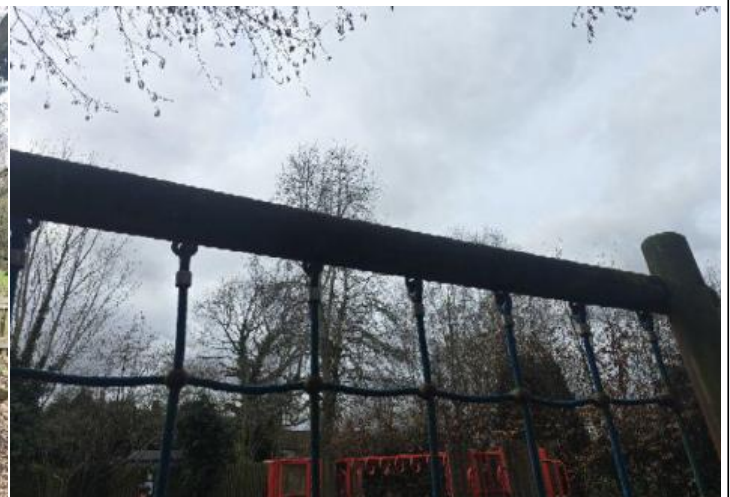
**Finding:** The inspector has some concerns about the internal condition of the timber and was unable to verify the structural integrity without further testing. We recommend a Resi-PD survey to establish the condition of the timber at it's core.

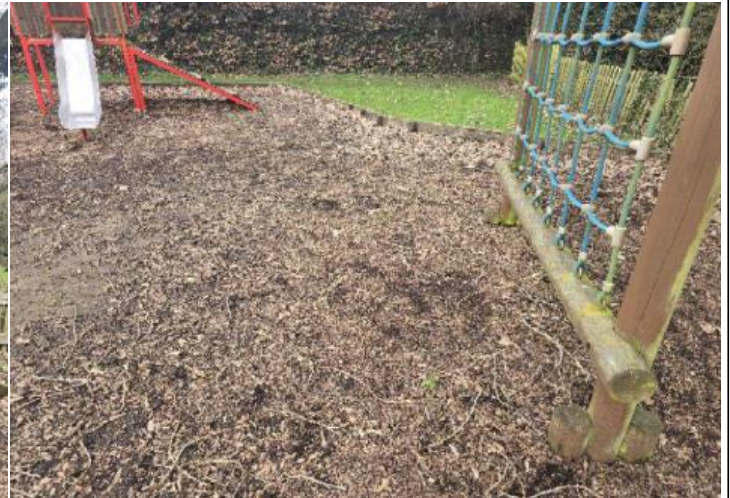
**Finding:** The depth of the loose fill surfacing is lower than the recommended depth specified in BS EN 1176 for a fall height over 2.0m. A minimum depth of 400mm is recommended (including an extra 100mm to allow for compaction and displacement as per BS EN 1176 Part 1 - Table 4)

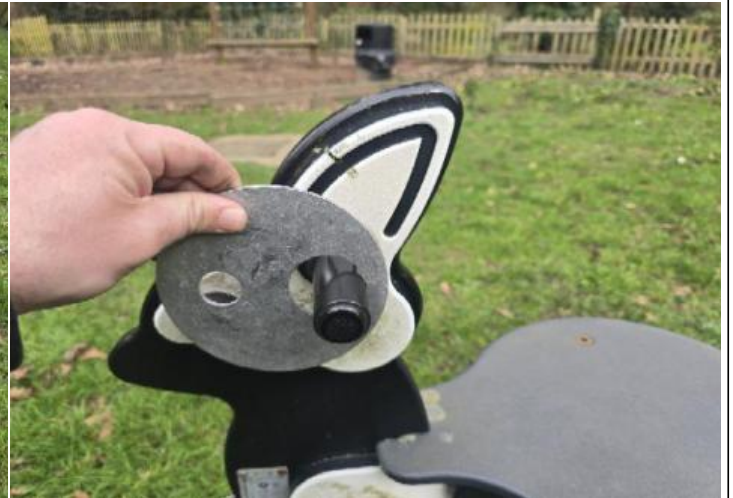
**Finding:** The end of handgrips and/or footrests have a cross section of less than 15cm<sup>2</sup> and fail to meet the requirements of BS EN 1176 Part 6  
**Action:** Monitor - No action given the risk assessment

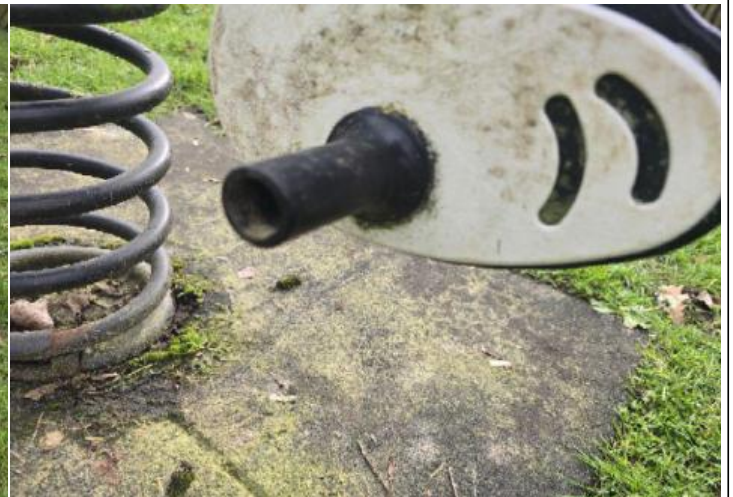
**Finding:** The end caps are missing on the Handgrips/Footrests  
**Action:** Replace missing end caps

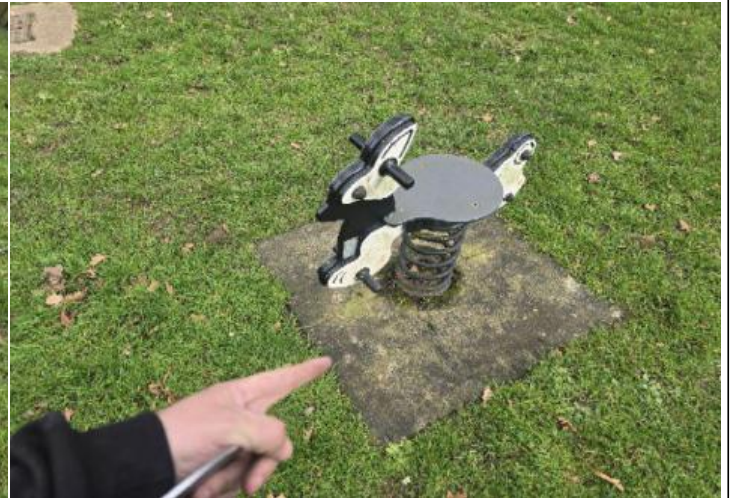
**Finding:** There are trip hazards at the edges of the surface **Action:** Remove trip hazard

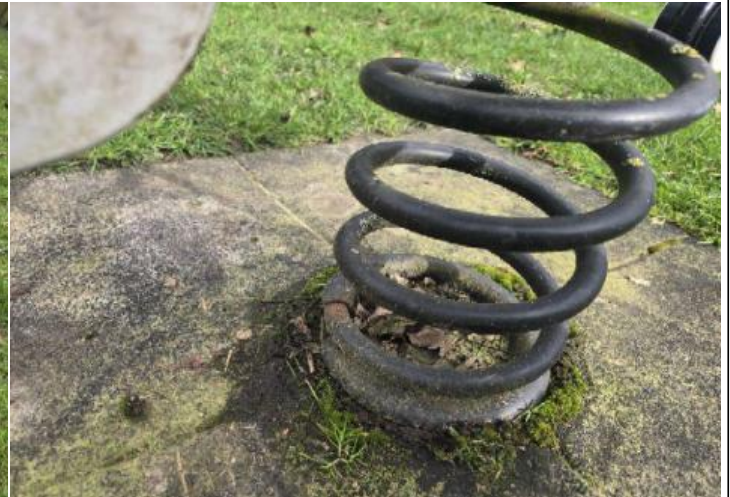
**Finding:** The paintwork on the spring has been damaged or worn exposing the metal underneath which is rusting **Action:** Treat any rusting components and repaint

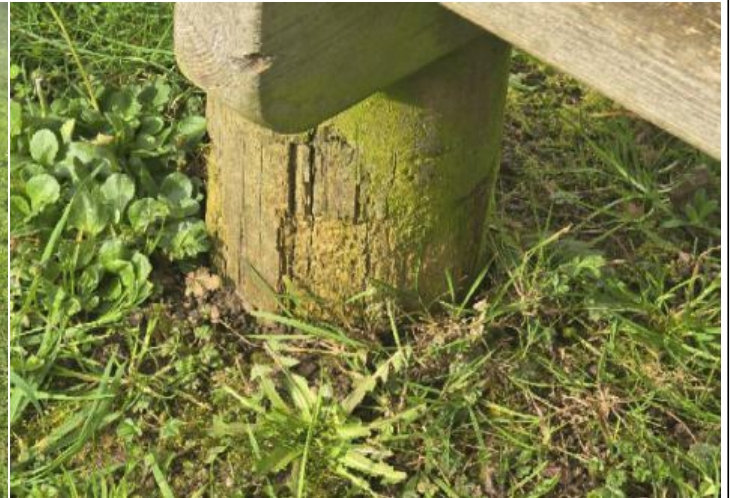
**Finding:** There is some strimmer / machinery damage apparent on the posts, this can penetrate the preservative applied to the timber and accelerate the rotting process

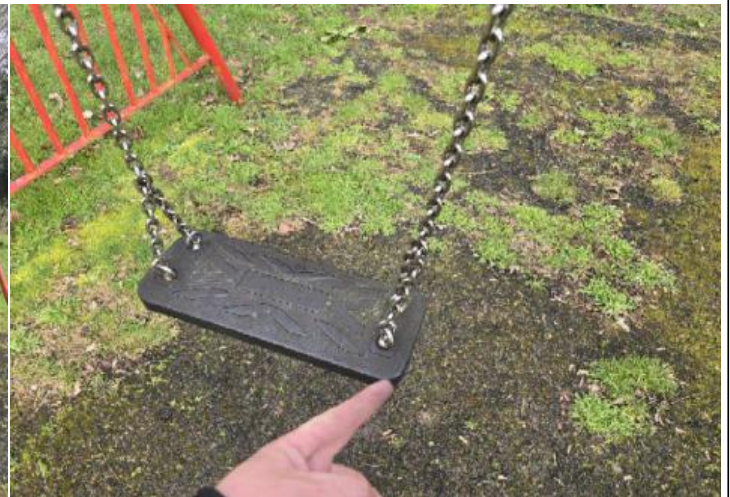
**Finding:** The swing seat connectors are loose

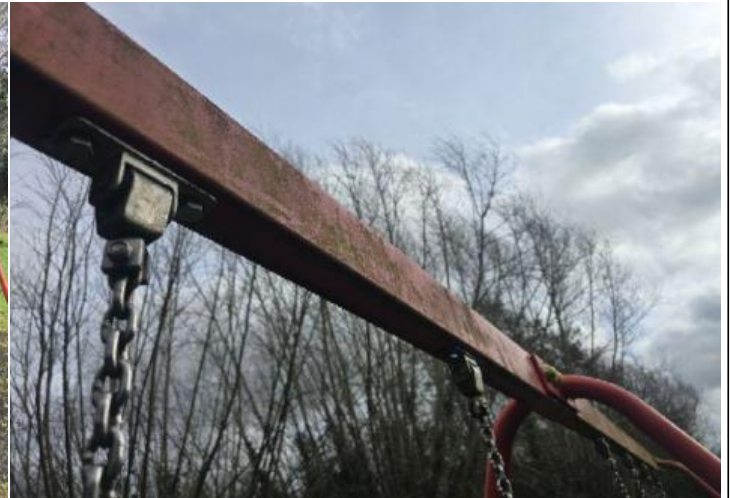
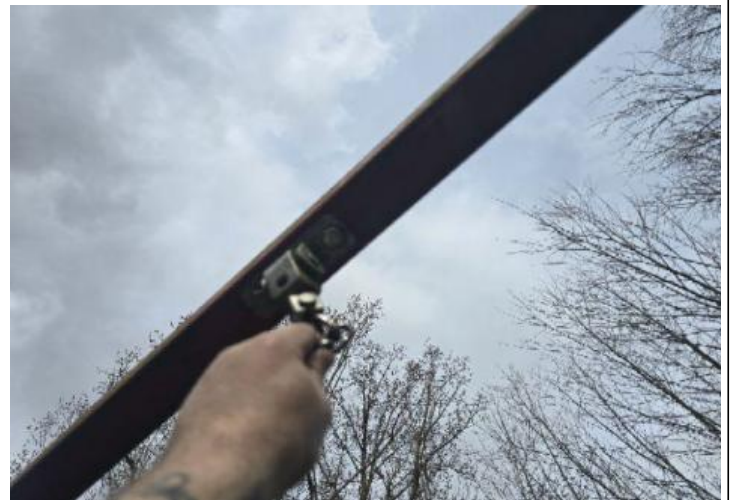
**Finding:** There is some notable evidence of chain wear

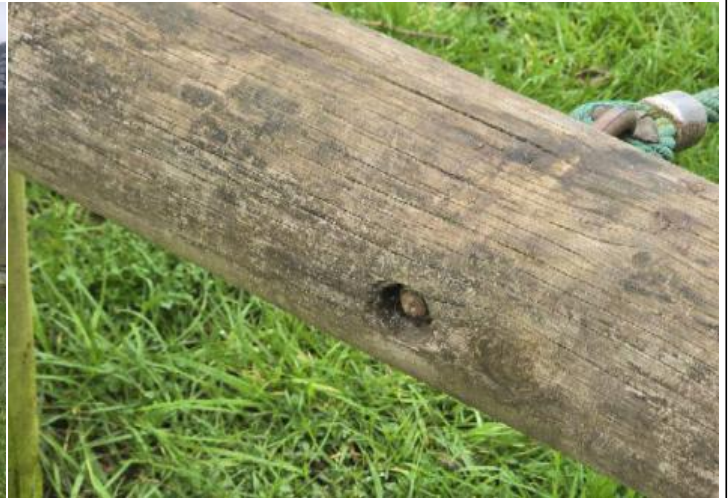
**Finding:** There is/are bolt cap covers missing or damaged on the item

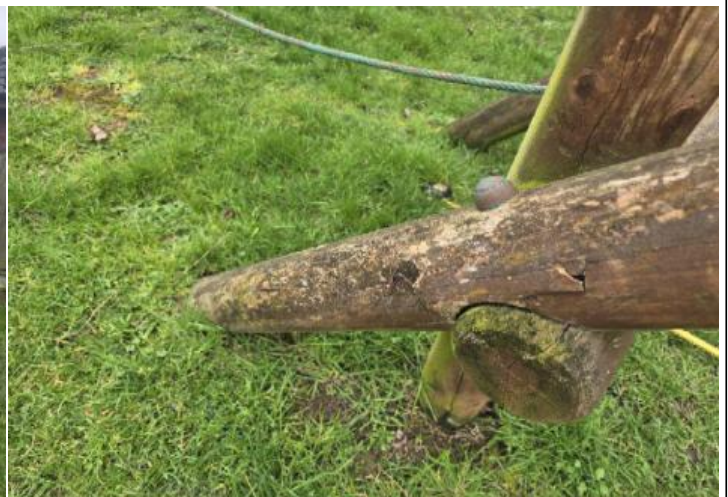
**Finding:** There is some evidence of rot in the timber post

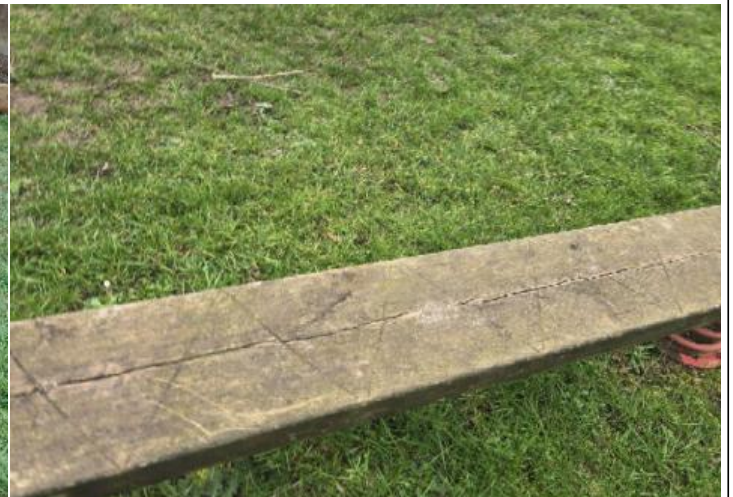
**Finding:** The timber has a number of splits/shakes or air cracks and this may affect the stability or allow water ingress which will accelerate the rotting process. Timber splits may also create rough / splintering edges.

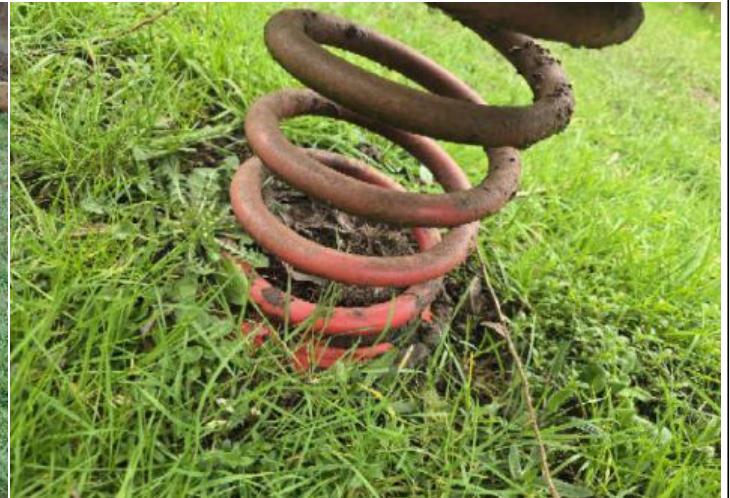
**Finding:** The paintwork on the spring has been damaged or worn exposing the metal underneath which is rusting **Action:** Treat any rusting components and repaint

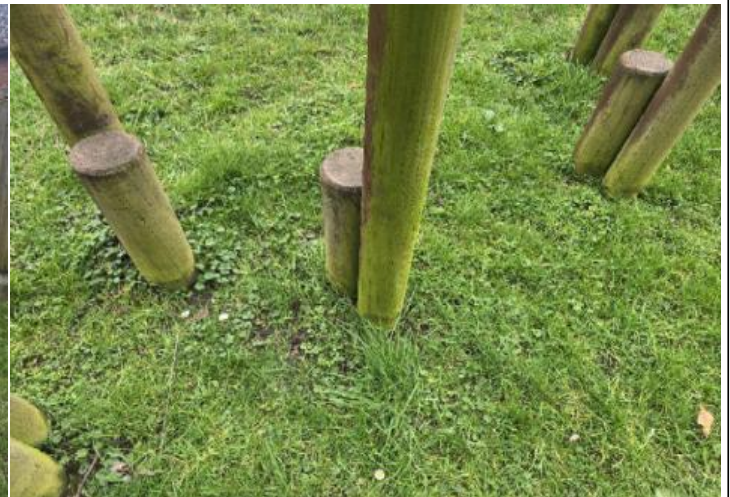
**Finding:** There is some evidence of rot in the timber

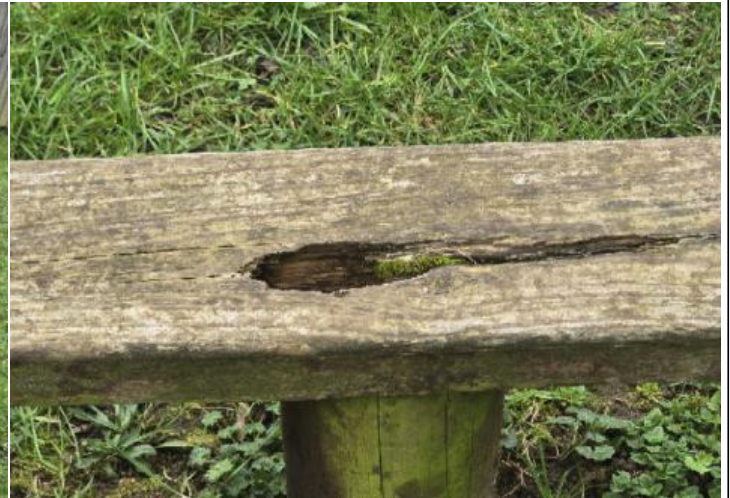
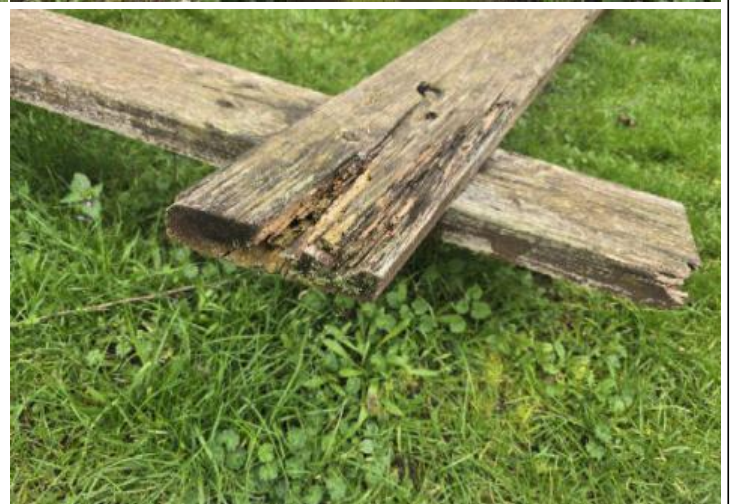
**Finding:** There are areas or parts of the timber on the structure that have rotted

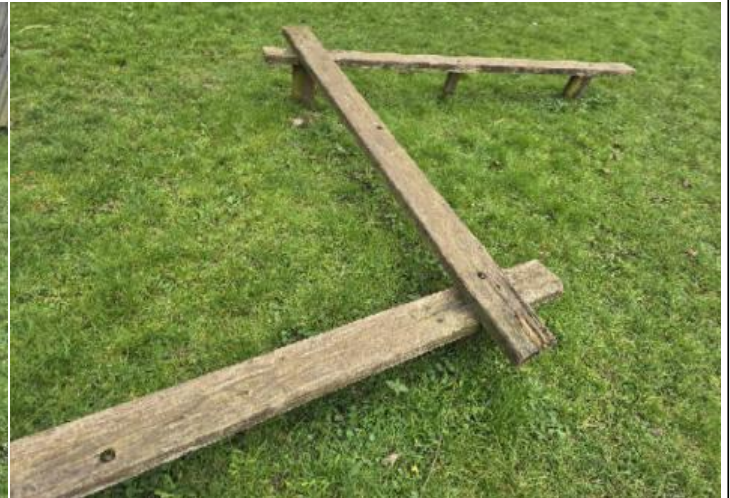
**Finding:** The balance beam is loose in its foundations

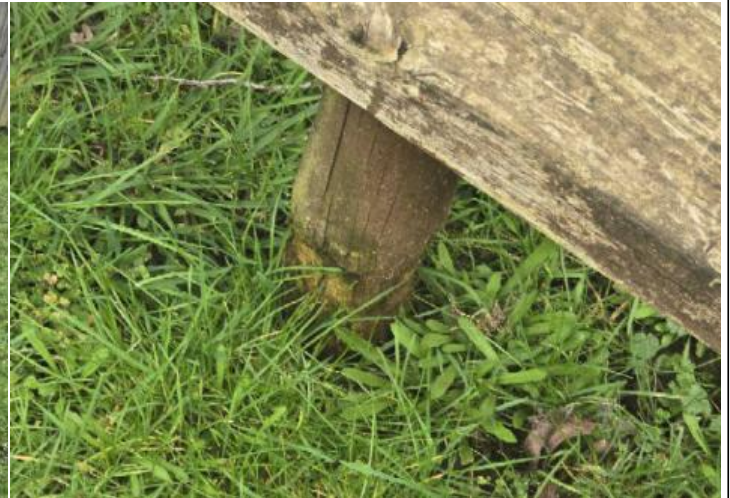
**Finding:** There is some strimmer / machinery damage apparent on the posts, this can penetrate the preservative applied to the timber and accelerate the rotting process

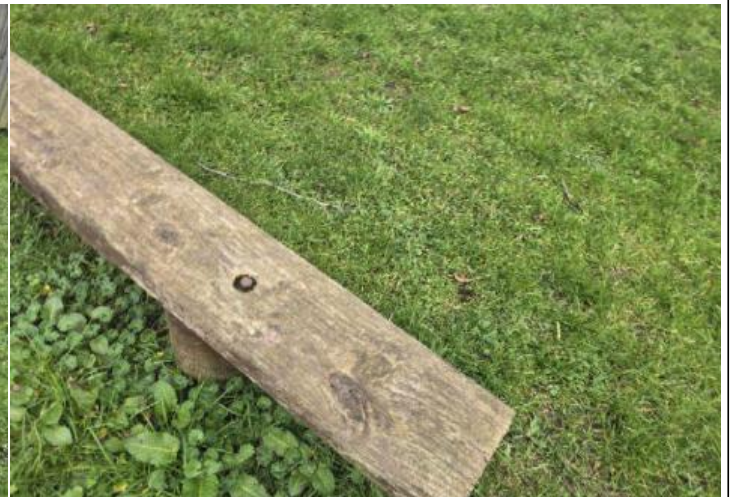
**Finding:** There is/are bolt cap covers missing or damaged on the item

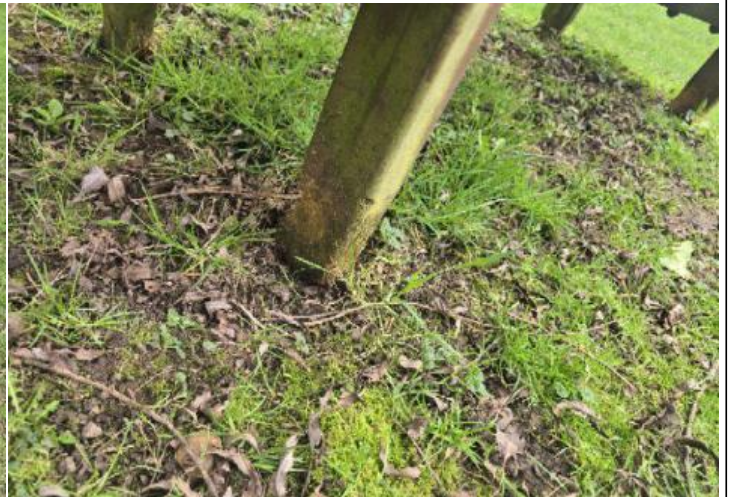
**Finding:** There is some strimmer / machinery damage apparent on the posts, this can penetrate the preservative applied to the timber and accelerate the rotting process
