# the **play inspection** company

## Annual Inspection

Babergh District Council

Copdock and Washbrook Parish Council - Mill Lane

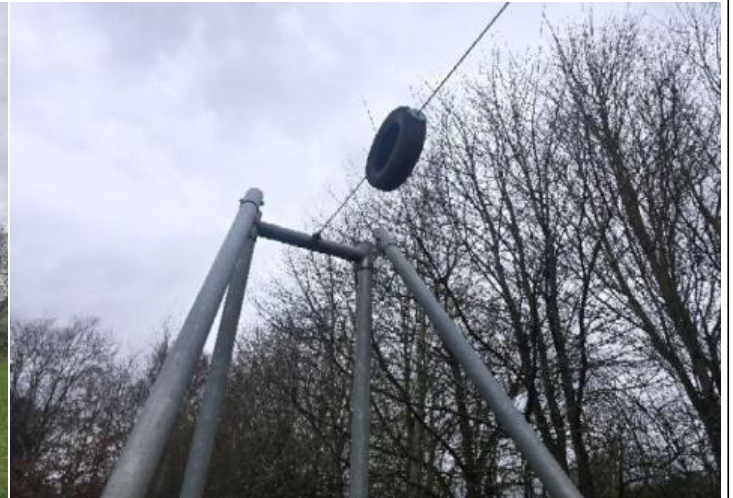
**Finding:** We have completed a visual inspection of the suspension links, cable and fixing points from ground level, however it is not possible to fully inspect these areas without either hiring equipment to gain access or removing the cable and suspension and inspecting at ground level. We recommend that the main cable and fixing security is thoroughly inspected at least in accordance with the manufacturers recommendations to check for wear, damage, security or internal rusting; this will help to ensure the continued safe use of the equipment

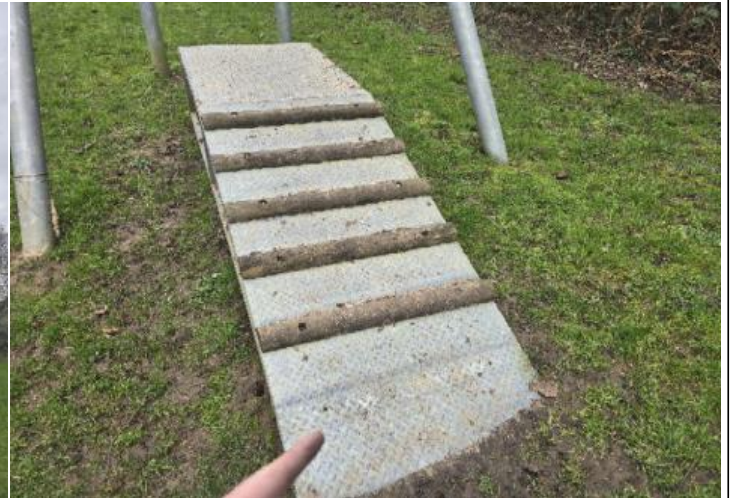
**Finding:** There are ramp treads missing

**Action:** Replace

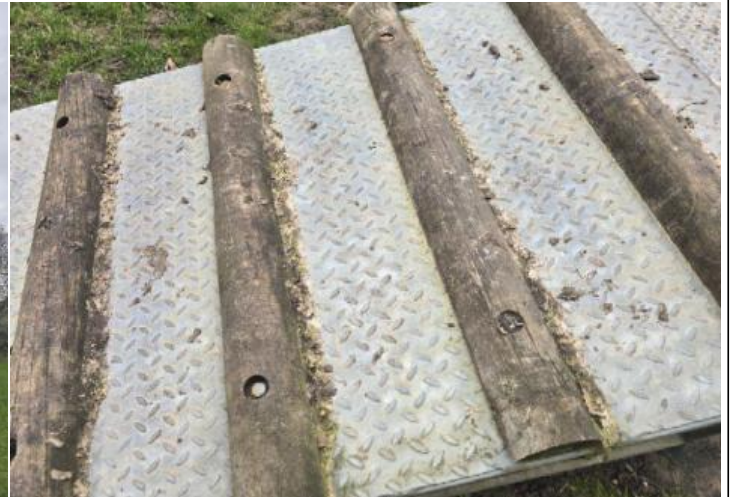
**Finding:** There is/are bolt cap covers missing or damaged on the item

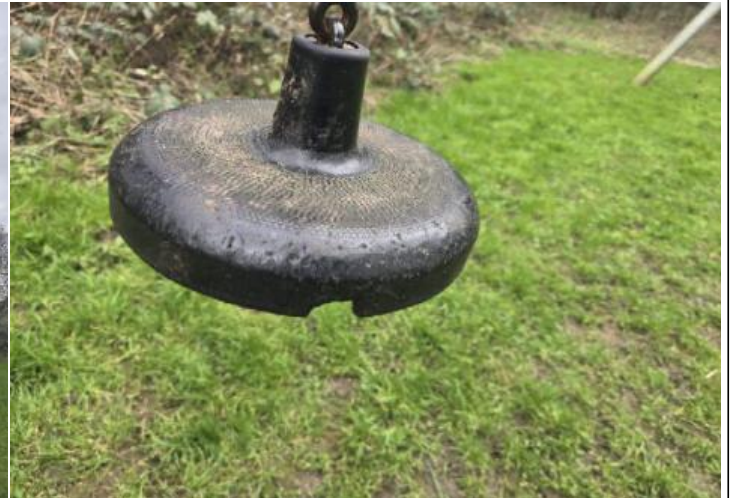
**Finding:** The cableway seat has been damaged

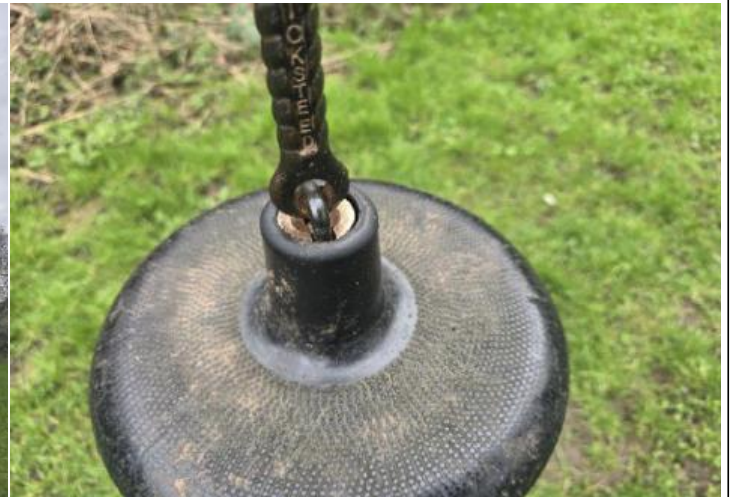
**Finding:** The seat connection cannot be inspected without dismantling the seat

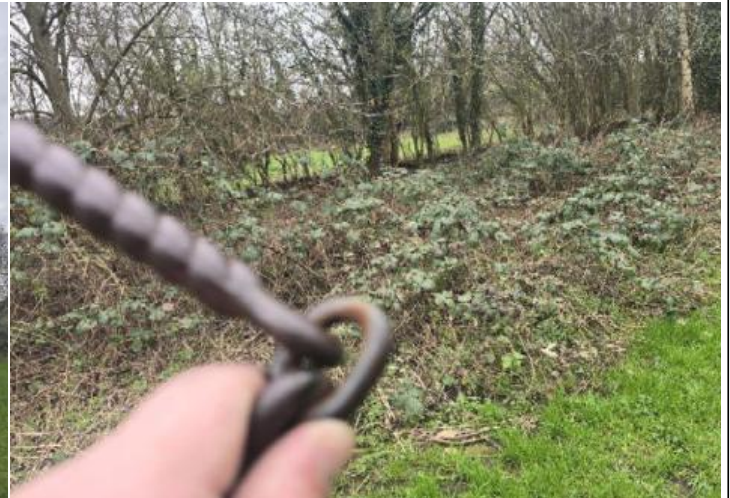
<b>Finding:</b> There is some notable evidence of chain wear	<b>Action:</b> Monitor for any further deterioration and replace when 40% worn
--	--

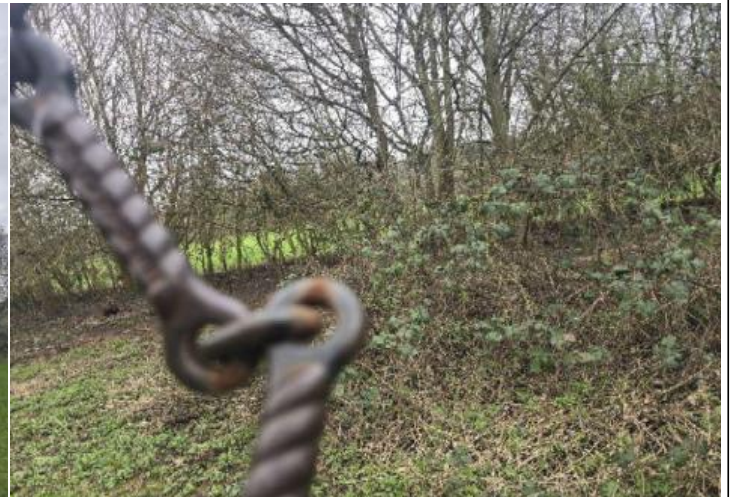
<b>Finding:</b> The connecting lugs are showing signs of wear	<b>Action:</b> Monitor for any further deterioration and repair as required
---	---

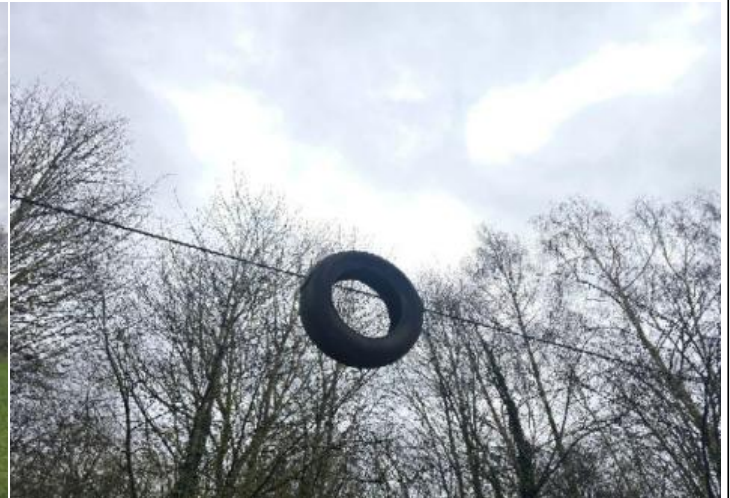
**Finding:** The dampening spring or tyre is damaged or broken on the item

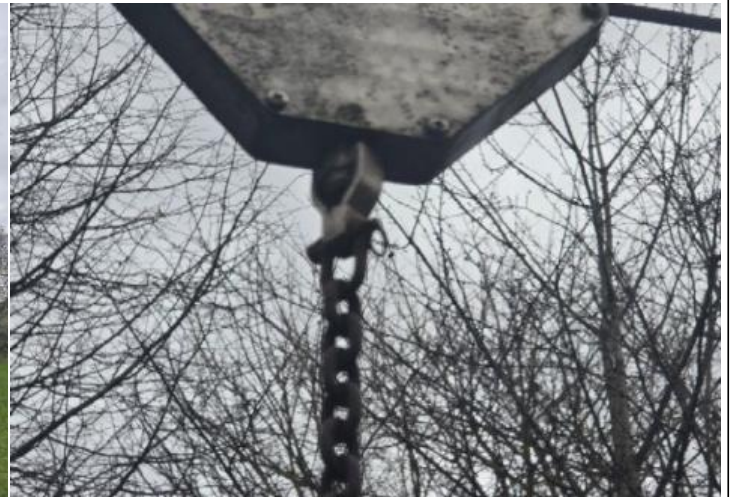
**Finding:** The shackles are worn in excess of 40% and require renewing

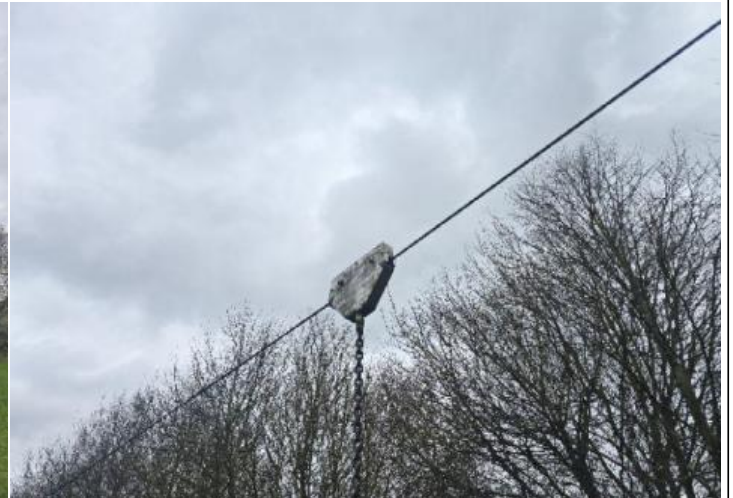
**Finding:** The nylon inserts are worn or missing at the point the cable enters the traveller

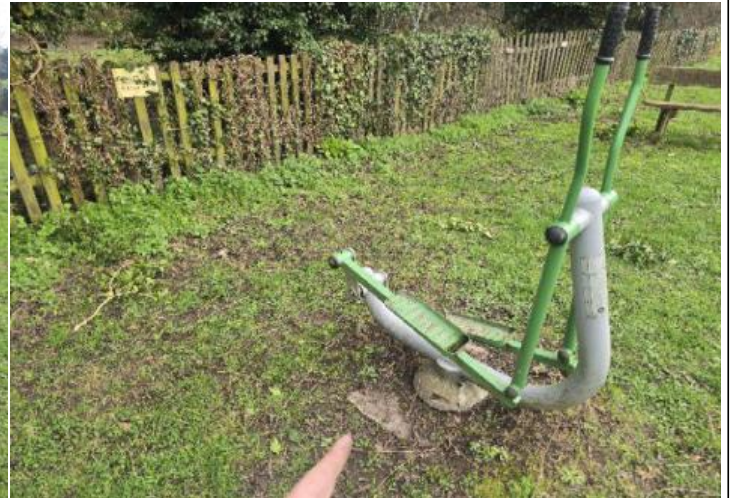
**Finding:** The surface has eroded and the foundations are exposed

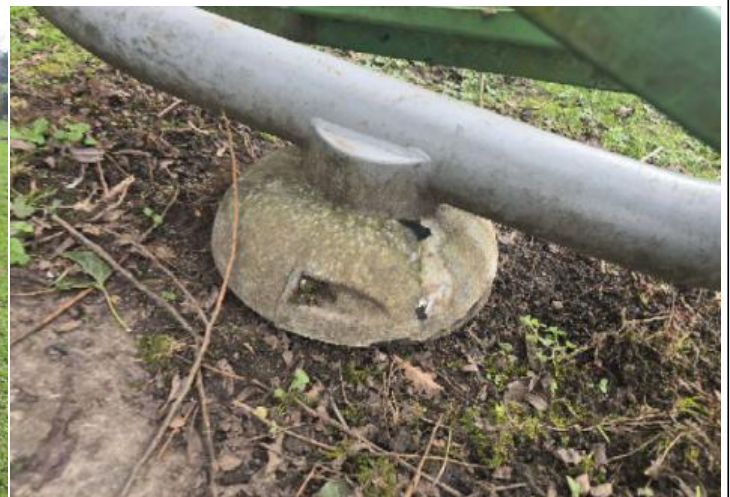
**Finding:** There is surface corrosion / rust present on the item

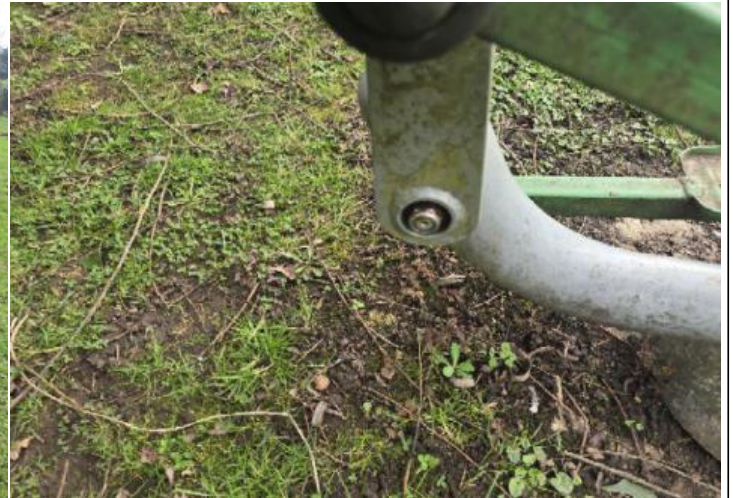
**Finding:** There is/are bolt cap covers missing or damaged on the cross rider
