Annual Inspection

Copdock and Washbrook Parish Council - Village Hall

Village Hall, Copdock, IP8 3JN

Inspection Ref: 2983759

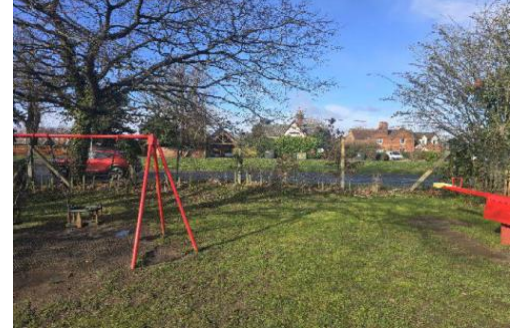
Item: Site General
Manufacturer: Owner/Operator
Surface Type: N/A
Item Quantity: 1
Equipment Compliance: N/A
Surface Area Compliance: N/A

The area around the item has eroded and may become slippery - Reinstate eroded area

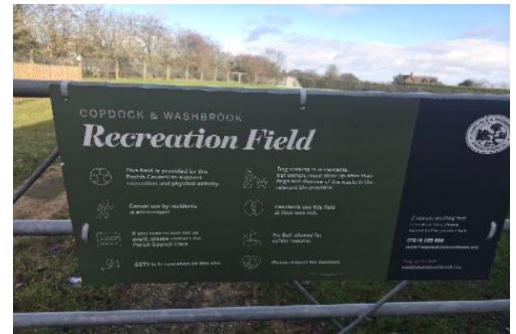
Item: Sign
Manufacturer: Not Identified
Surface Type: N/A
Item Quantity: 1
Equipment Compliance: N/A
Surface Area Compliance: N/A

Cable ties are present and there are sharp projecting ends - Replace with a more appropriate fixing method

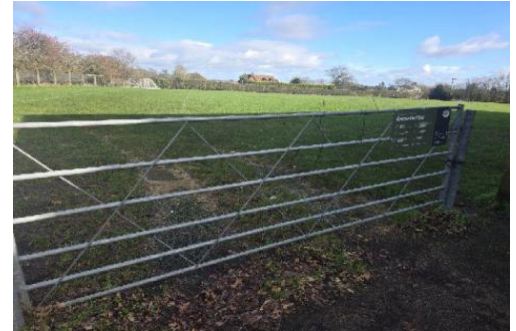
Item: Gate - Maintenance
Manufacturer: Not Identified
Surface Type: Grass
Item Quantity: 1
Equipment Compliance: N/A
Surface Area Compliance: N/A

The maintenance gate was correctly padlocked at the time of inspection, however this means that the inspector was unable to fully assess the gate - Ensure that there are 12mm gaps throughout the full range of motion on gate/s and between leaves where relevant

There are projecting bolt thread(s) present - Remove excess thread length and deburr or provide cap

Cable ties are present and there are sharp projecting ends - Remove

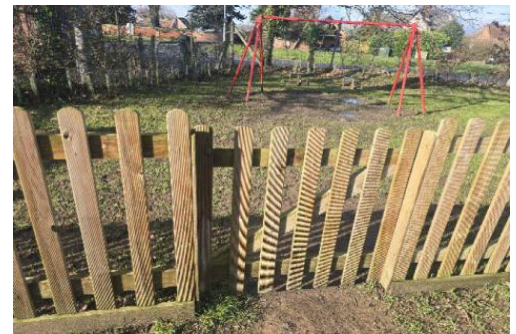
Item: Gate
Manufacturer: Not Identified
Surface Type: Grass
Item Quantity: 1
Equipment Compliance: N/A
Surface Area Compliance: N/A

The area around the item has eroded and may become slippery - Reinstate eroded area

There are openings that are less than 12mm that could trap or crush fingers - Provide a 12mm gap throughout full range of motion at both sides of gate

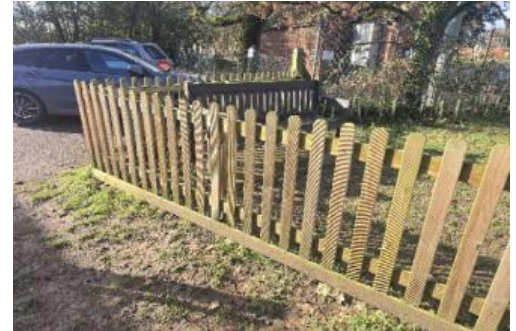
Item: Fencing - Post & Rail
Manufacturer: Not Identified
Surface Type: Grass
Item Quantity: 1
Equipment Compliance: N/A
Surface Area Compliance: N/A

This item is satisfactory - no work required -

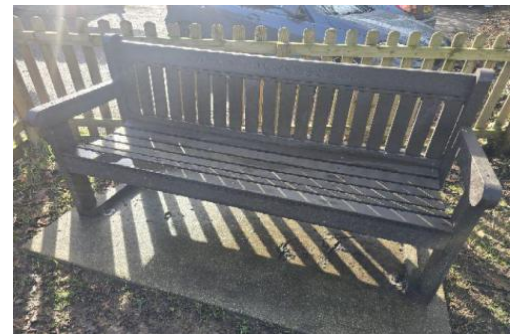
Item: Bench
Manufacturer: Not Identified
Surface Type: Concrete
Item Quantity: 1
Equipment Compliance: N/A
Surface Area Compliance: N/A

There are trip hazards at the edges of the surface - Remove trip hazard

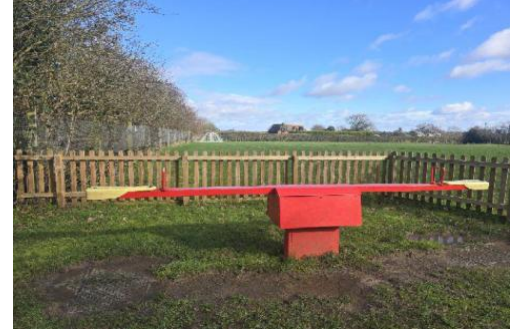
Item: See Saw
Manufacturer: Wicksteed Playgrounds
Surface Type: Matta
Item Quantity: 1
Equipment Compliance: No
Surface Area Compliance: Yes

There are gaps opening between the grass mat tiles - Provide additional ties or secure / reinstate surface

The item fails to meet the requirements of BS EN 1176 Part 1 4.2.7.2 for head and neck entrapment in the handles - Monitor - No action given the risk assessment

The paint is flaking off the metalwork - Rub down and re-paint

The seat has minor damage or wear - Monitor for any further deterioration and replace as required

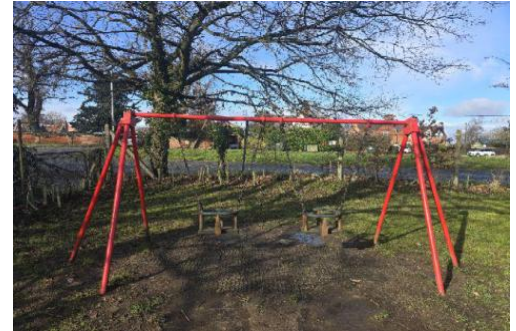
Item: 1 Bay 2 Seat (Cradle)
Manufacturer: Not Identified
Surface Type: Grass Matrix Tiles
Item Quantity: 1
Equipment Compliance: No
Surface Area Compliance: Yes

The grass mats are silted up, the soil is compacted and the area will become very slippery when the soil is wet. - Reinstate as required

The edges of the grass mat surface are raised / lifting above the surrounding surface - Secure edges of grass mats as per the API Code of Practice to remove trip hazards

There is moderate damage to the surface - Repair the damaged areas of surfacing

There is algae or moss on the surface of the seats - Clean and treat appropriately

There is some notable evidence of chain wear - Monitor for any further deterioration and replace when 40% worn

The chain openings are in excess of 8.6mm and do not meet the recommendations of BS EN 1176 Part 1 - Monitor - No action given the risk assessment

The paint is flaking off the metalwork - Rub down and re-paint

There is some wear to the shackles. - Monitor for any further deterioration and replace when 40% worn

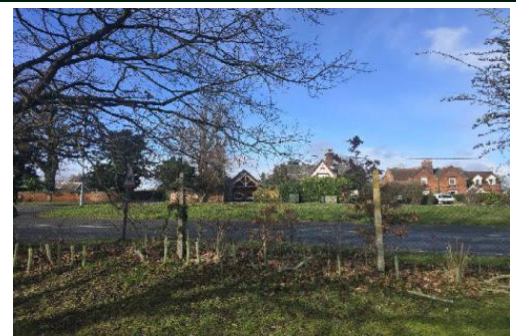
Item: Fence - Steel Mesh
Manufacturer: Not Identified
Surface Type: Grass
Item Quantity: 1
Equipment Compliance: N/A
Surface Area Compliance: N/A

The adjacent foliage is overhanging - Cut back and maintain

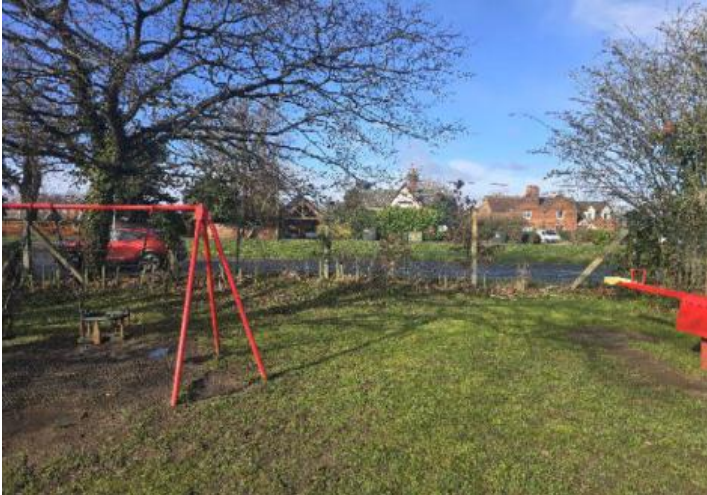
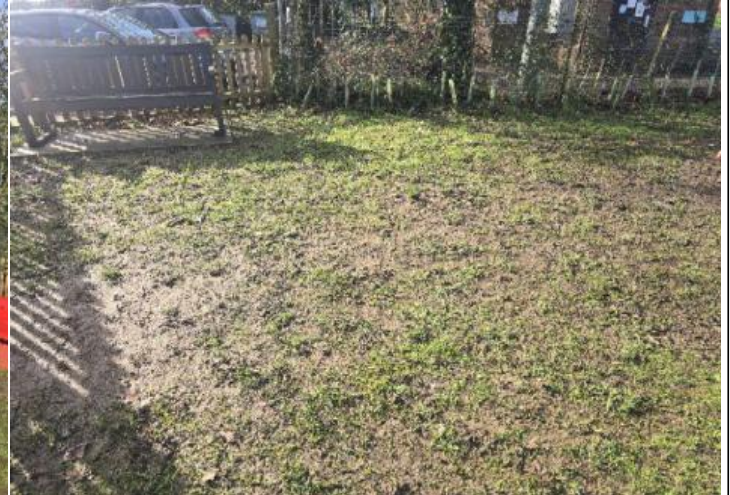
Item: Ancillary Items - Site General
Manufacturer: Owner/Operator

Finding: The area around the item has eroded and may become slippery

Action: Reinstate eroded area

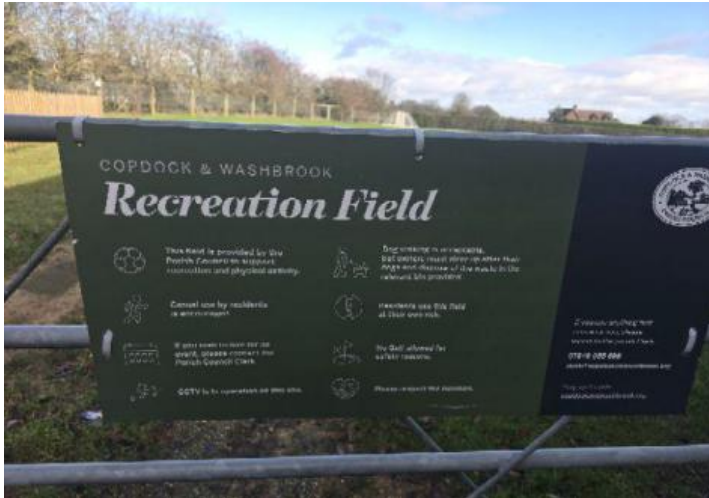
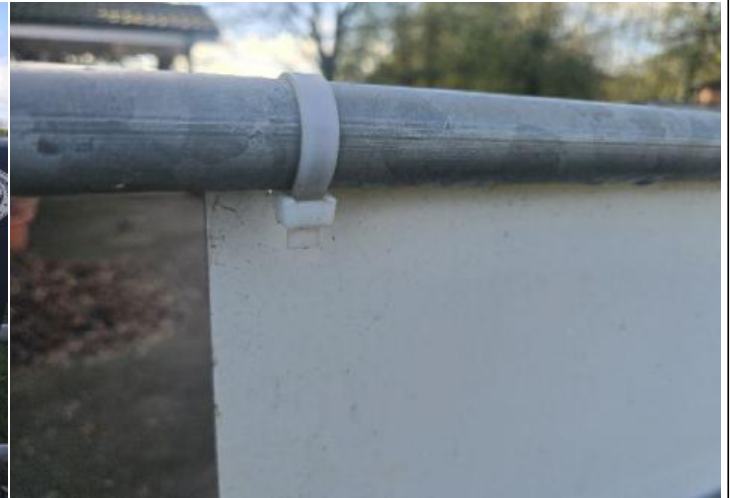
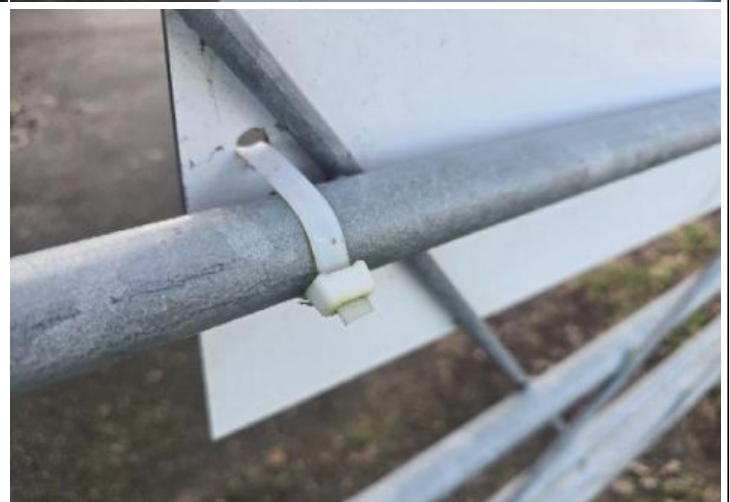
Item: Ancillary Items - Sign
Manufacturer: Not Identified

Finding: Cable ties are present and there are sharp projecting ends

Action: Replace with a more appropriate fixing method

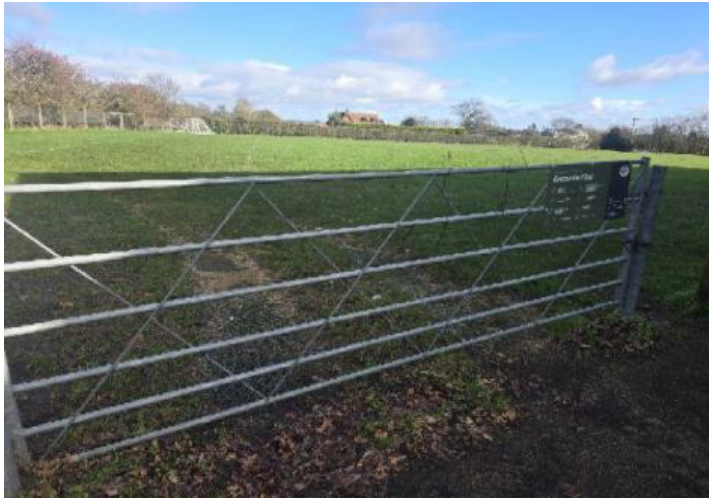
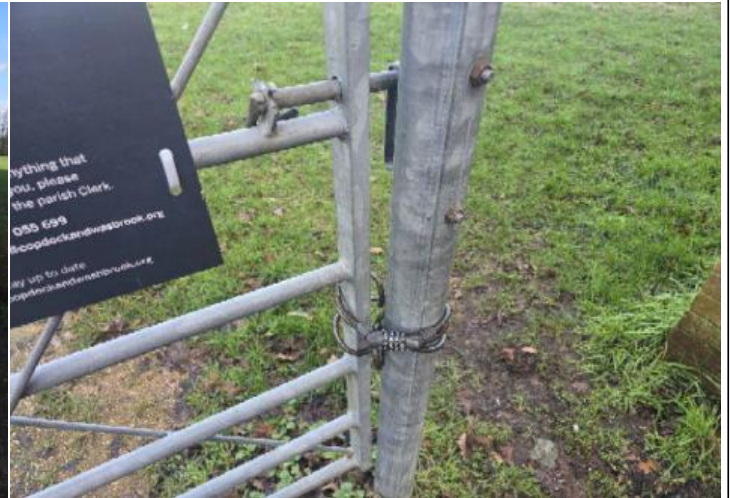
Item: Gates - Gate - Maintenance
Manufacturer: Not Identified

Finding: The maintenance gate was correctly padlocked at the time of inspection, however this means that the inspector was unable to fully assess the gate

Action: Ensure that there are 12mm gaps throughout the full range of motion on gate/s and between leaves where relevant

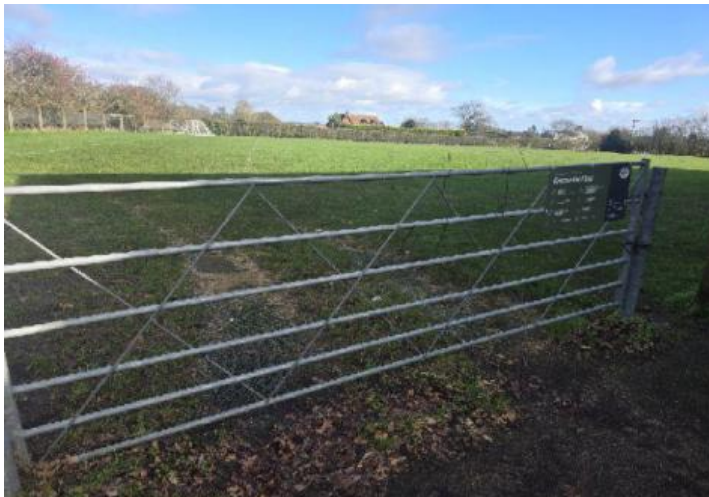
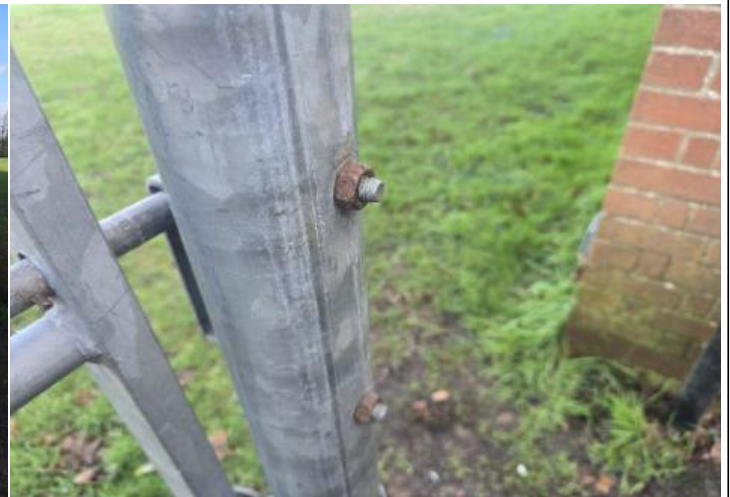
Item: Gates - Gate - Maintenance
Manufacturer: Not Identified

Finding: There are projecting bolt thread(s) present

Action: Remove excess thread length and deburr or provide cap

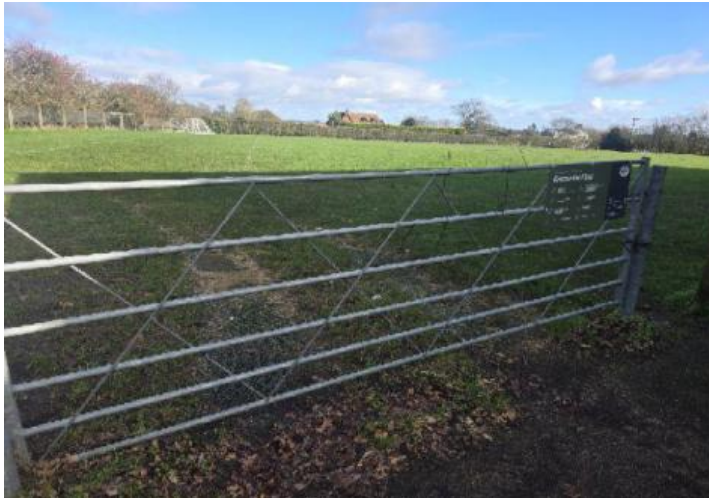
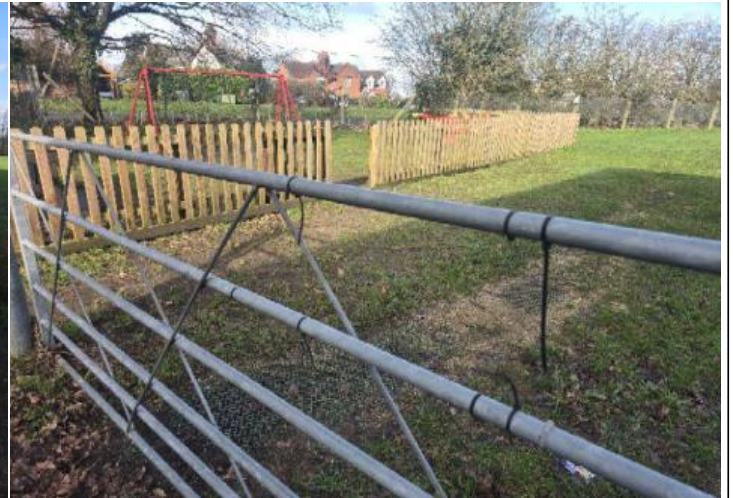
Item: Gates - Gate - Maintenance
Manufacturer: Not Identified

Finding: Cable ties are present and there are sharp projecting ends

Action: Remove

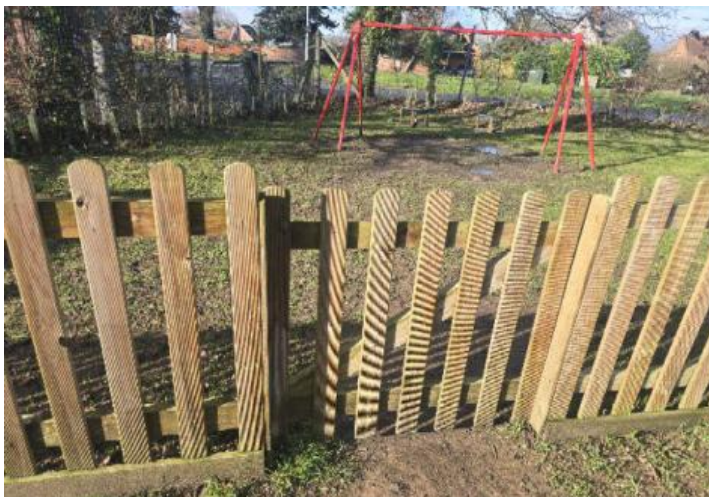
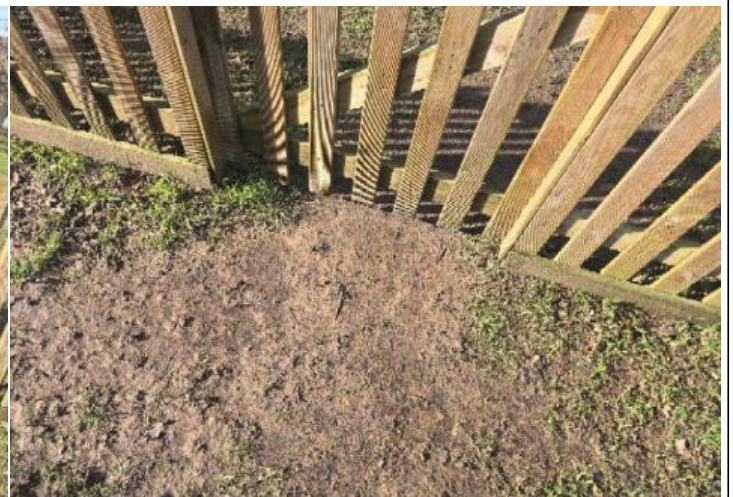
Item: Gates - Gate
Manufacturer: Not Identified

Finding: The area around the item has eroded and may become slippery

Action: Reinstate eroded area

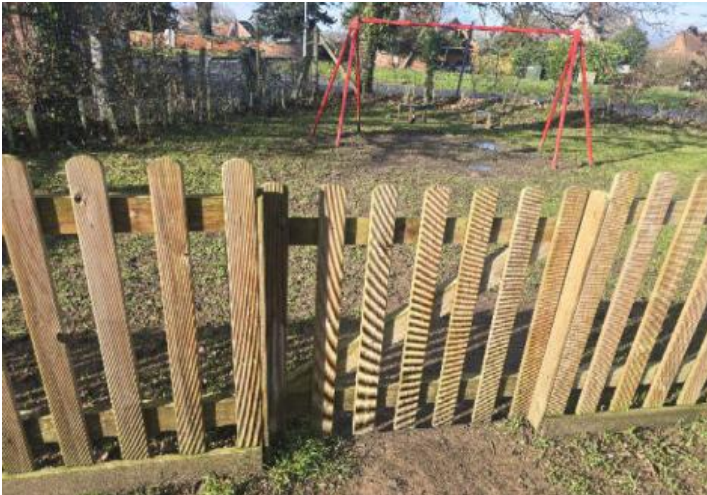
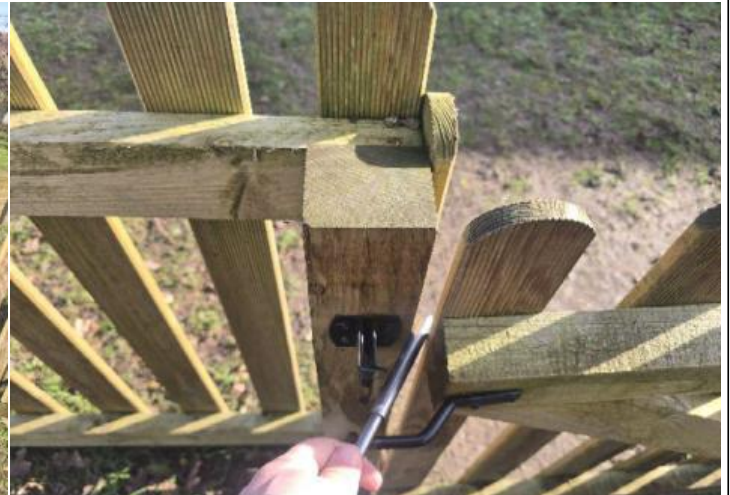
Item: Gates - Gate
Manufacturer: Not Identified

Finding: There are openings that are less than 12mm that could trap or crush fingers

Action: Provide a 12mm gap throughout full range of motion at both sides of gate

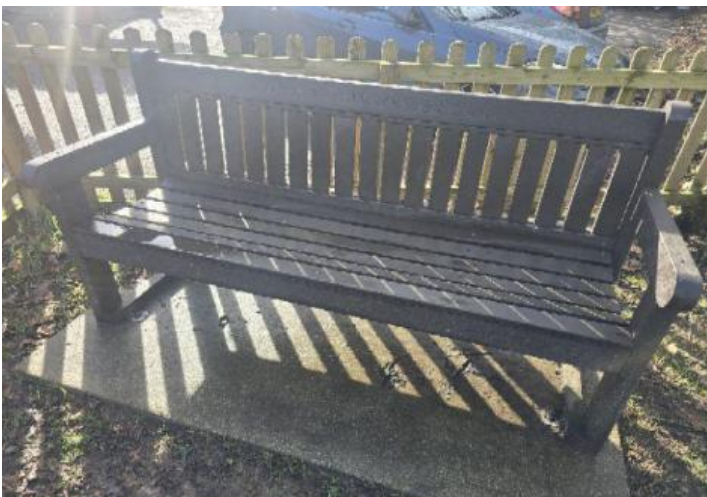
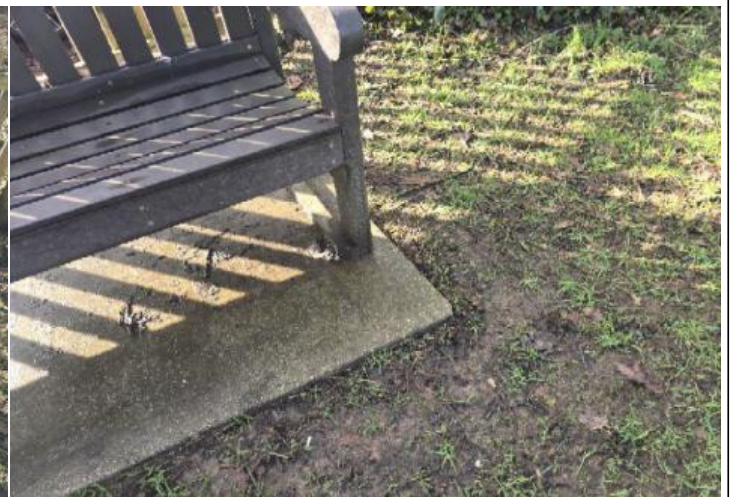
Item: Ancillary Items - Bench
Manufacturer: Not Identified

Finding: There are trip hazards at the edges of the surface

Action: Remove trip hazard

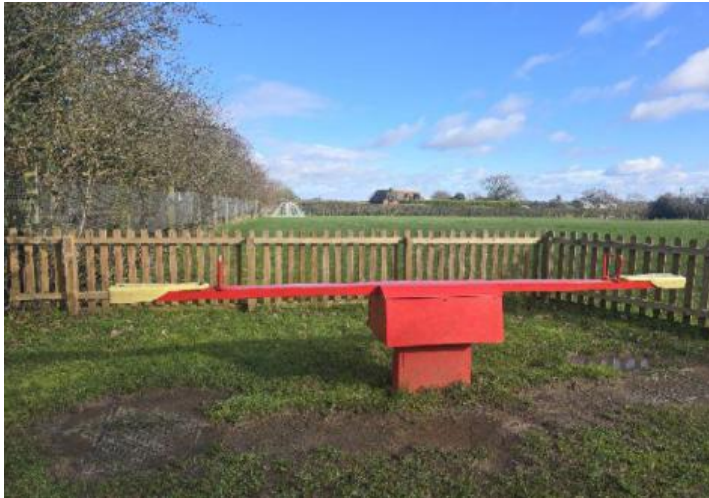
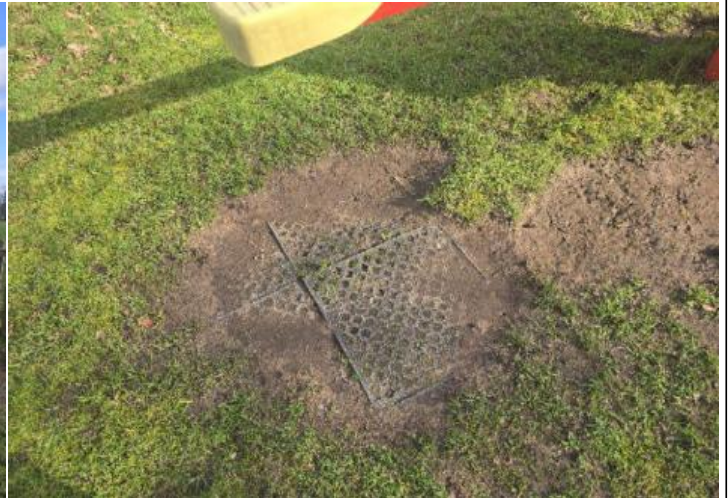
Item: Rocking Equipment - See Saw
Manufacturer: Wicksteed Playgrounds

Finding: There are gaps opening between the grass mat tiles

Action: Provide additional ties or secure / reinstate surface tiles

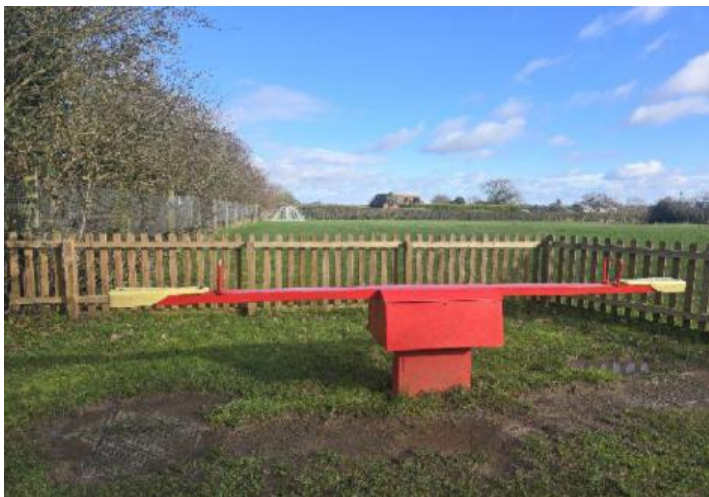
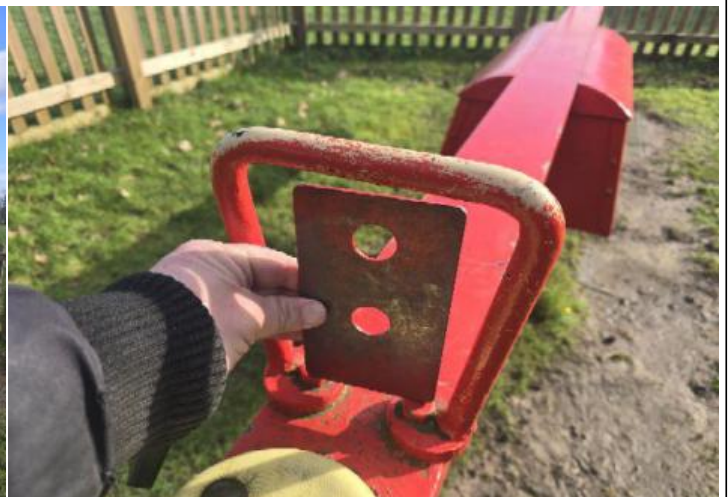
Item: Rocking Equipment - See Saw
Manufacturer: Wicksteed Playgrounds

Finding: The item fails to meet the requirements of BS EN 1176 Part 1 4.2.7.2 for head and neck entrapment in the handles

Action: Monitor - No action given the risk assessment

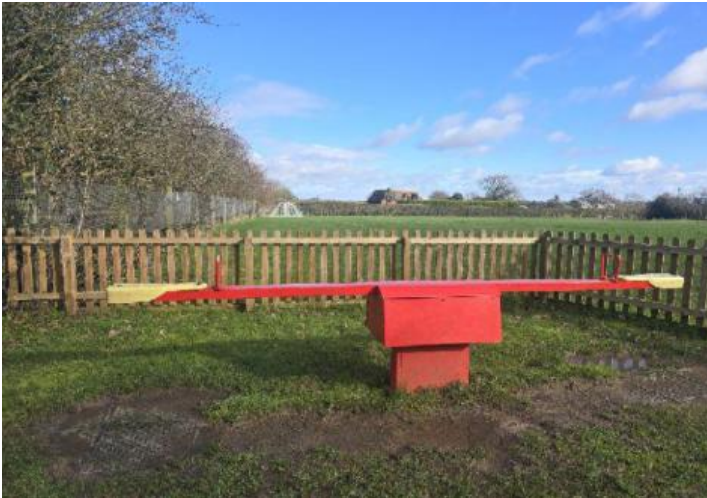
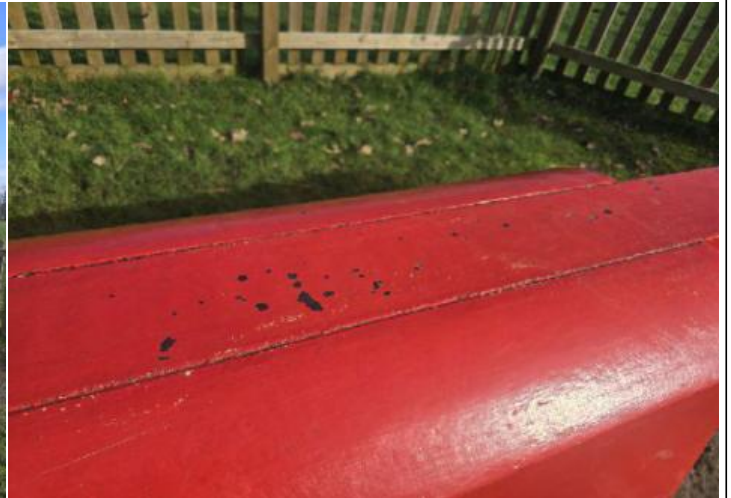
Item: Rocking Equipment - See Saw
Manufacturer: Wicksteed Playgrounds

Finding: The paint is flaking off the metalwork

Action: Rub down and re-paint

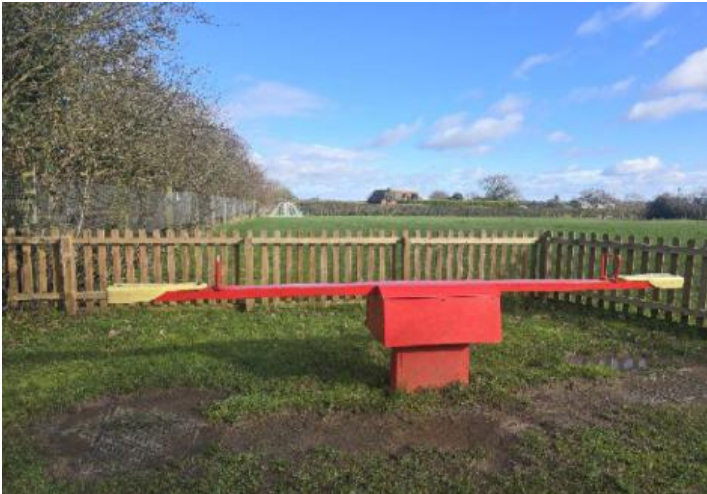
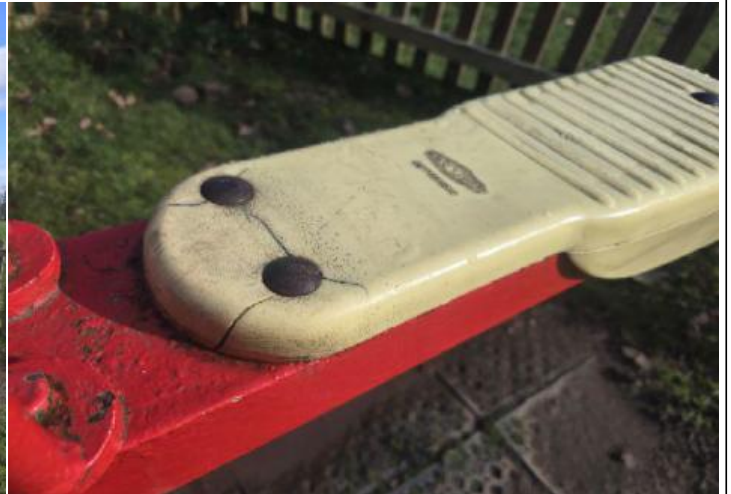
Item: Rocking Equipment - See Saw
Manufacturer: Wicksteed Playgrounds

Finding: The seat has minor damage or wear

Action: Monitor for any further deterioration and replace as required

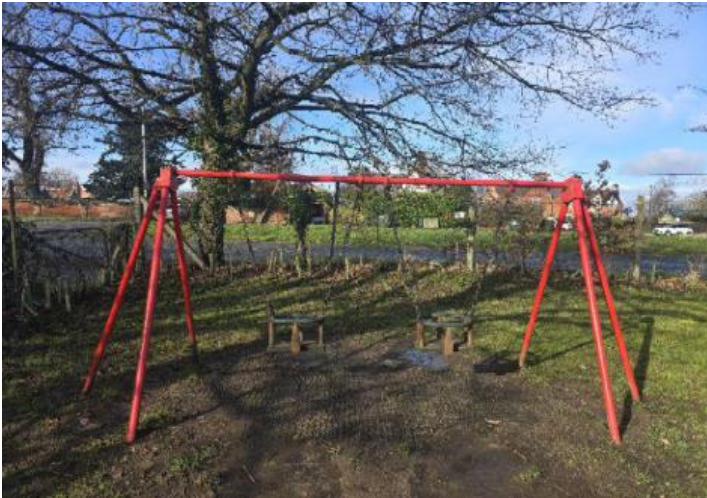
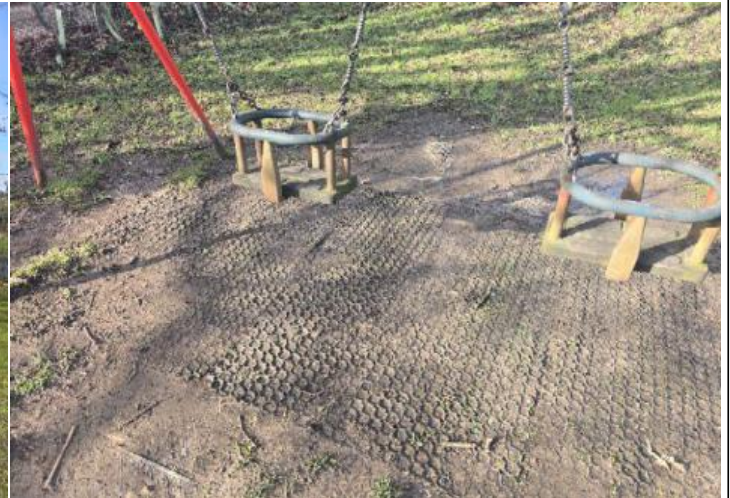
Item: Swings - 1 Bay 2 Seat (Cradle)
Manufacturer: Not Identified

Finding: The grass mats are silted up, the soil is compacted and the area will become very slippery when the soil is wet. **Action:** Reinstate as required

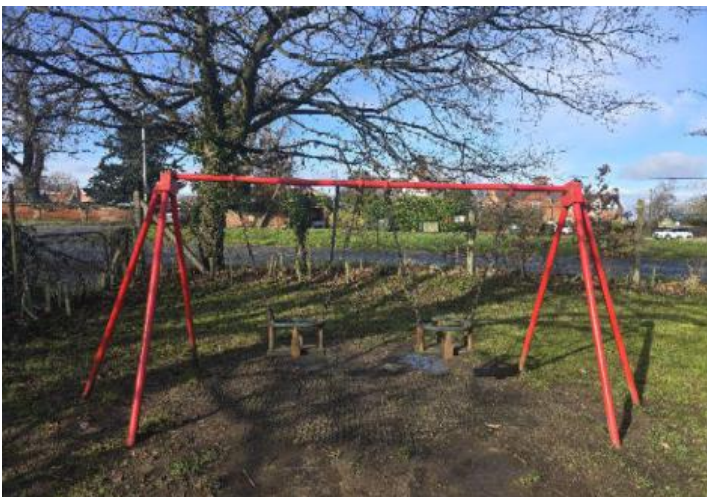
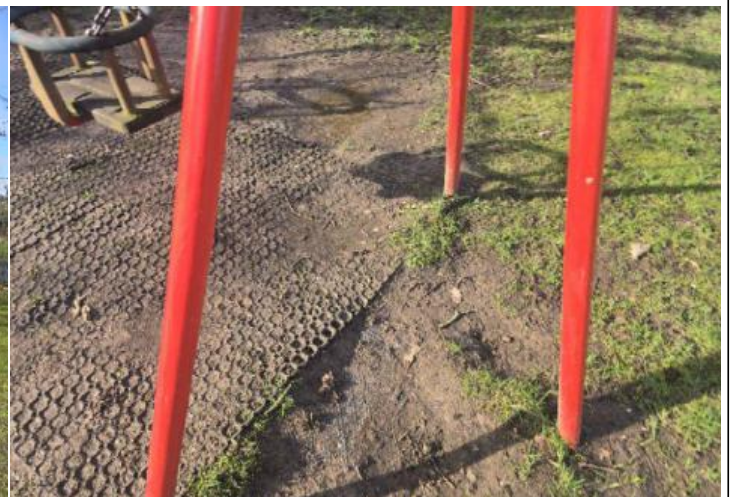
Item: Swings - 1 Bay 2 Seat (Cradle)
Manufacturer: Not Identified

Finding: The edges of the grass mat surface are raised / lifting above the surrounding surface **Action:** Secure edges of grass mats as per the API Code of Practice to remove trip hazards

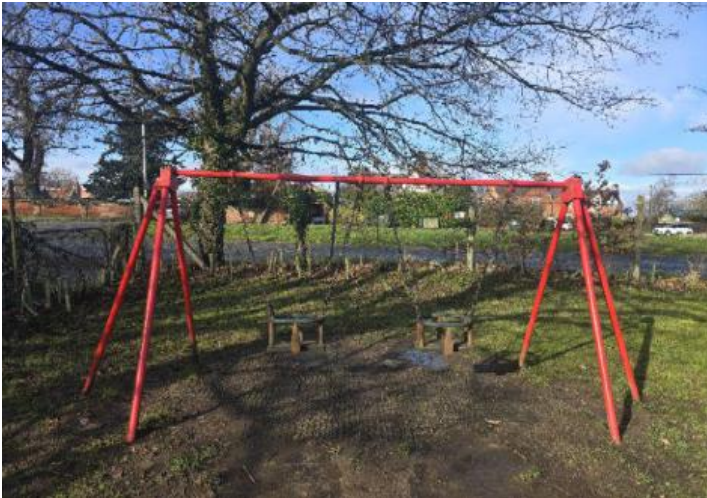
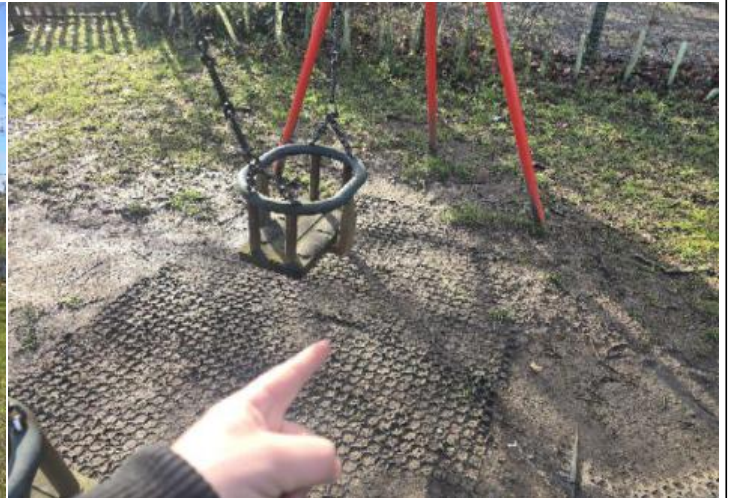
Item: Swings - 1 Bay 2 Seat (Cradle)
Manufacturer: Not Identified

Finding: There is moderate damage to the surface

Action: Repair the damaged areas of surfacing

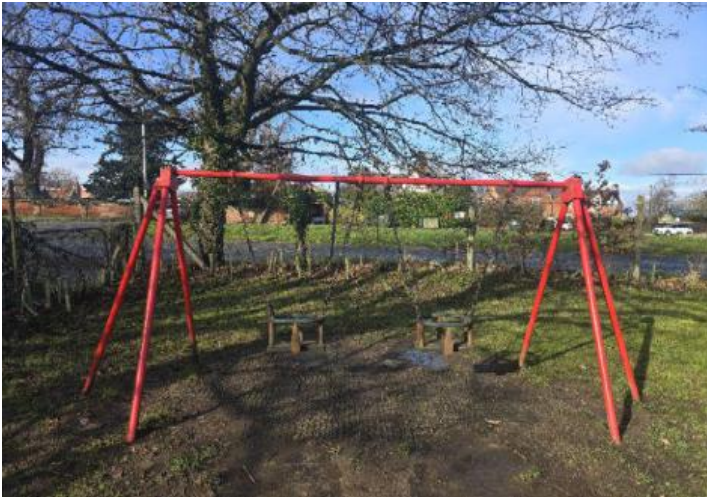
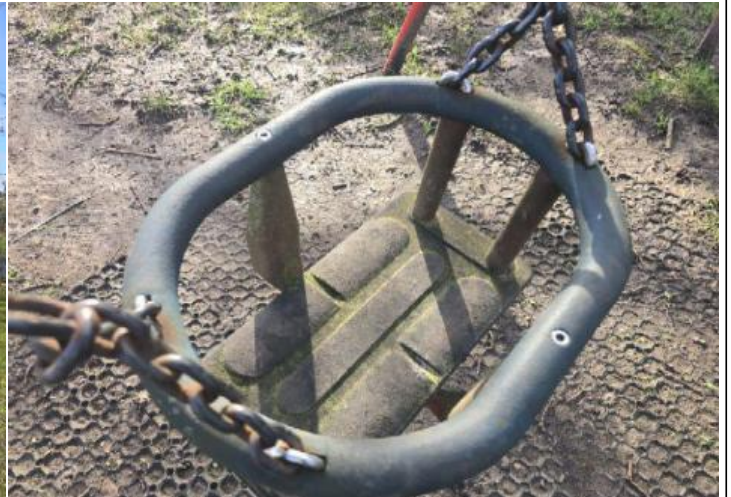
Item: Swings - 1 Bay 2 Seat (Cradle)
Manufacturer: Not Identified

Finding: There is algae or moss on the surface of the seats

Action: Clean and treat appropriately

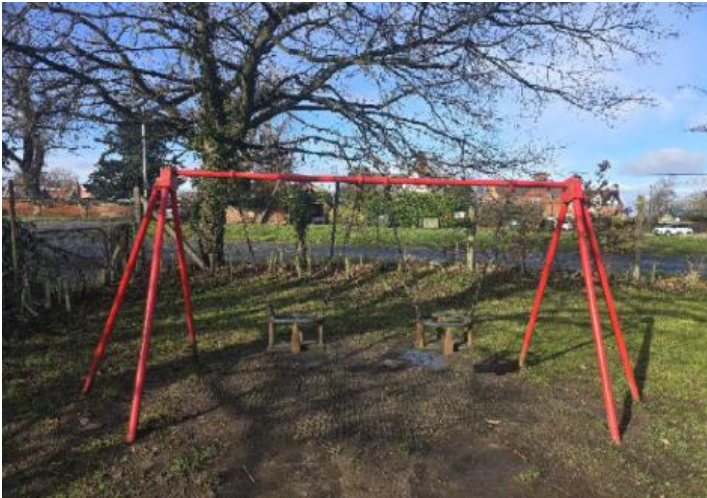
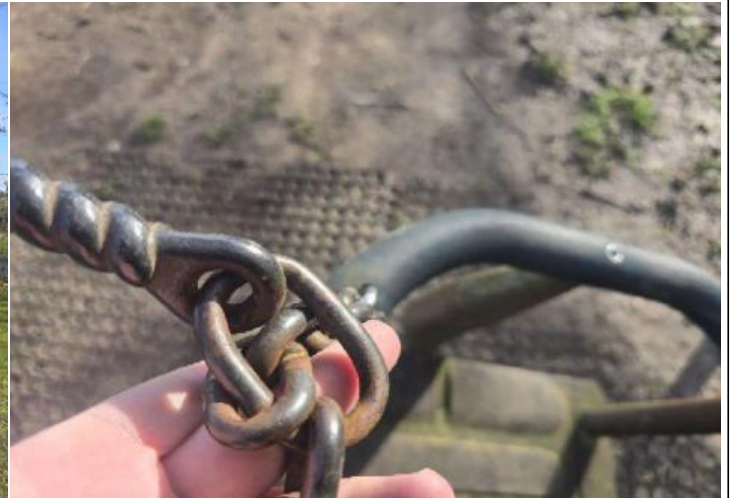
Item: Swings - 1 Bay 2 Seat (Cradle)
Manufacturer: Not Identified

Finding: There is some notable evidence of chain wear

Action: Monitor for any further deterioration and replace when 40% worn

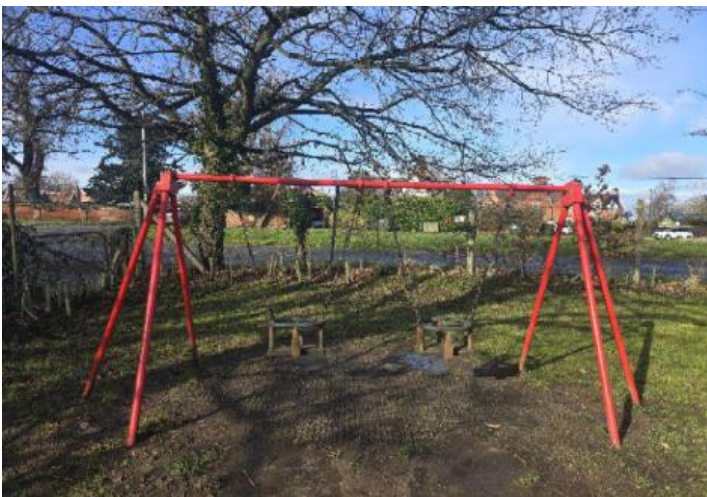
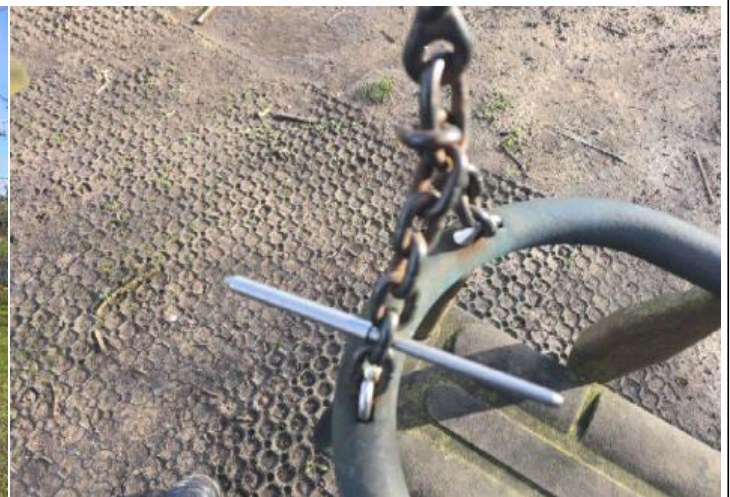
Item: Swings - 1 Bay 2 Seat (Cradle)
Manufacturer: Not Identified

Finding: The chain openings are in excess of 8.6mm and do not meet the recommendations of BS EN 1176 Part 1

Action: Monitor - No action given the risk assessment

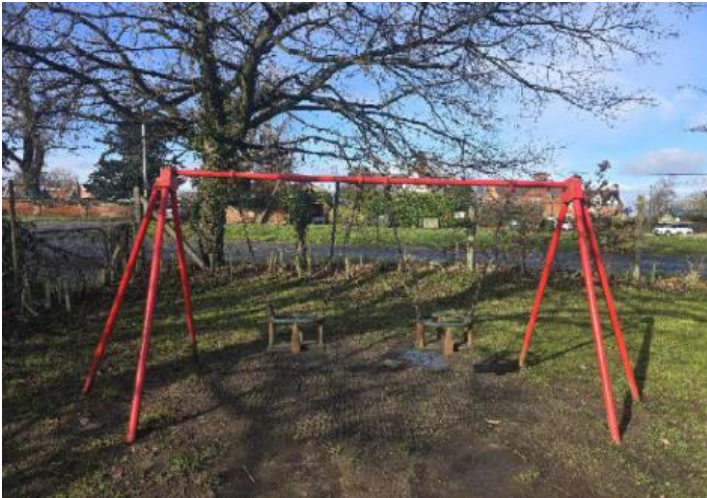
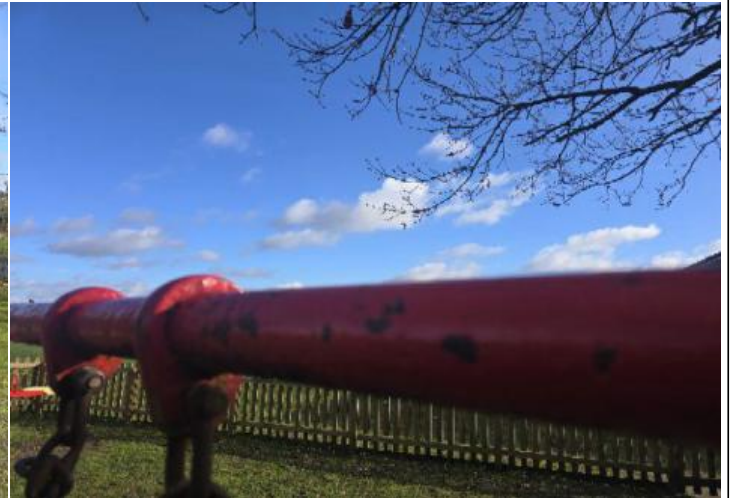
Item: Swings - 1 Bay 2 Seat (Cradle)
Manufacturer: Not Identified

Finding: The paint is flaking off the metalwork

Action: Rub down and re-paint

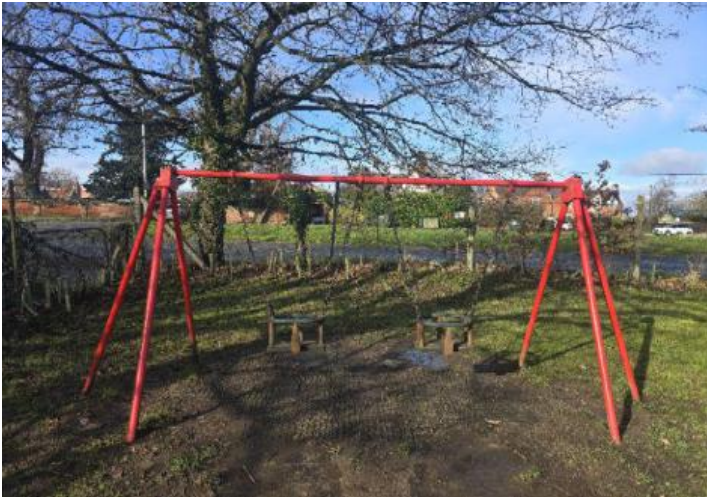
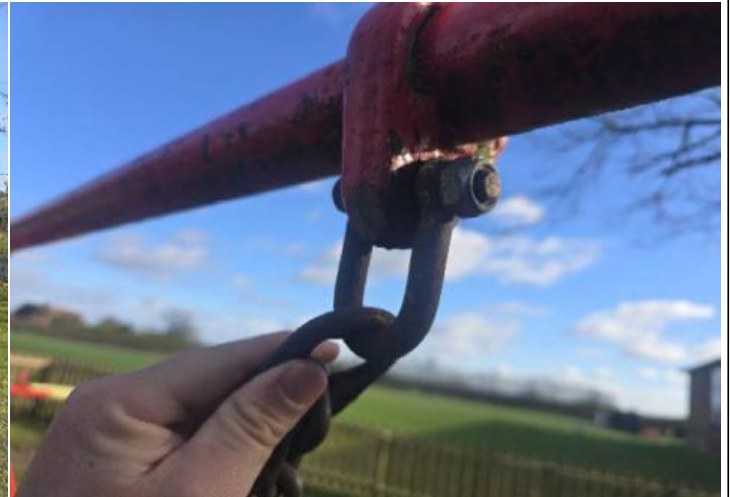
Item: Swings - 1 Bay 2 Seat (Cradle)
Manufacturer: Not Identified

Finding: There is some wear to the shackles.

Action: Monitor for any further deterioration and replace when 40% worn

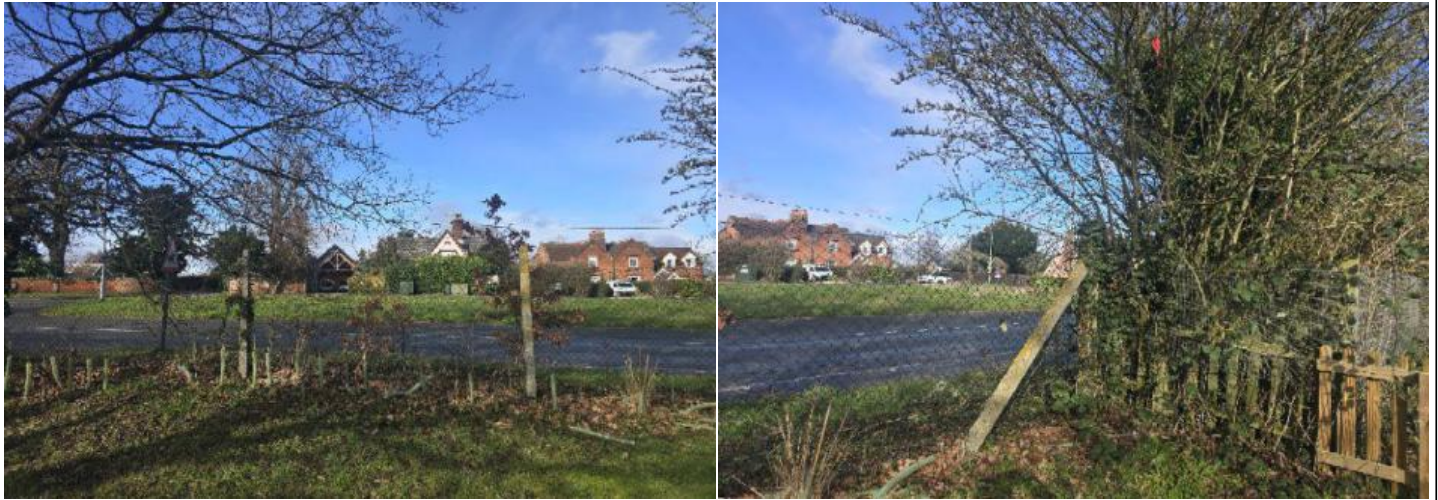
Item: Fences - Fence - Steel Mesh
Manufacturer: Not Identified

Finding: The adjacent foliage is overhanging

Action: Cut back and maintain
