the **play inspection** company

Annual Inspection

Copdock and Washbrook Parish Council - Fen View

Inspected: 16-February-2026 - 15:00 by James Law (RPII Annual Inspector)

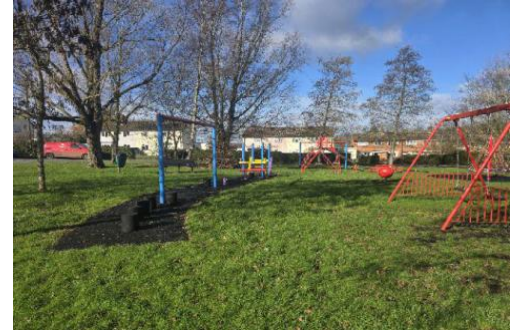
Item: Site General
Manufacturer: Owner/Operator
Surface Type: N/A
Item Quantity: 1
Equipment Compliance: N/A
Surface Area Compliance: N/A

There is no physical barrier between the road and the play area - Ensure a full and sufficient risk assessment is in place and review regularly

There is a damaged and unsecured domestic football goal present on site - Remove

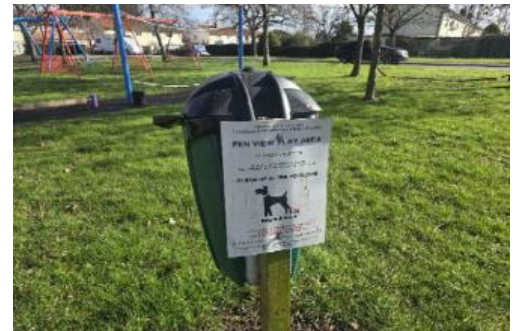
Item: Sign
Manufacturer: Not Identified
Surface Type: N/A
Item Quantity: 1
Equipment Compliance: N/A
Surface Area Compliance: N/A

This item is satisfactory - no work required -

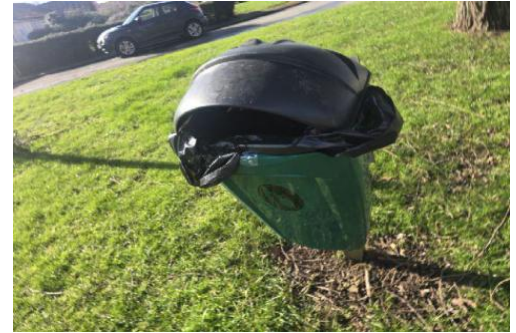
Item: Litter Bin
Manufacturer: Not Identified
Surface Type: Grass
Item Quantity: 1
Equipment Compliance: N/A
Surface Area Compliance: N/A

The post is loose in its foundations - Reinstall item to secure

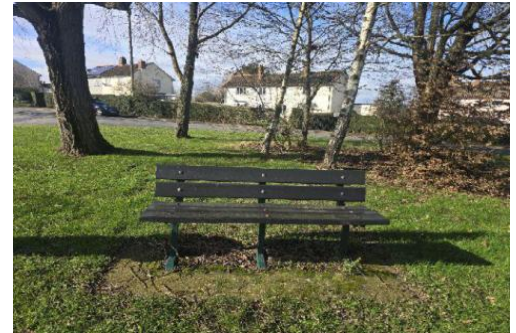
Item: Bench
Manufacturer: Not Identified
Surface Type: Concrete
Item Quantity: 1
Equipment Compliance: N/A
Surface Area Compliance: N/A

The paintwork on this item has been damaged or worn exposing the metal underneath which is rusting / corroding - Treat affected areas and repaint

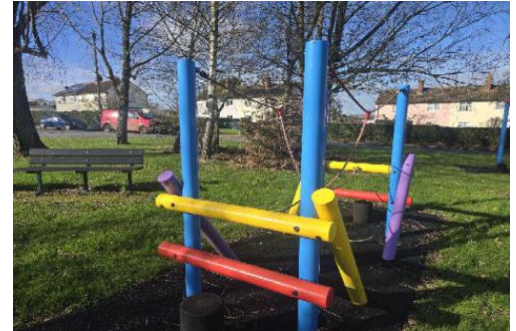
Item: Rope Bridge
Manufacturer: Not Identified
Surface Type: Wet Pour
Item Quantity: 1
Equipment Compliance: No
Surface Area Compliance: Yes

The paintwork on this item has been damaged or worn exposing the metal underneath which is rusting / corroding - Treat affected areas and repaint

The connecting links are in excess of 8.6mm and less than 12mm and fail the requirements of BS EN 1176 Part 1; clause 4.2.13, Chains - Monitor use and replace with compliant links at the next maintenance cycle

There are missing inserts creating finger entrapment/s in the framework and the item fails to meet the requirements of BS EN 1176 Part 1 4.2.7.6 Entrapment of fingers - Replace the missing inserts to remove the entrapment

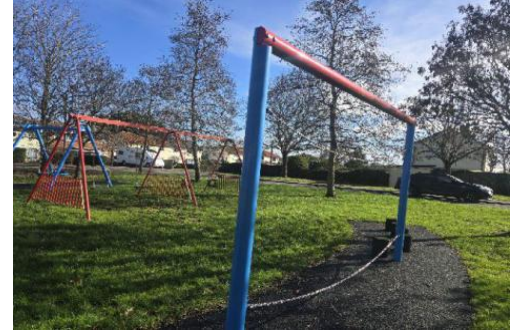
Item: Chain Traverse
Manufacturer: Not Identified
Surface Type: Wet Pour
Item Quantity: 1
Equipment Compliance: Yes
Surface Area Compliance: Yes

There is/are bolt cap covers missing or damaged on the item - Replace missing or damaged bolt cap covers

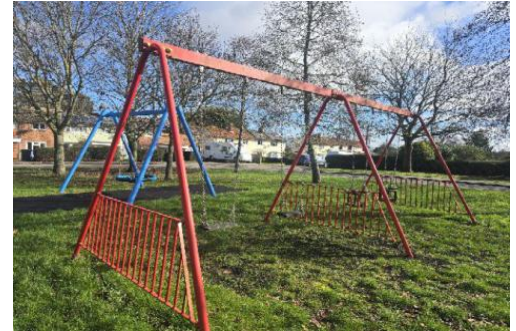
Item: 2 Bay (2 Flat, 2 Cradle)
Manufacturer: Not Identified
Surface Type: Bonded Rubber Mulch
Item Quantity: 1
Equipment Compliance: Yes
Surface Area Compliance: Yes

There is moderate damage to the surface - Repair the damaged areas of surfacing

The bushes are showing signs of wear - Monitor for any further deterioration and replace as required

BS EN 1176 Part 2: Annex A makes a recommendation that fences or enclosures should be 1.50m from the edges of the swing seat to the sides, and subject to risk assessment, from the edge of the impact area. This is however, a low risk finding and no remedial action is recommended. - Monitor - No action given the risk assessment

There is algae, silt or moss growth on the surface resulting in slippery conditions - Clean and treat appropriately

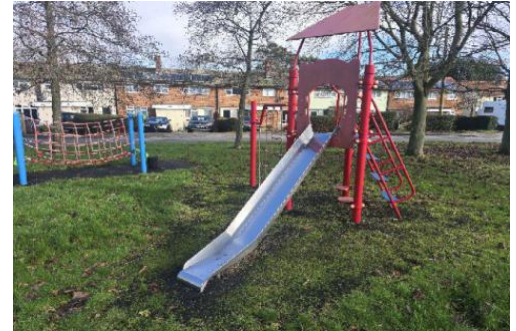
Item: Multi Play (Junior)
Manufacturer: Not Identified
Surface Type: Bonded Rubber Mulch
Item Quantity: 1
Equipment Compliance: No
Surface Area Compliance: Yes

There are a number of dents in the slide surface - Monitor for any further deterioration and repair as required

There is/are finger entrapment/s in the framework and the item fails to meet the requirements of BS EN 1176 Part 1 4.2.7.6 Entrapment of fingers - Monitor - No action given the risk assessment

There is/are bolt cap covers missing or damaged on the item - Replace missing or damaged bolt cap covers

The item fails to meet the requirements of BS EN 1176 Part 1 4.2.7.2 head and neck entrapment in the barriers and/or steps - Monitor - No action given the risk assessment

There is or are fixings missing on the post - Replace all missing fixings

A number of fixing(s) have worked loose - Secure all loose fixings

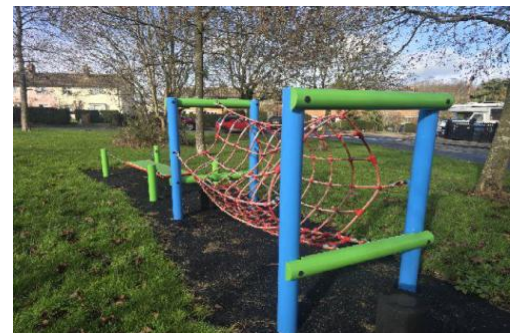
Item: Rope Tunnel
Manufacturer: Not Identified
Surface Type: Wet Pour
Item Quantity: 1
Equipment Compliance: No
Surface Area Compliance: Yes

There is/are finger entrapment/s in the frame and the item fails to meet the requirements of BS EN 1176 Part 1 4.2.7.6 Entrapment of fingers - Monitor - No action given the risk assessment

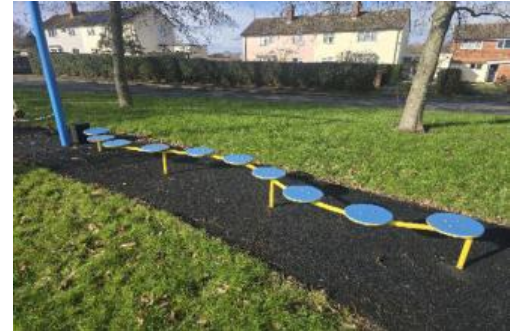
Item: Activity Trail
Manufacturer: Not Identified
Surface Type: Wet Pour
Item Quantity: 1
Equipment Compliance: Yes
Surface Area Compliance: Yes

This item is satisfactory - no work required -

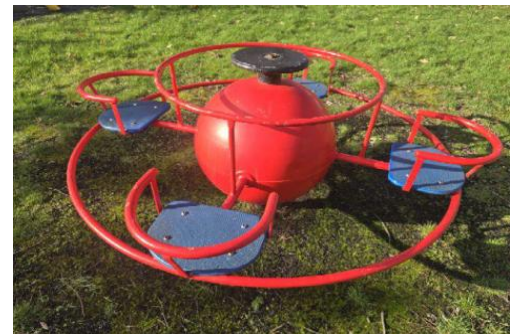
Item: Roundabout
Manufacturer: Not Identified
Surface Type: Bonded Rubber Mulch
Item Quantity: 1
Equipment Compliance: No
Surface Area Compliance: Yes

The item fails to meet the requirements of BS EN 1176 Part 1 4.2.7.2 for head and neck entrapment in the framework - Monitor - No action given the risk assessment

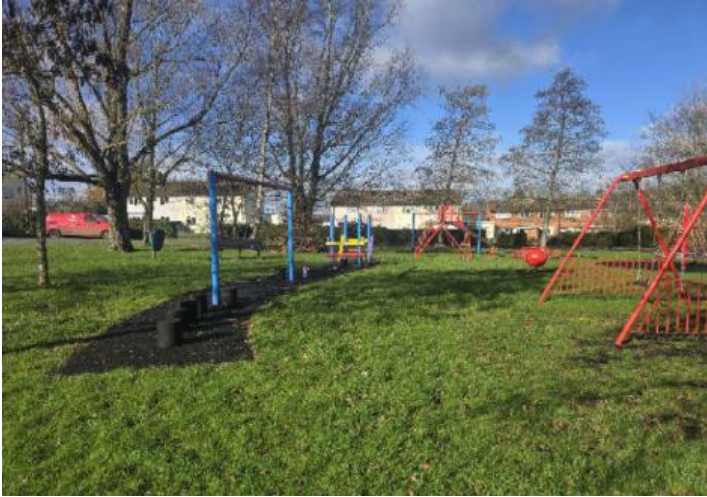
Item: Ancillary Items - Site General
Manufacturer: Owner/Operator

Finding: There is no physical barrier between the road and the play area

Action: Ensure a full and sufficient risk assessment is in place and review regularly

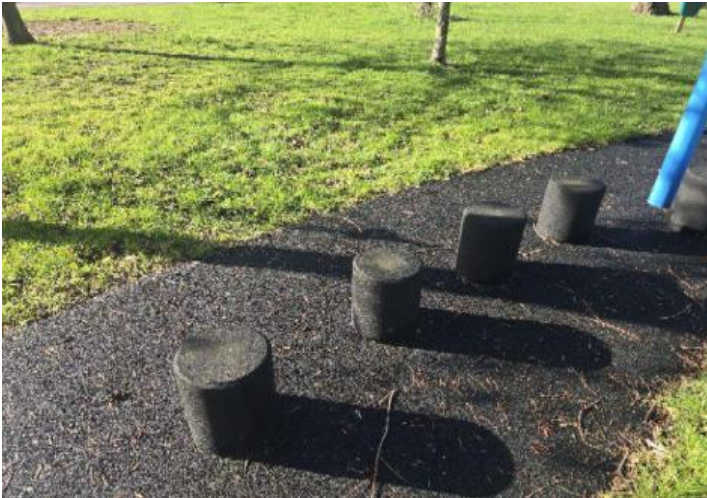
Item: Activity Equipment - Rubber Steps
Manufacturer: Not Identified

Finding: The step between the items is quite large and users may not be able to complete the step without touching ground, the items could therefore be considered to be within the falling space of each other, however the intention of the play activity continuity is easily apparent and foreseeable to the user

Action: Monitor - No action given the risk assessment

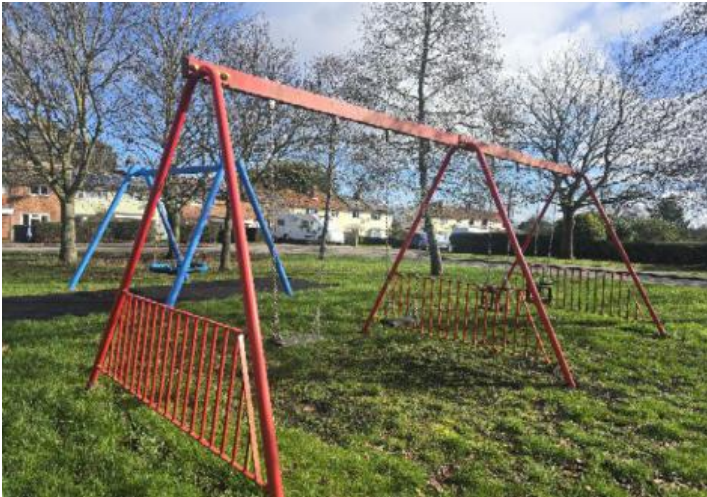
Item: Swings - 2 Bay (2 Flat, 2 Cradle)
Manufacturer: Not Identified

Finding: There is algae or moss on the surface of the seats

Action: Clean and treat appropriately

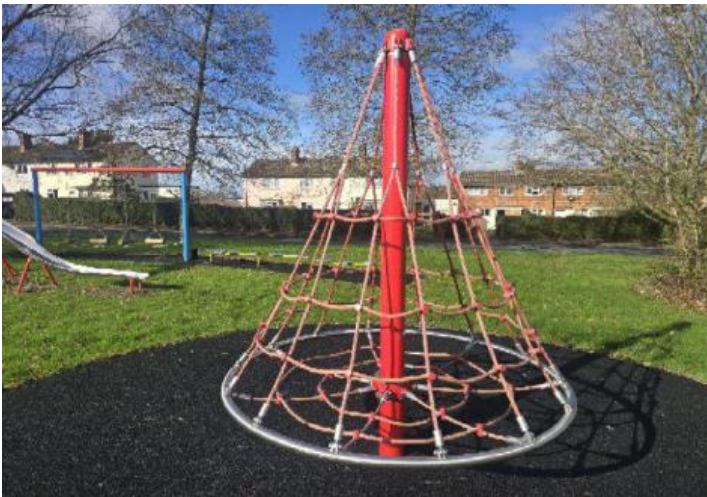
Item: Rotor Play - Rotating Net
Manufacturer: Not Identified

Finding: The paint is flaking off the metalwork

Action: Rub down and re-paint

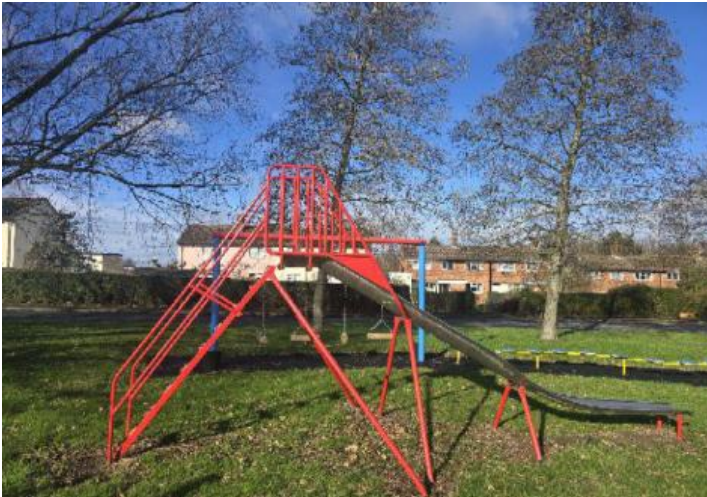
Item: Other - Free Standing Slide
Manufacturer: Not Identified

Finding: There are projecting bolt thread(s) present

Action: Remove excess thread length and deburr or provide cap

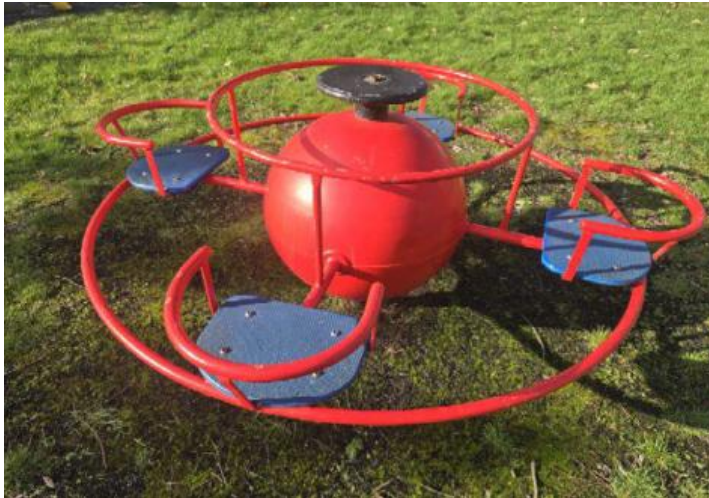
Item: Rotor Play - Roundabout
Manufacturer: Not Identified

Finding: The paint is flaking off the metalwork

Action: Rub down and re-paint
