# the **play inspection** company

## Annual Inspection

Babergh District Council

Copdock and Washbrook Parish Council - Mill Lane

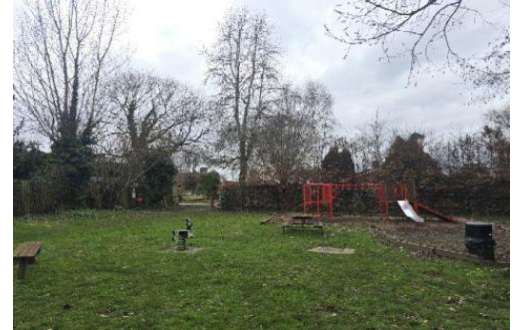
There is some tree debris on the surfacing - Remove and maintain

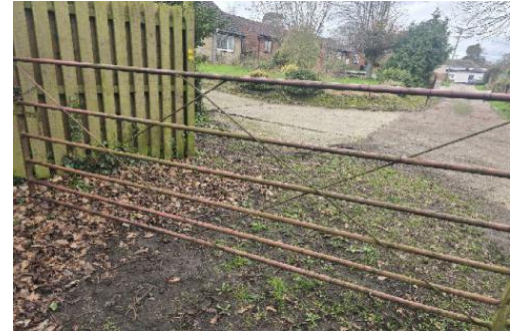
The gate latch is damaged and gate post is missing - Repair or replace post

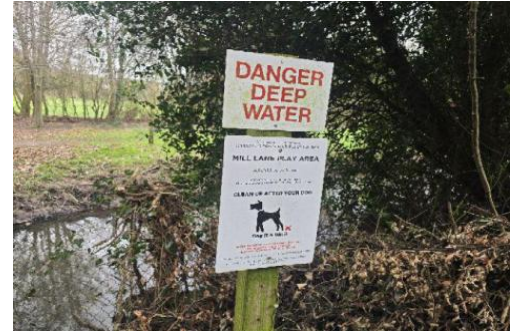
The item is slightly loose in its foundations - Monitor for any further deterioration and repair as required

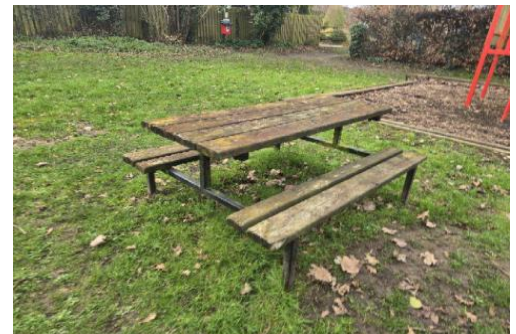
There is algae or moss on the surface of the equipment - Clean and treat appropriately

There is some evidence of fire damage to the item - Monitor for any further deterioration and repair as required

There is/are bolt cap covers missing or damaged on the item - Replace missing or damaged bolt cap covers

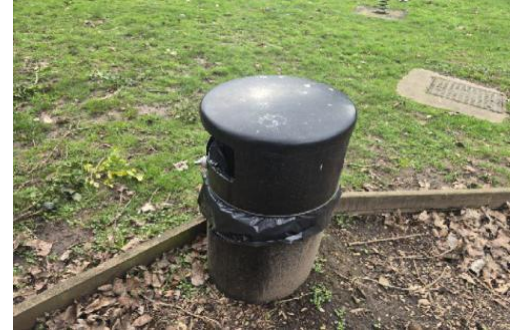
The lid or door of the litter bin is not secured - Ensure the lid or door is kept locked

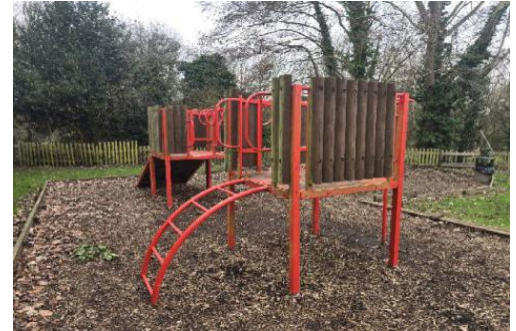
There are areas or parts of the timber edging that have rotted and are unsecured - Replace all affected timbers

The depth of the loose fill surfacing is lower than the recommended depth specified in BS EN 1176; the free height of fall of the equipment is less than 2.0m and a minimum of 300mm depth should be provided (including an extra 100mm to allow for compaction and displacement as per BS EN 1176 Part 1 - Table 4) - Top up loose fill surfacing to recommended levels

The loose fill safety surfacing has become compacted and degraded to mulch - Top up with fresh material

The item fails to meet the requirements of BS EN 1176 Part 1 4.2.7.2 for head and neck entrapment in the framework - Monitor - No action given the risk assessment

There are a number of dents in the slide surface - Monitor for any further deterioration and repair as required

There is/are inserts missing - Replace missing inserts

There are areas or parts of the timber ramp that have rotted - Replace all affected timbers

<b>Finding 13</b>	<b>Finding 14</b>
There is some evidence of rot in the timber - Monitor for any further deterioration and replace as required	There is/are finger entrapment/s in the starting section of the slide and the item fails to meet the requirements of BS EN 1176 Part 1 4.2.7.6 Entrapment of fingers - Monitor - No action given the risk assessment
<b>Finding 15</b>	<b>Finding 16</b>
The item fails to meet the requirements of BS EN 1176 Part 1 4.2.7.2 head and neck entrapment in the barriers and/or steps - Monitor - No action given the risk assessment	The timber edge forms a hard object within the falling space of the equipment and there is also insufficient surfacing provided in contravention of BS EN 1176 Part 1 - Consider adjusting distance of the timber edging to comply ( 1.5m)

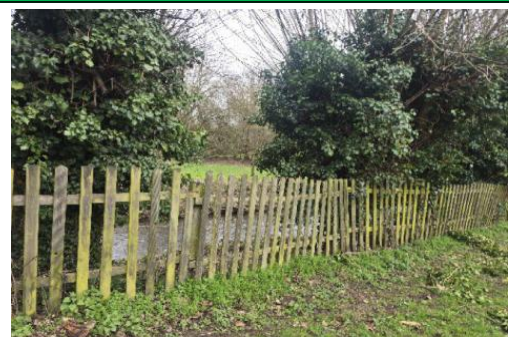
<b>Finding 1</b>	<b>Finding 2</b>
The adjacent foliage is overhanging the fencing - Cut back and maintain	There are areas or parts of the timber fencing that have rotted - Replace all affected timbers
<b>Finding 3</b>	
The fence is damaged and is leaning in places - Repair or replace all affected sections

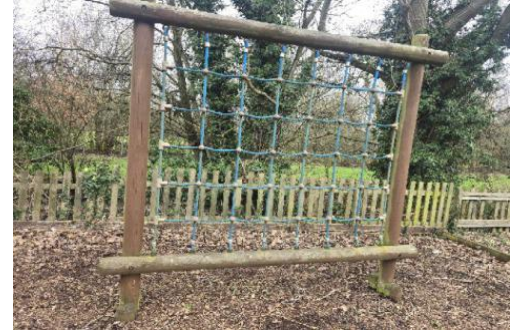
There is algae or moss on the surface of the equipment - Clean and treat appropriately

There is/are bolt cap covers missing or damaged on the item - Replace missing or damaged bolt cap covers

The loose fill safety surfacing has become compacted and degraded to mulch - Top up with fresh material

The inspector has some concerns about the internal condition of the timber and was unable to verify the structural integrity without further testing. We recommend a Resi-PD survey to establish the condition of the timber at it's core. - Contact the Play Inspection Company office for further information

The depth of the loose fill surfacing is lower than the recommended depth specified in BS EN 1176 for a fall height over 2.0m. A minimum depth of 400mm is recommended (including an extra 100mm to allow for compaction and displacement as per BS EN 1176 Part 1 - Table 4) - Top up loosefill to recommended levels

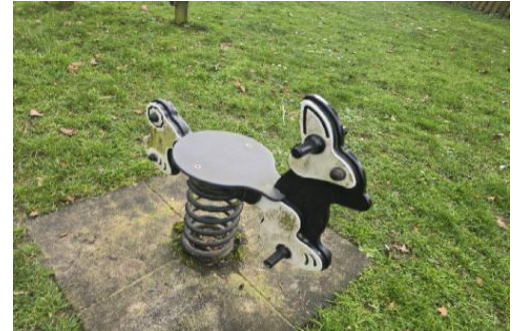
The end of handgrips and/or footrests have a cross section of less than 15cm<sup>2</sup> and fail to meet the requirements of BS EN 1176 Part 6 - Monitor - No action given the risk assessment

The end caps are missing on the Handgrips/Footrests - Replace missing end caps

There are trip hazards at the edges of the surface - Remove trip hazard

The paintwork on the spring has been damaged or worn exposing the metal underneath which is rusting - Treat any rusting components and repaint

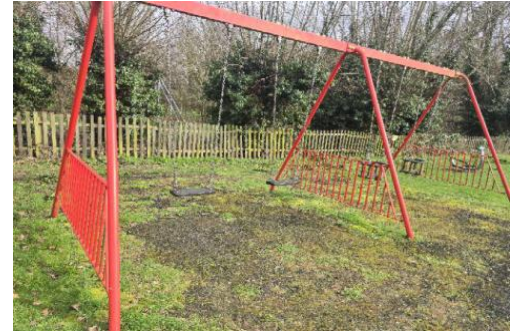
The swing seat connectors are loose - Tighten to secure

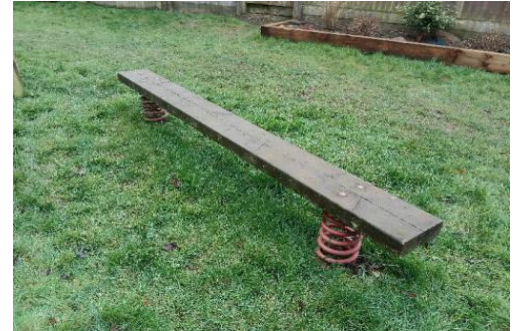
The adjacent items forms a projecting obstacle / hard object within the falling space of the equipment, in contravention of the requirements of BS EN 1176 Part 1 - Monitor - No action given the risk assessment

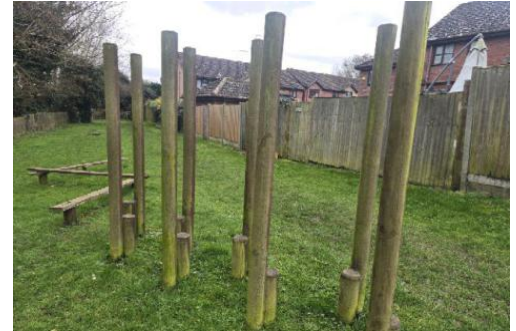
The spring balance beam forms a projecting obstacle / hard object within the falling space of the equipment, in contravention of the requirements of BS EN 1176 Part 1 - Monitor - No action given the risk assessment

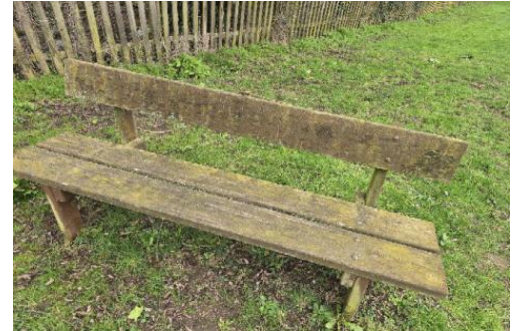
There is algae or moss on the surface of the equipment -  
 Clean and treat appropriately

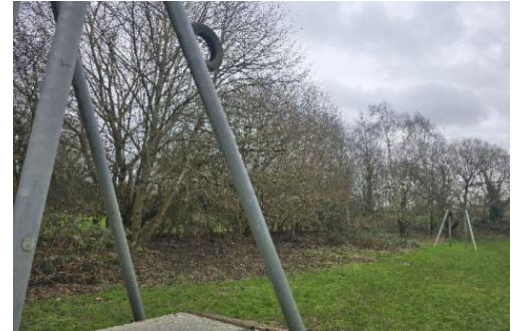
We have completed a visual inspection of the suspension links, cable and fixing points from ground level, however it is not possible to fully inspect these areas without either hiring equipment to gain access or removing the cable and suspension and inspecting at ground level. We recommend that the main cable and fixing security is thoroughly inspected at least in accordance with the manufacturers recommendations to check for wear, damage, security or internal rusting; this will help to ensure the continued safe use of the equipment - Inspect in accordance with the manufacturers recommendations

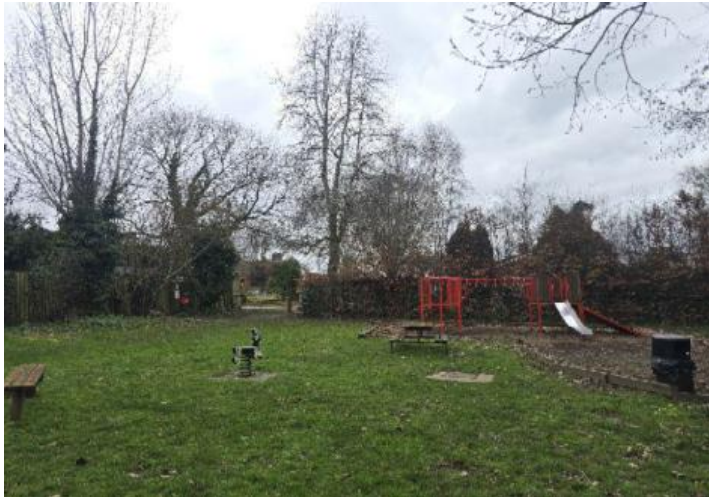
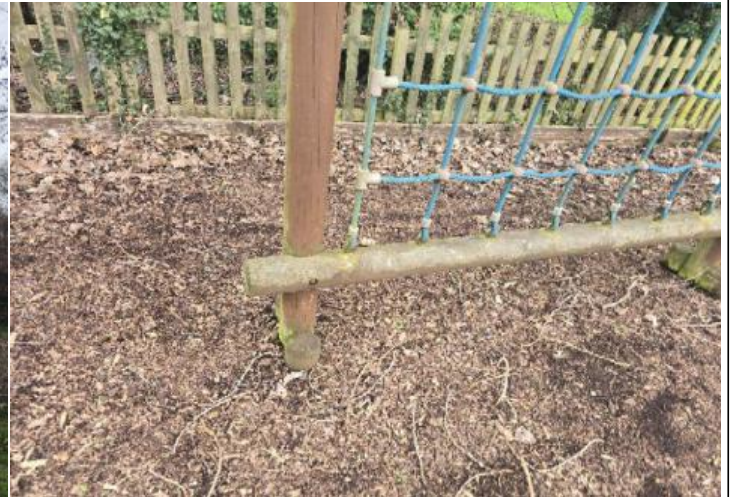
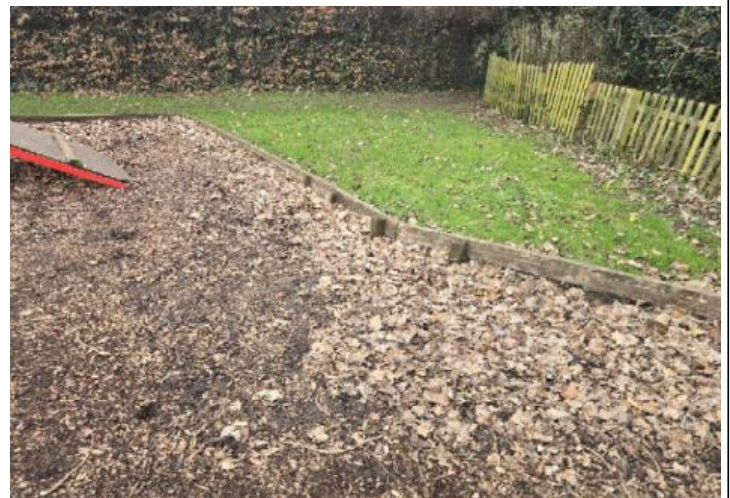
**Finding:** There is some tree debris on the surfacing

**Action:** Remove and maintain

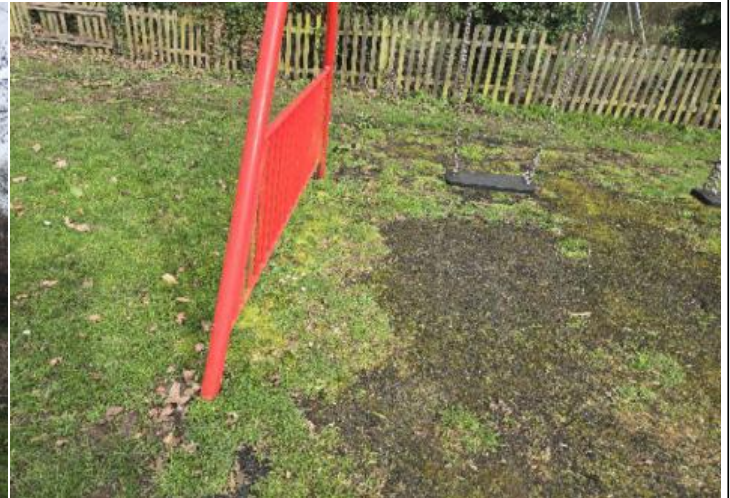
**Finding:** There is weed / vegetation growth within the surface

**Action:** Remove weed / vegetation growth

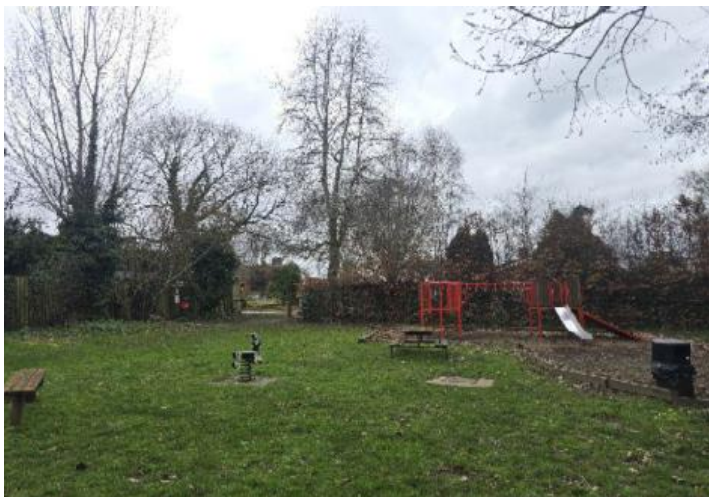
**Finding:** It is recommended that Adult Outdoor Fitness equipment is installed a minimum of 25m away from a childrens playground or separated and screened to discourage access by younger children

**Action:** Monitor use and review risk assessment regularly

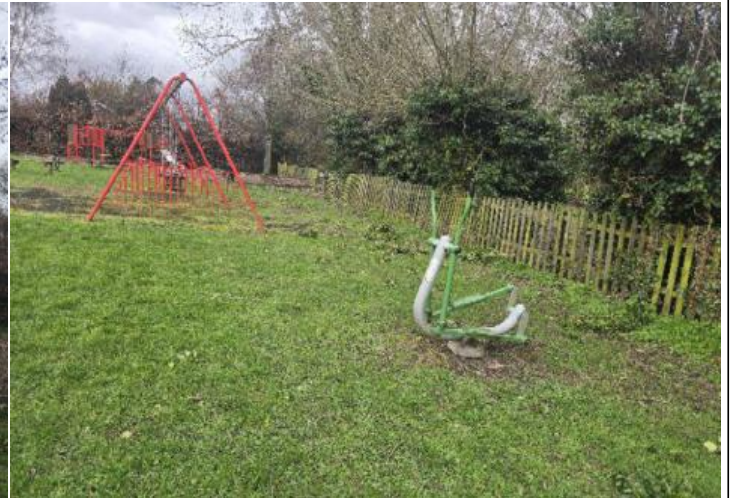
**Finding:** Signage should be provided for the outdoor fitness equipment in accordance with the requirements of BS EN 16630, key requirements of the sign include, but are not limited to, intended users, medical safety and emergency contact details

**Action:** Provide appropriate signage

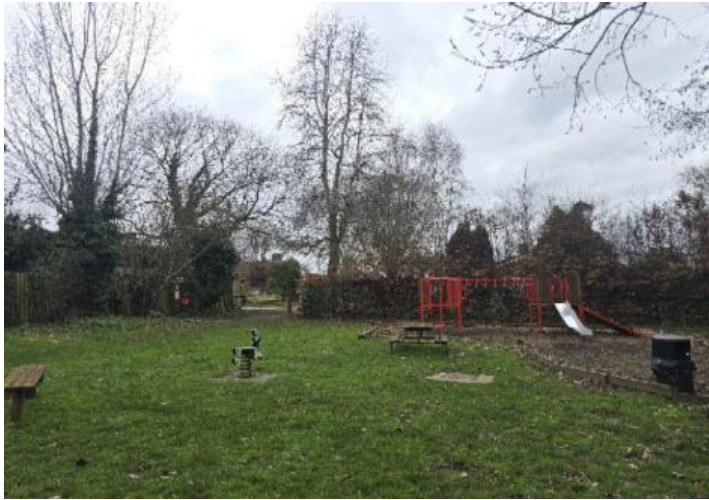
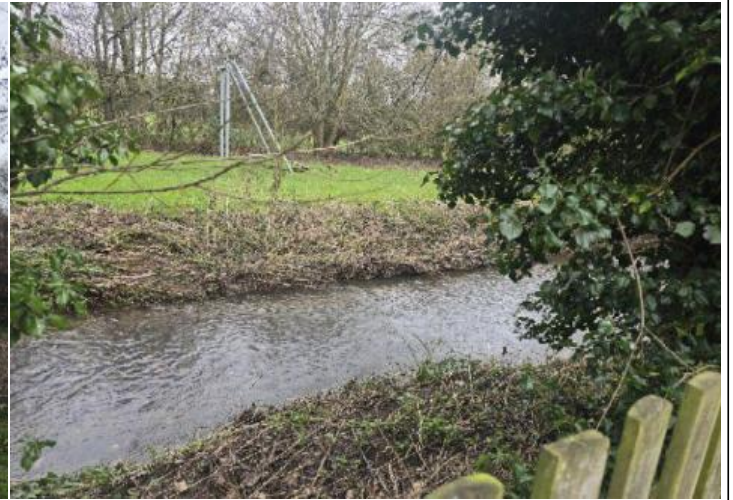
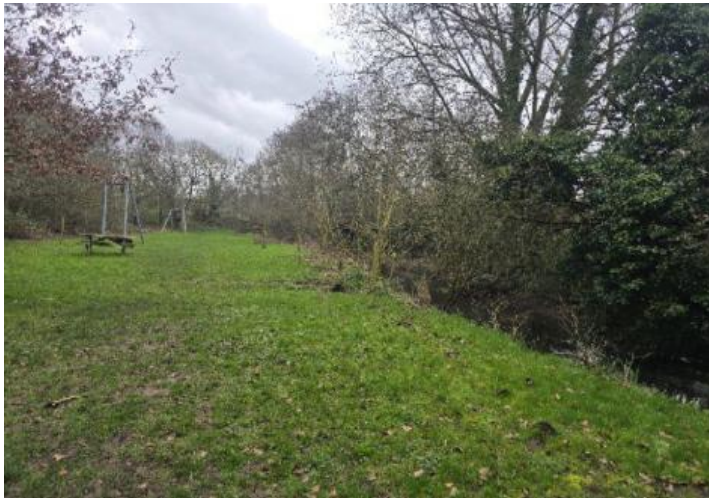
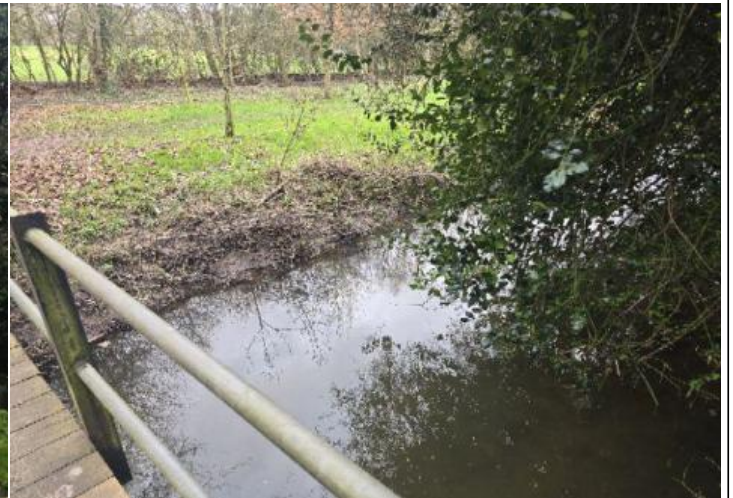
**Finding:** NOTE - There is a body of water or a water basin in close proximity to the playground. Risk assessment of this is a specialist field and outside the scope of our inspection.

**Action:** Contact our official water safety partner the RLSS (Royal Life Saving Society) at [www.rlss.org.uk](http://www.rlss.org.uk) and / or ensure that the appropriate risk assessment is in place

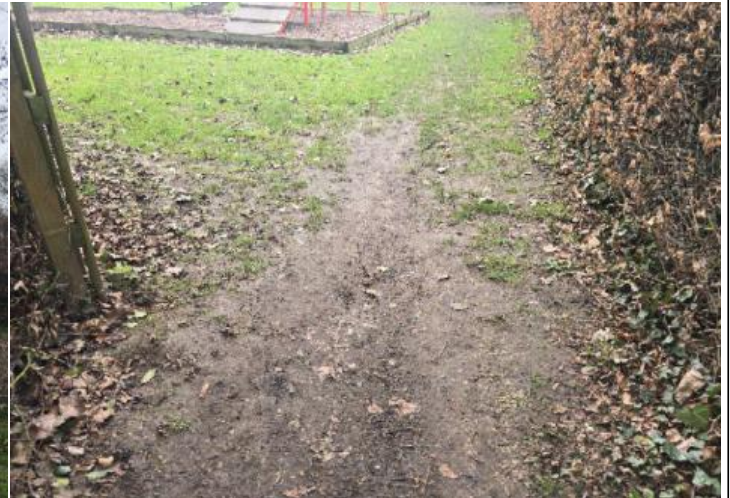
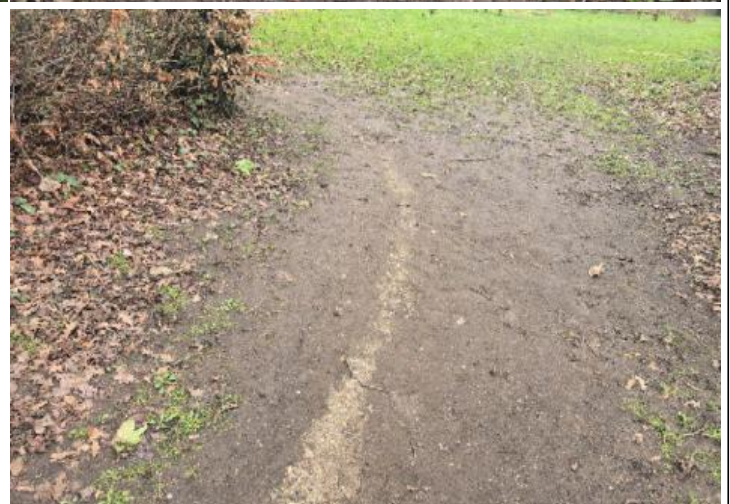
**Finding:** The area around the item has eroded and may become slippery

**Action:** Reinststate eroded area

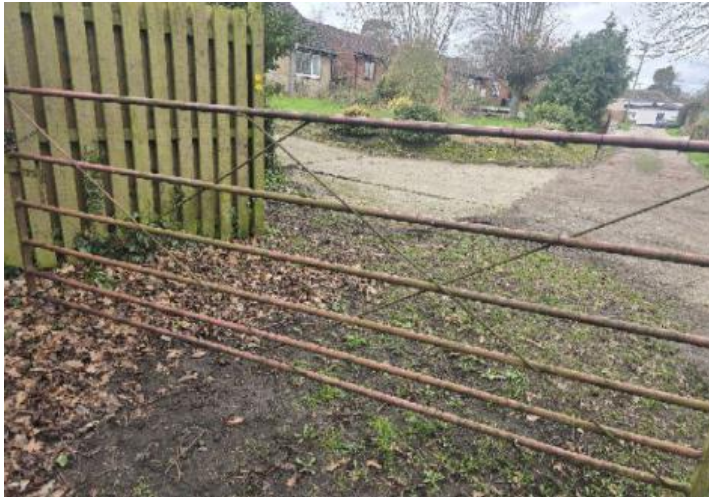
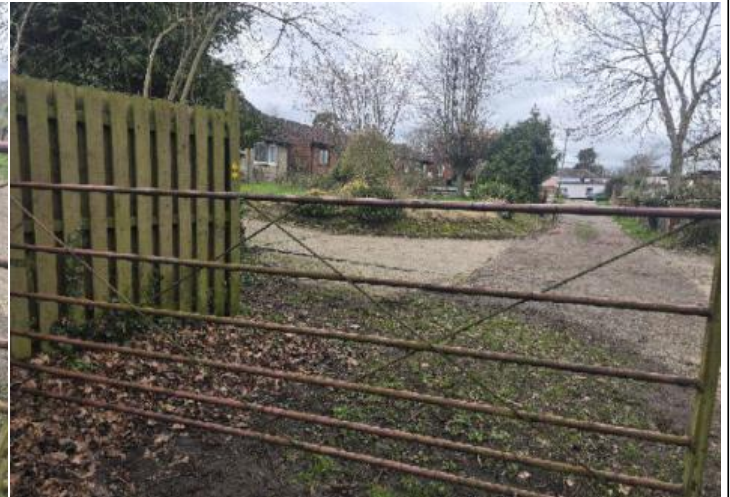
**Finding:** There is no padlock on the maintenance gate **Action:** Provide a padlock to secure the gate

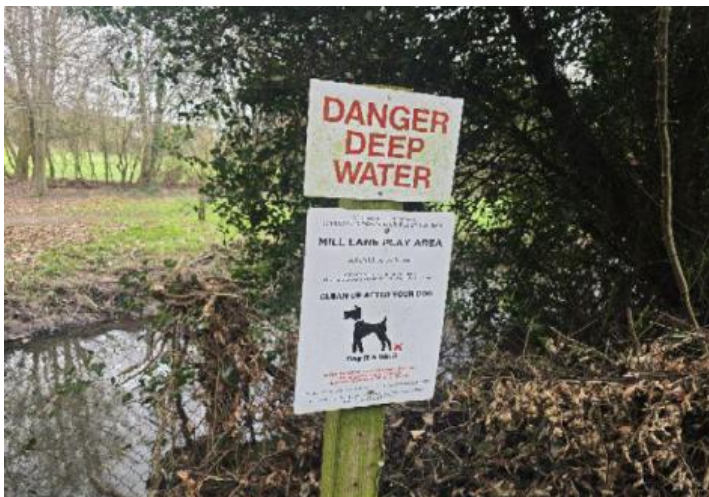
**Finding:** The item is slightly loose in its foundations

**Action:** Monitor for any further deterioration and repair as required

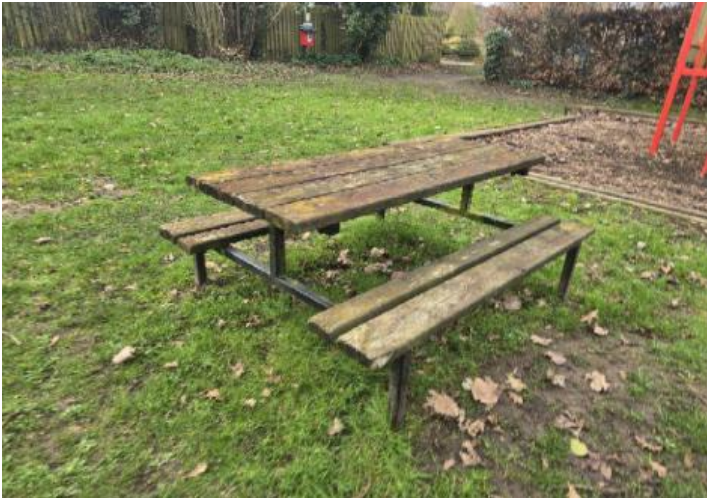
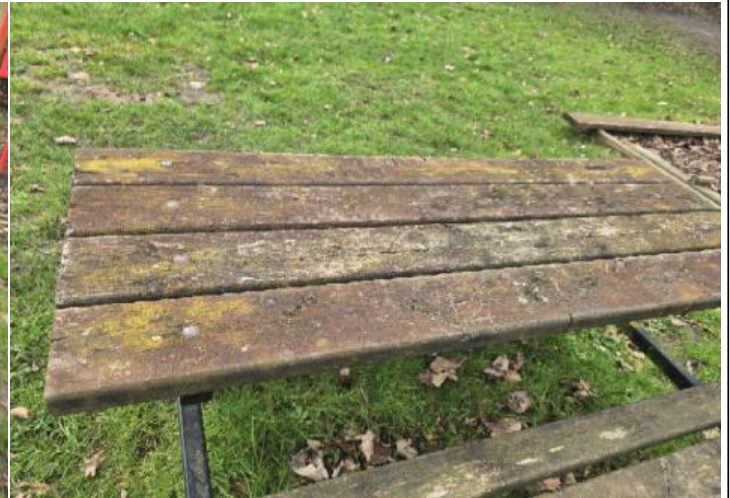
**Finding:** There is algae or moss on the surface of the equipment

**Action:** Clean and treat appropriately

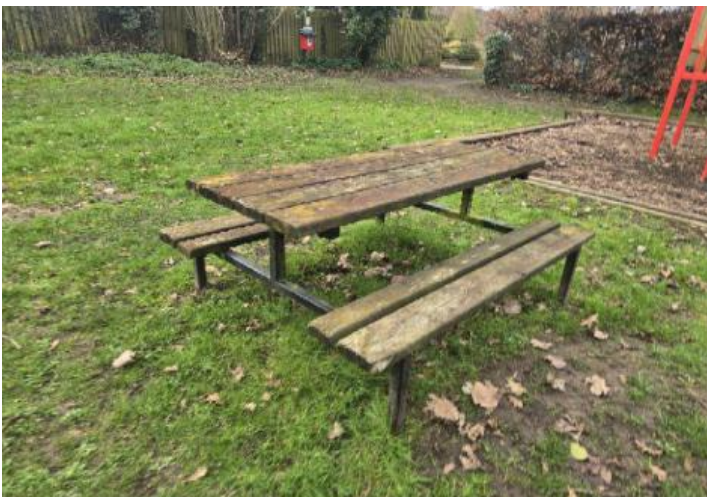
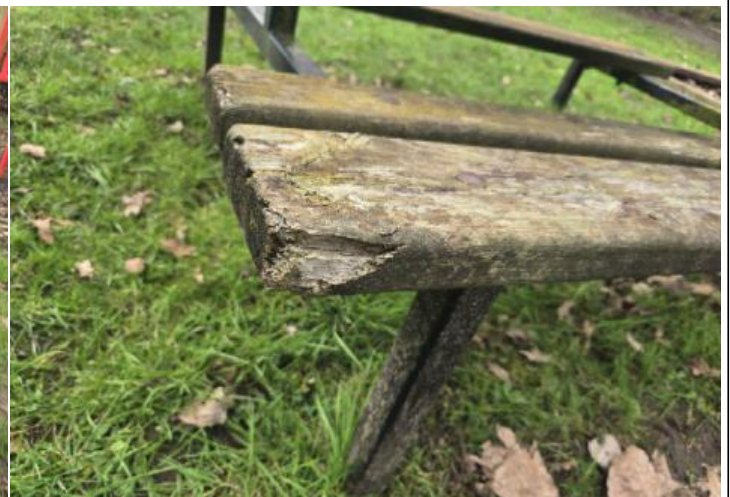
**Finding:** Parts of the timber are rough or splintered

**Action:** Remove all rough or sharp edges

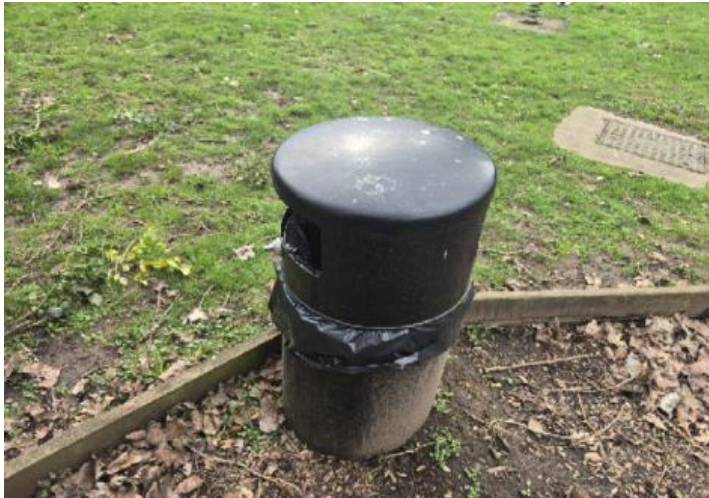
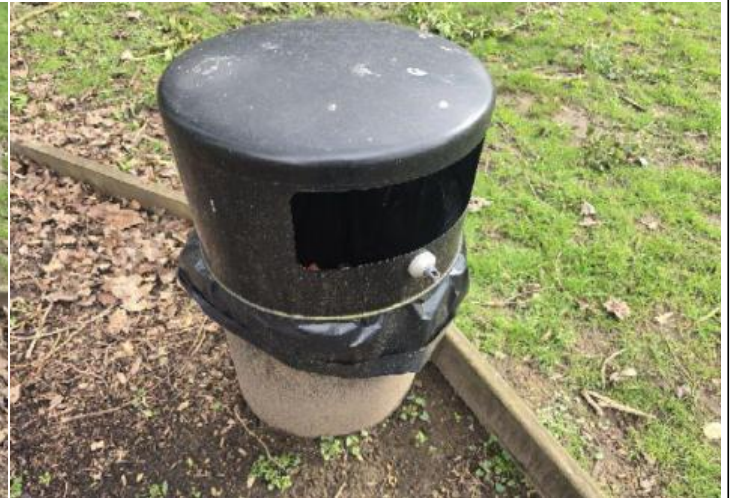
**Item:** Ancillary Items - Litter Bin  
**Manufacturer:** Not Identified

**Finding:** The lid or door of the litter bin is not secured

**Action:** Ensure the lid or door is kept locked

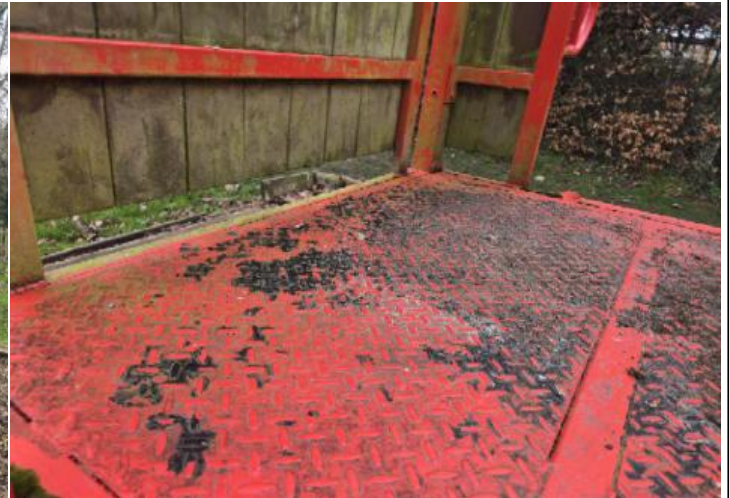
**Item:** Activity Equipment - Multi Play (Junior)  
**Manufacturer:** Not Identified

**Finding:** The paint is flaking off the metalwork

**Action:** Rub down and re-paint

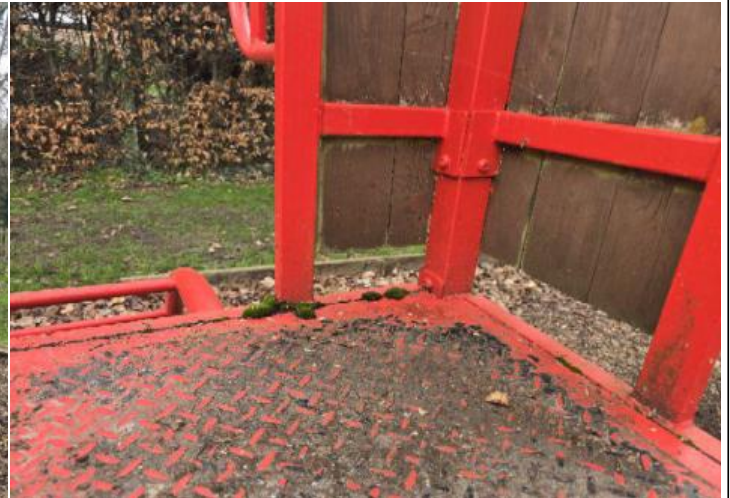
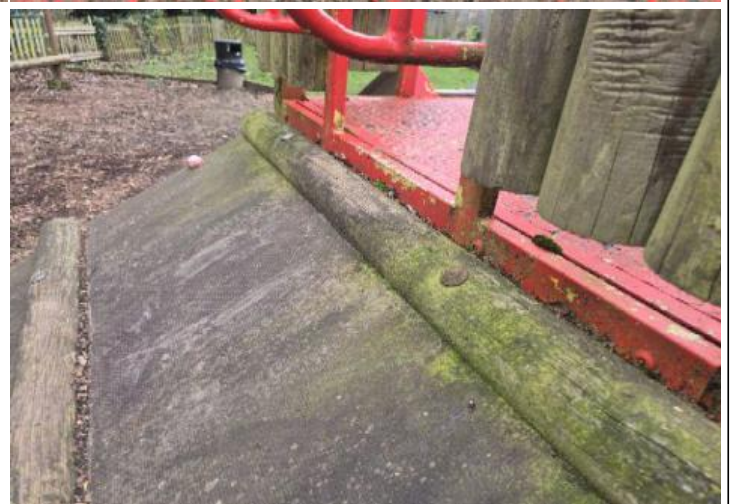
**Item:** Activity Equipment - Multi Play (Junior)  
**Manufacturer:** Not Identified

**Finding:** There is algae or moss on the surface of the equipment

**Action:** Clean and treat appropriately

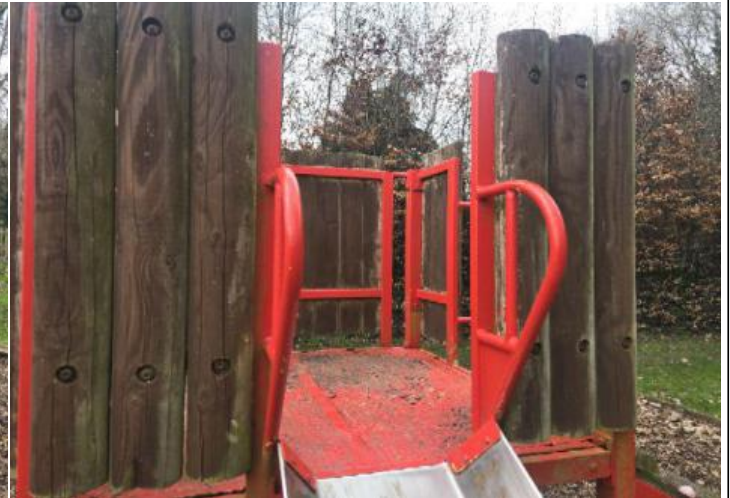
**Item:** Activity Equipment - Multi Play (Junior)  
**Manufacturer:** Not Identified

**Finding:** This item has no slide bar fitted as required by BS EN 1176 Part 3  
**Action:** Monitor - No action given the risk assessment

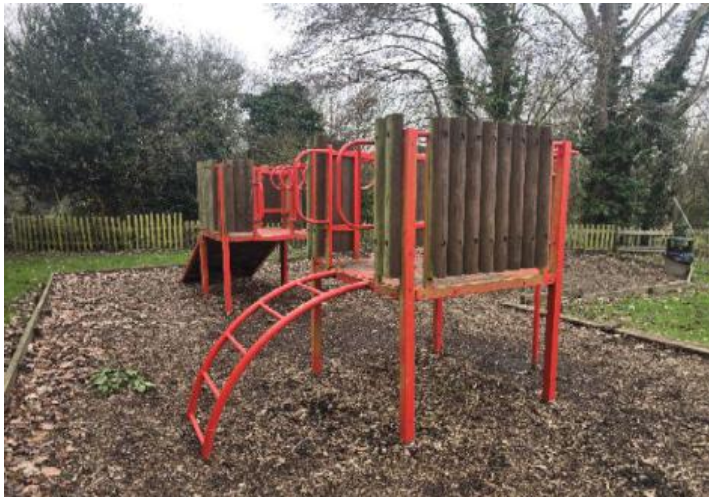
**Item:** Activity Equipment - Multi Play (Junior)  
**Manufacturer:** Not Identified

**Finding:** There are a number of dents in the slide surface  
**Action:** Monitor for any further deterioration and repair as required

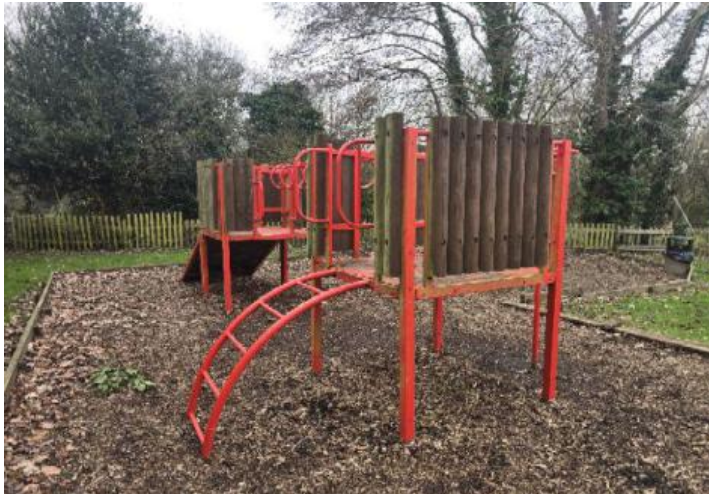
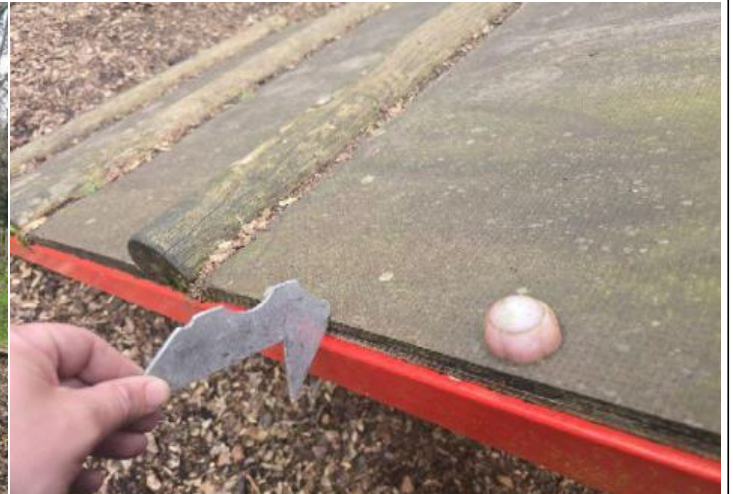
**Item:** Activity Equipment - Multi Play (Junior)  
**Manufacturer:** Not Identified

**Finding:** The item has exposed edges and corners that are sharp, or with a radius of less than 3mm, and does not meet the requirements of BS EN 1176 Part 1 - 4.2.5

**Action:** Provide a 3mm radius to all exposed edges and corners, or remove sharp edge

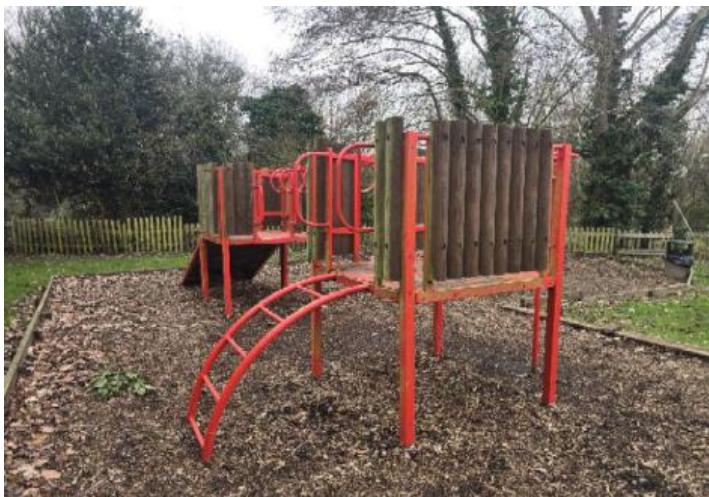
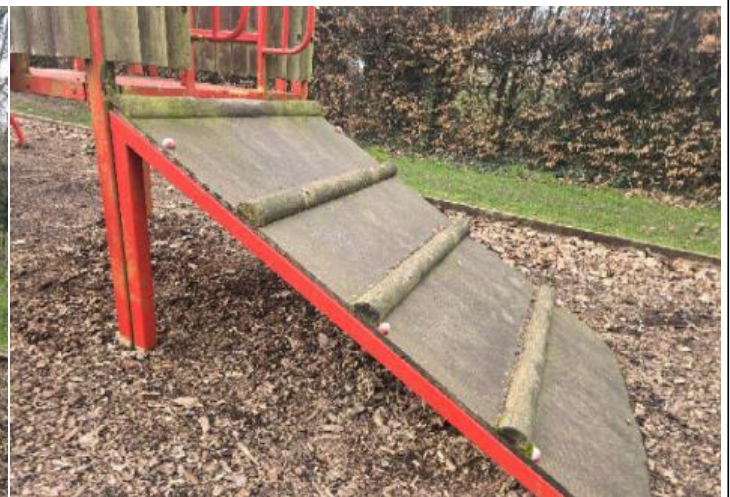
**Item:** Activity Equipment - Multi Play (Junior)  
**Manufacturer:** Not Identified

**Finding:** The access ramp height is greater than 600mm and the angle of ascent is less than 38 degrees. Barriers or guardrails are required to comply with the requirements BS EN 1176

**Action:** Monitor - No action given the risk assessment

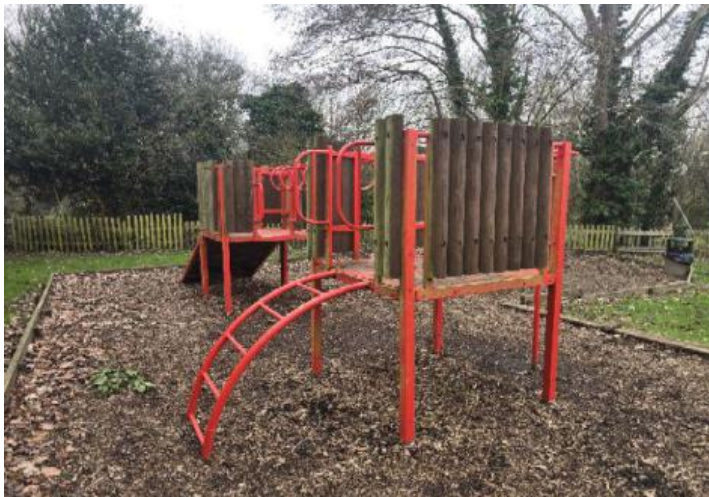
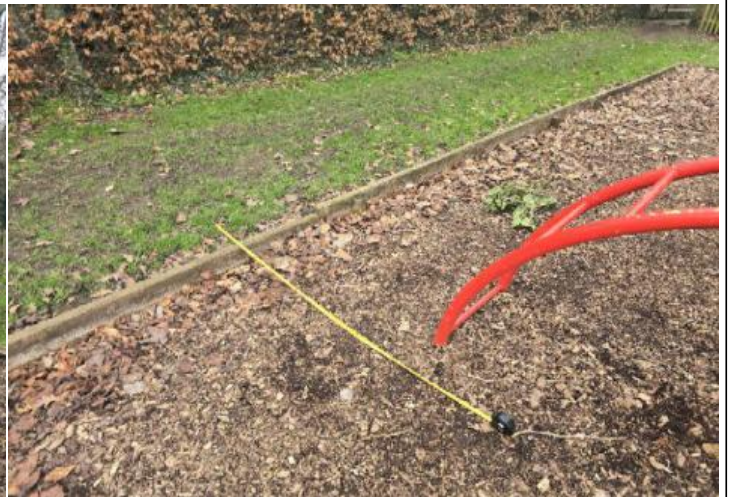
**Item:** Activity Equipment - Multi Play (Junior)  
**Manufacturer:** Not Identified

**Finding:** The timber edge forms a hard object within the falling space of the equipment and there is also insufficient surfacing provided in contravention of BS EN 1176 Part 1

**Action:** Consider adjusting distance of the timber edging to comply ( 1.5m)

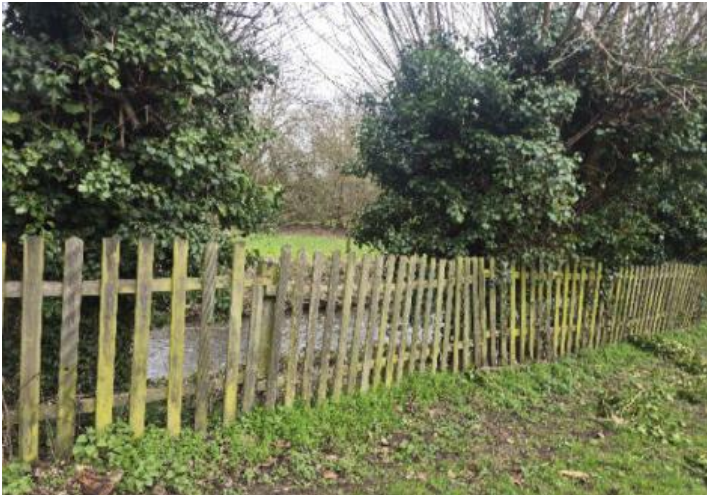
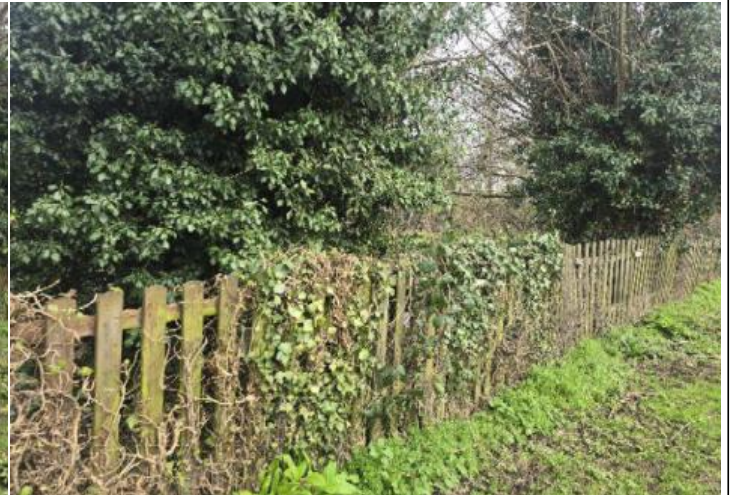
**Item:** Fences - Fencing - Timber  
**Manufacturer:** Not Identified

**Finding:** The adjacent foliage is overhanging the fencing

**Action:** Cut back and maintain

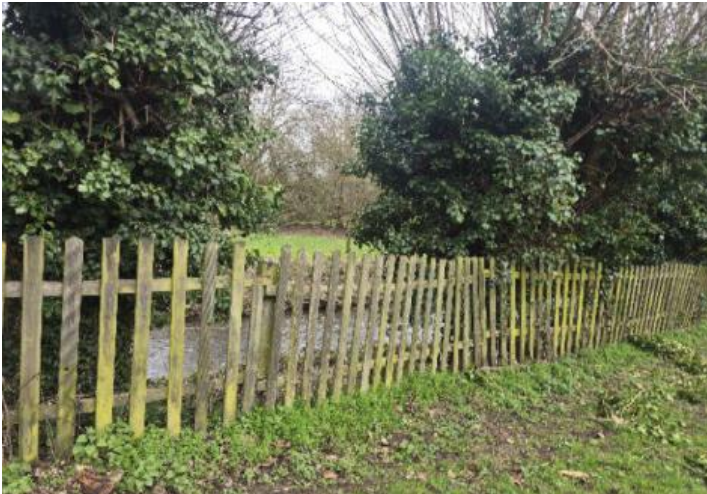
**Item:** Fences - Fencing - Timber  
**Manufacturer:** Not Identified

**Finding:** There are areas or parts of the timber fencing that have rotted

**Action:** Replace all affected timbers

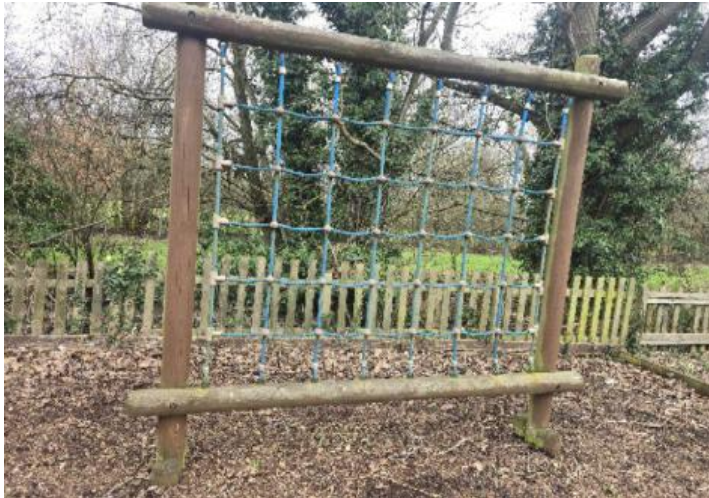
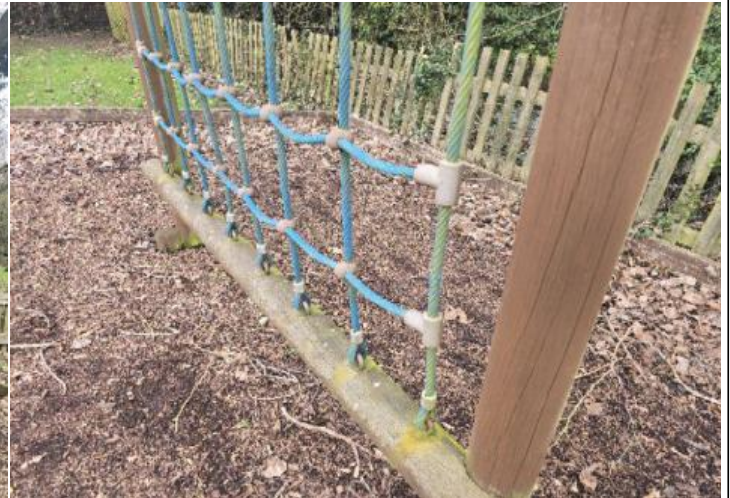
**Item:** Activity Equipment - Net Climber  
**Manufacturer:** Not Identified

**Finding:** There is algae or moss on the surface of the equipment

**Action:** Clean and treat appropriately

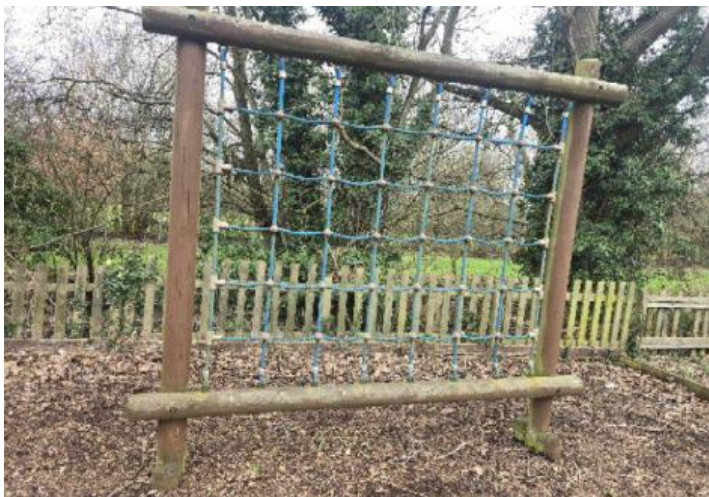
**Item:** Activity Equipment - Net Climber  
**Manufacturer:** Not Identified

**Finding:** The loose fill safety surfacing has become compacted and degraded to mulch

**Action:** Top up with fresh material

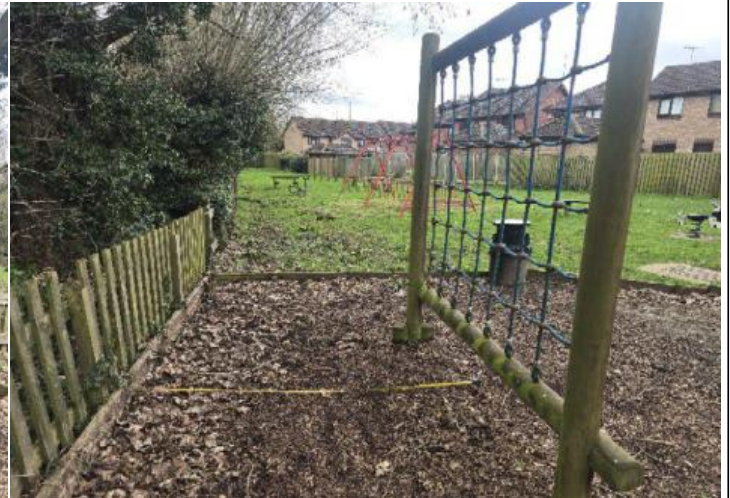
**Item:** Activity Equipment - Net Climber  
**Manufacturer:** Not Identified

**Finding:** The timber edge / fencing forms a hard object within the falling space of the equipment and there is also insufficient surfacing provided in contravention of BS EN 1176 Part 1

**Action:** Monitor - No action given the risk assessment

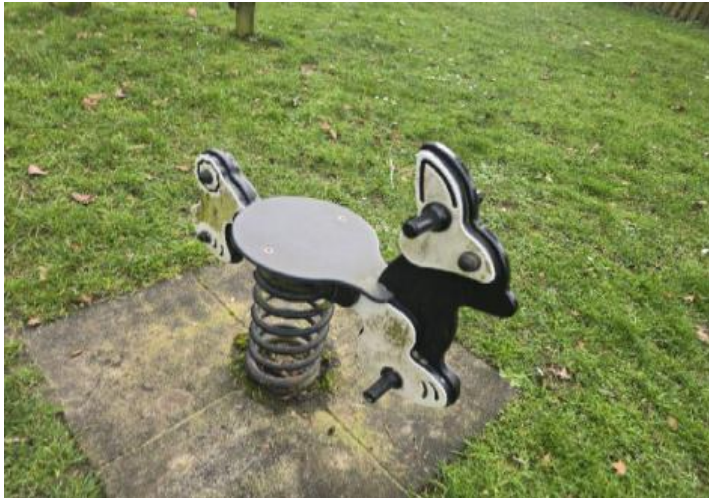
**Item:** Rocking Equipment - Spring Rabbit  
**Manufacturer:** Not Identified

**Finding:** The end of handgrips and/or footrests have a cross section of less than 15cm<sup>2</sup> and fail to meet the requirements of BS EN 1176 Part 6  
**Action:** Monitor - No action given the risk assessment

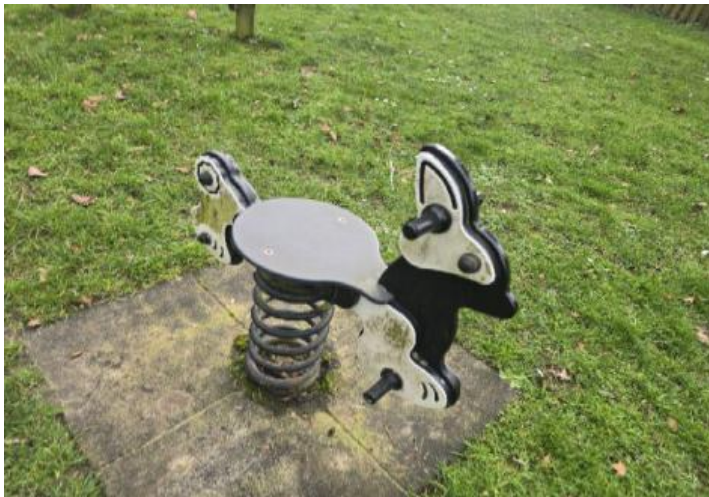
**Item:** Rocking Equipment - Spring Rabbit  
**Manufacturer:** Not Identified

**Finding:** The end caps are missing on the Handgrips/Footrests  
**Action:** Replace missing end caps

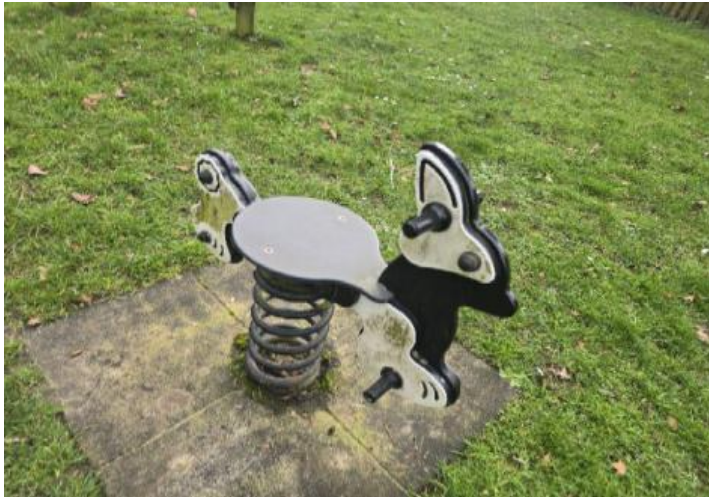
**Item:** Rocking Equipment - Spring Rabbit  
**Manufacturer:** Not Identified

**Finding:** The paintwork on the spring has been damaged or worn exposing the metal underneath which is rusting **Action:** Treat any rusting components and repaint

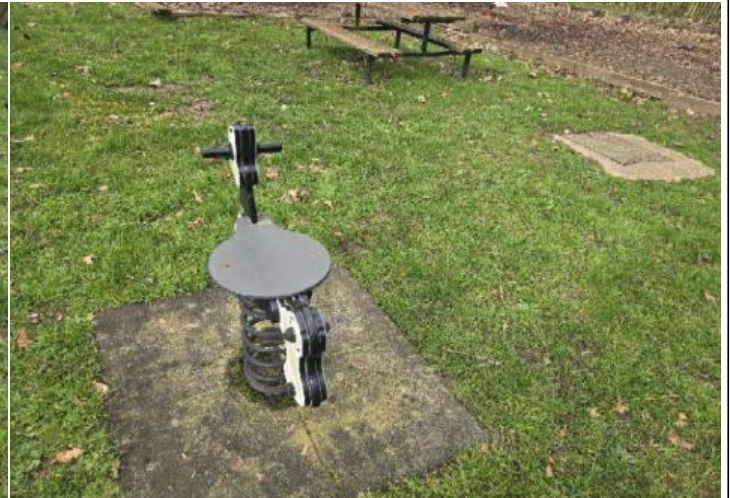
**Item:** Rocking Equipment - Spring Rabbit  
**Manufacturer:** Not Identified

**Finding:** The spring rotates on the base

**Action:** Secure spring to prevent rotation

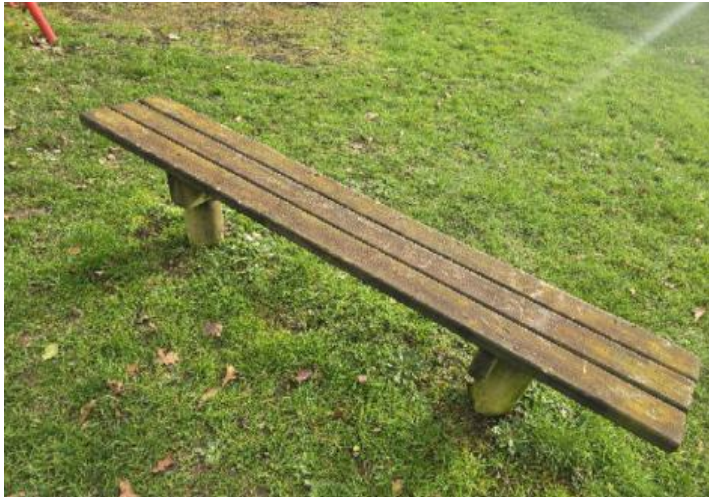
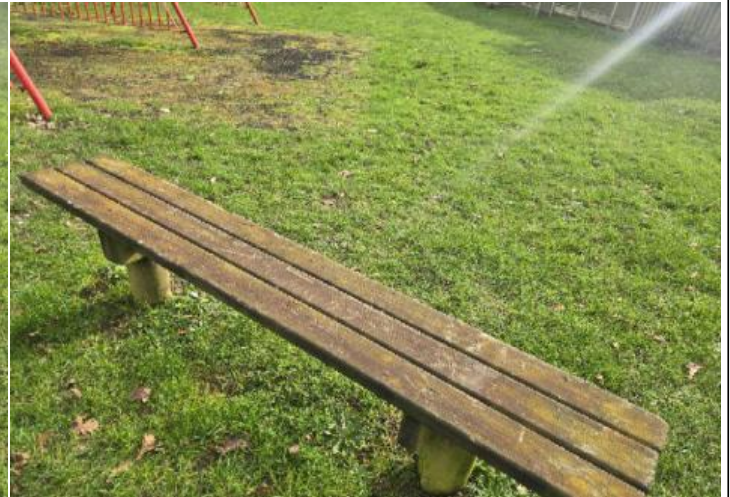
**Item:** Ancillary Items - Bench  
**Manufacturer:** Not Identified

**Finding:** There is algae or moss on the surface of the equipment

**Action:** Clean and treat appropriately

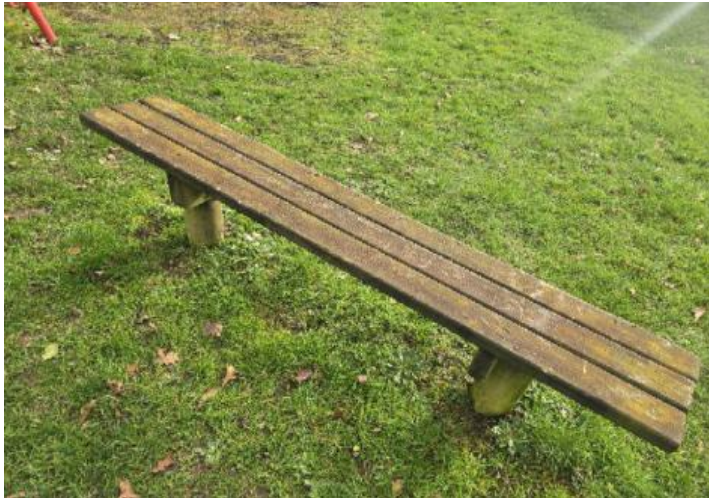
**Item:** Ancillary Items - Bench  
**Manufacturer:** Not Identified

**Finding:** There is some strimmer / machinery damage apparent on the posts, this can penetrate the preservative applied to the timber and accelerate the rotting process

**Action:** Monitor for any deterioration (rot) and replace as required

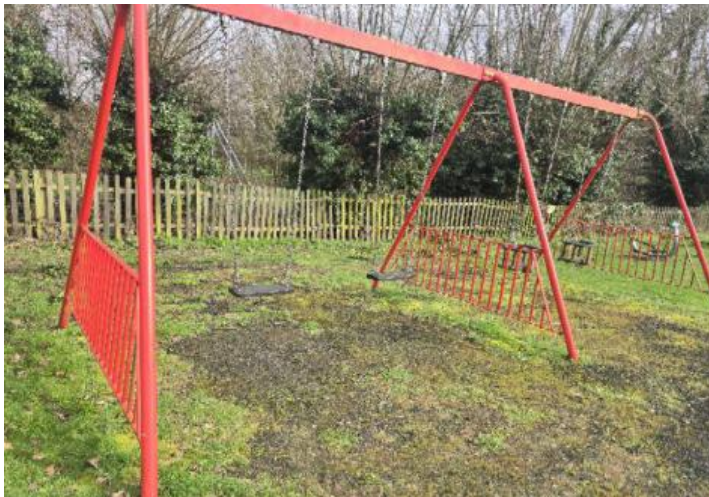
**Item:** Swings - 2 Bay (2 Flat, 2 Cradle)  
**Manufacturer:** Not Identified

**Finding:** The swing seat connectors are loose

**Action:** Tighten to secure

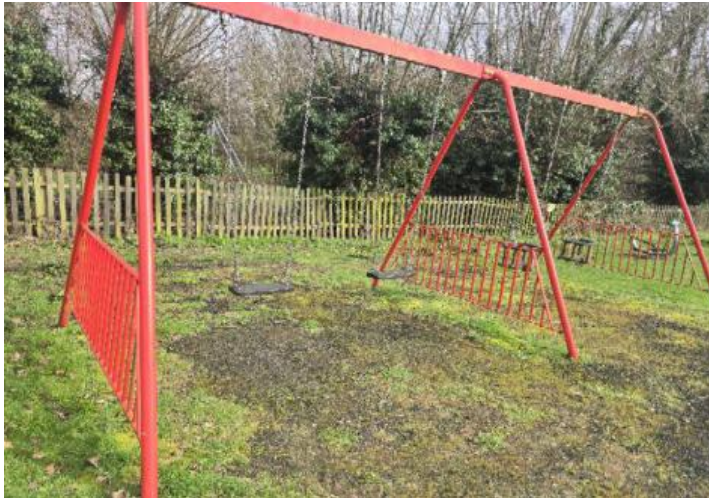
**Item:** Swings - 2 Bay (2 Flat, 2 Cradle)  
**Manufacturer:** Not Identified

**Finding:** There is some notable evidence of chain wear

**Action:** Monitor for any further deterioration and replace when 40% worn
