# the **play inspection** company

## Annual Inspection

Babergh District Council

Copdock and Washbrook Parish Council - Mill Lane

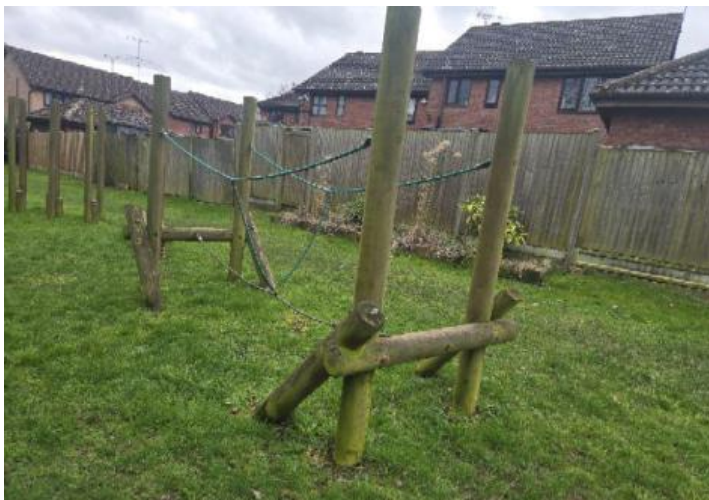
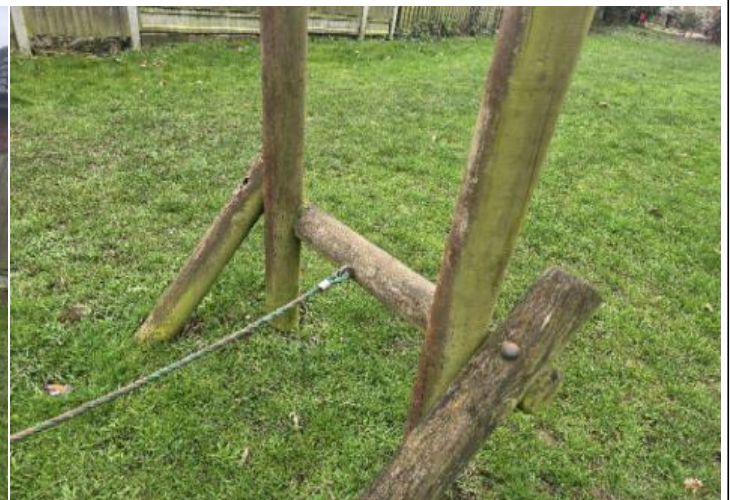
**Item:** Activity Equipment - Rope Bridge  
**Manufacturer:** Not Identified

**Finding:** There is algae or moss on the surface of the equipment

**Action:** Clean and treat appropriately

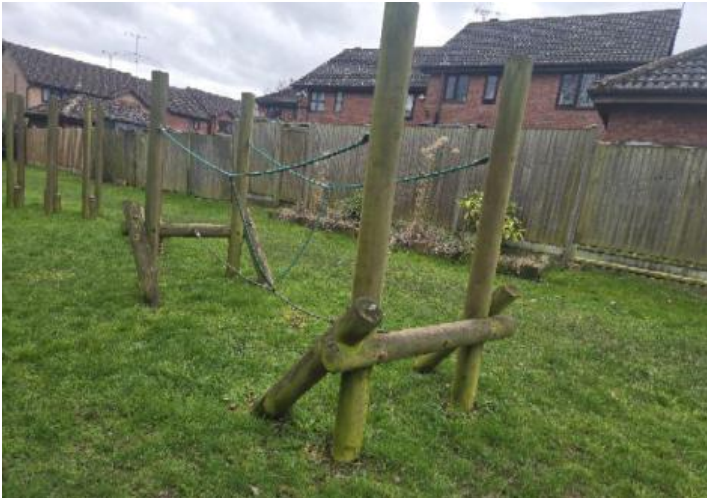
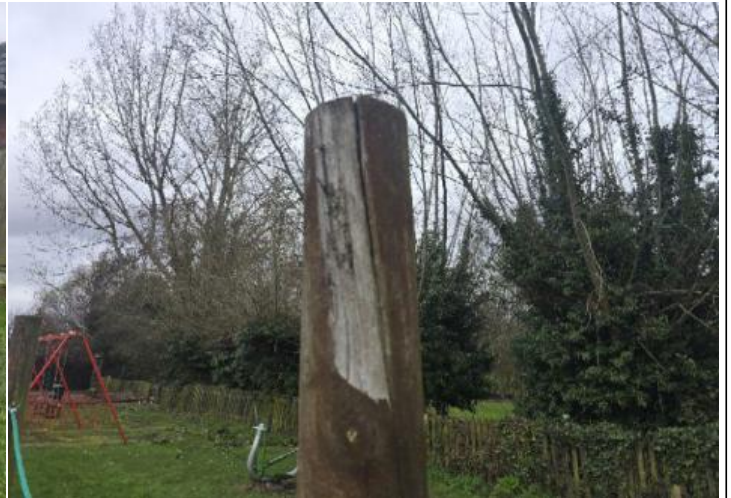
**Item:** Activity Equipment - Rope Bridge  
**Manufacturer:** Not Identified

**Finding:** Parts of the timber are rough or splintered

**Action:** Remove all rough or sharp edges

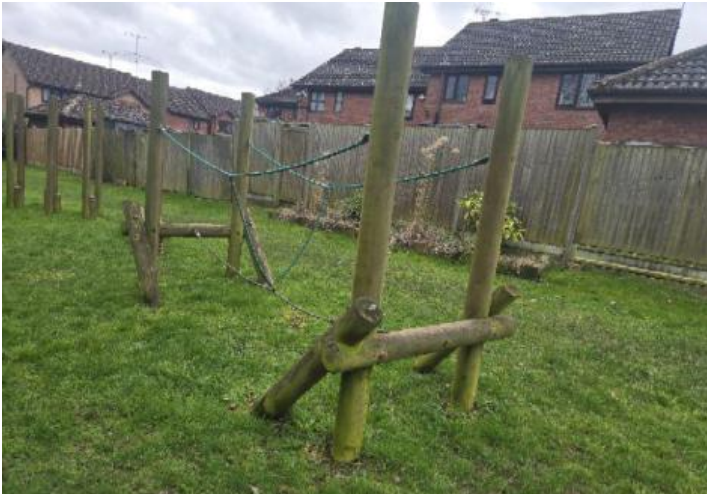
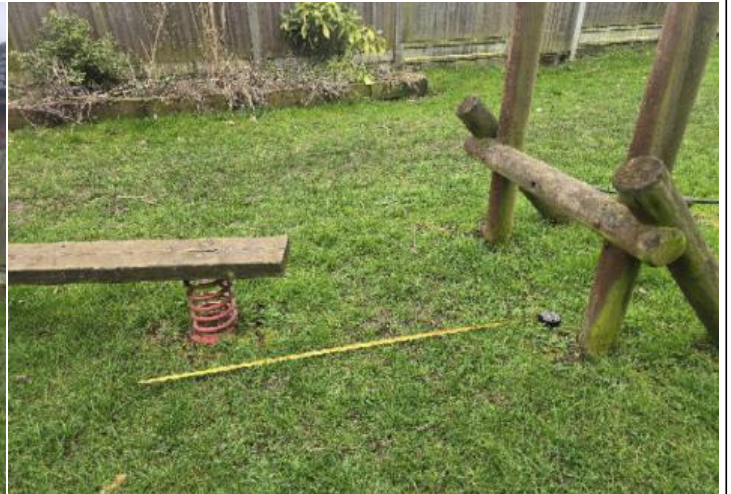
**Item:** Activity Equipment - Rope Bridge  
**Manufacturer:** Not Identified

**Finding:** The spring balance beam forms a projecting obstacle / hard object within the falling space of the equipment, in contravention of the requirements of BS EN 1176 Part 1

**Action:** Monitor - No action given the risk assessment

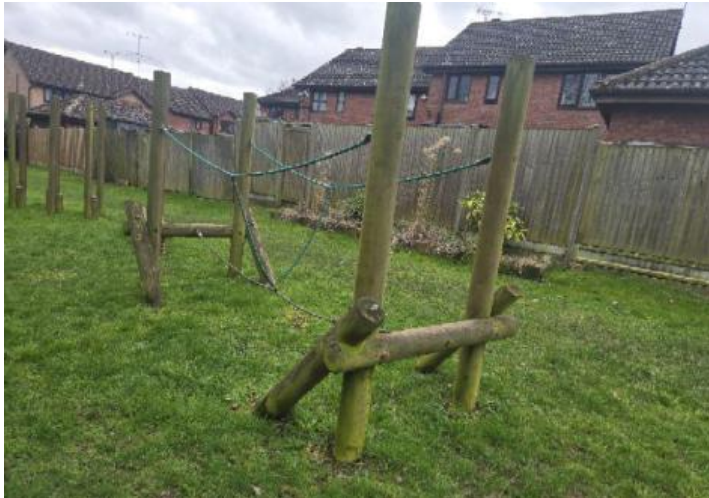
**Item:** Activity Equipment - Rope Bridge  
**Manufacturer:** Not Identified

**Finding:** There is/are bolt cap covers missing or damaged on the item

**Action:** Replace missing or damaged bolt cap covers

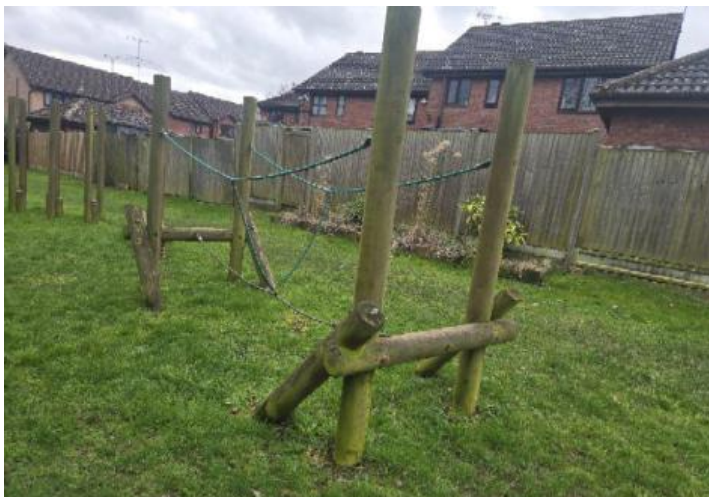
**Item:** Activity Equipment - Rope Bridge  
**Manufacturer:** Not Identified

**Finding:** There is some evidence of rot in the timber post

**Action:** Monitor for any further deterioration and replace as required

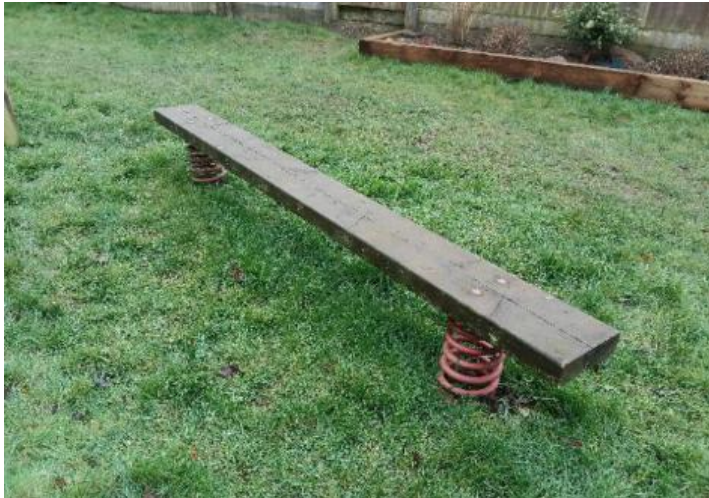
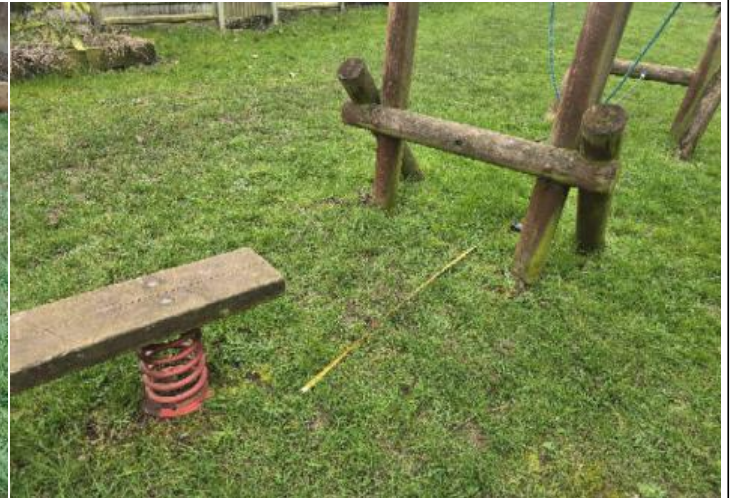
**Item:** Activity Equipment - Spring Balance Beam **Risk Level:** L - Low Risk  
**Manufacturer:** Not Identified **Surface:** Grass

**Finding:** The adjacent items forms a projecting obstacle / hard object within the falling space of the equipment, in contravention of the requirements of BS EN 1176 Part 1

**Action:** Monitor - No action given the risk assessment

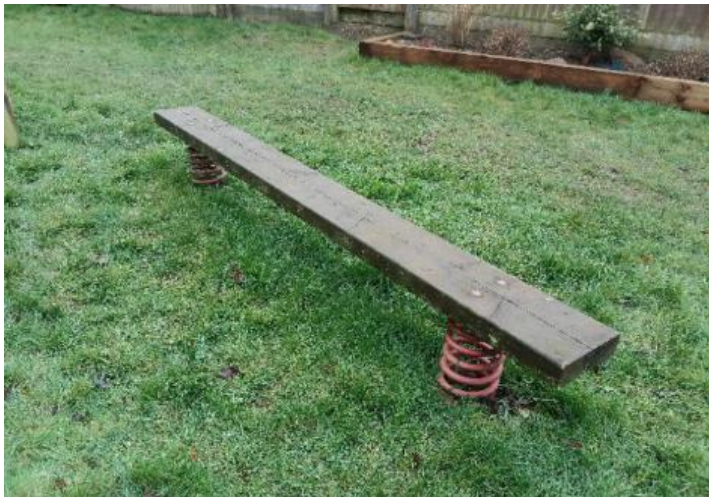
**Item:** Activity Equipment - Spring Balance Beam **Risk Level:** L - Low Risk  
**Manufacturer:** Not Identified **Surface:** Grass

**Finding:** The timber has a number of splits/shakes or air cracks and this may affect the stability or allow water ingress which will accelerate the rotting process. Timber splits may also create rough / splintering edges.

**Action:** Monitor, sand down any rough edges and ensure the splits do not cross through fixing points of the structure and/or cause any instability

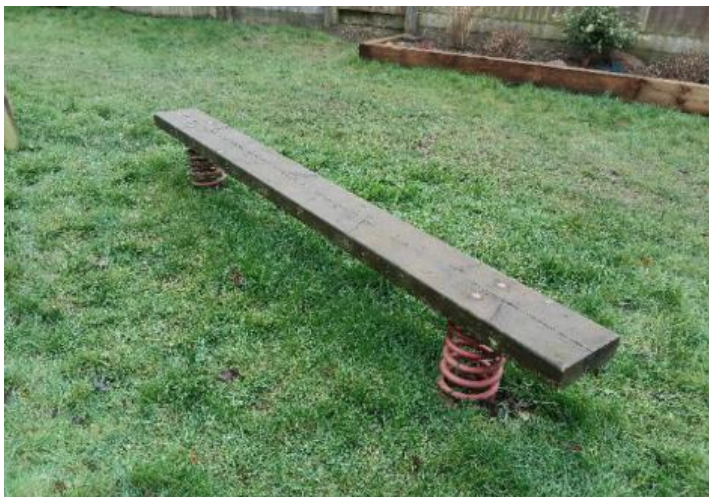
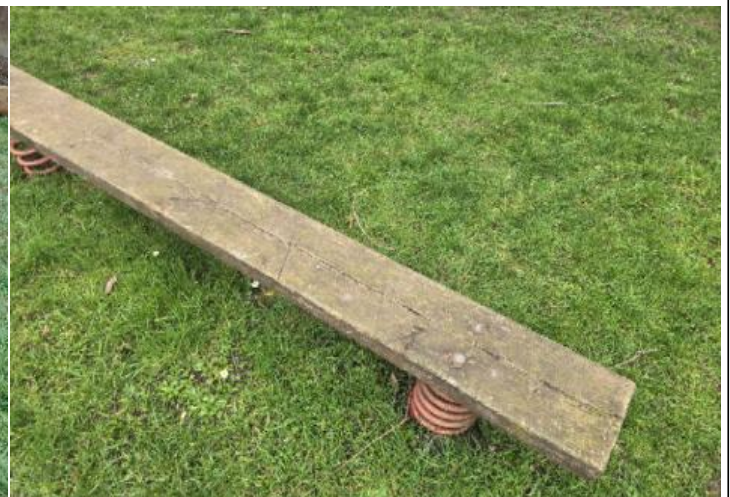
**i** 6 - Low Risk (Finding 4)

**Item:** Activity Equipment - Spring Balance Beam **Risk Level:** L - Low Risk  
**Manufacturer:** Not Identified **Surface:** Grass

**Finding:** There is algae or moss on the surface of the equipment **Action:** Clean and treat appropriately

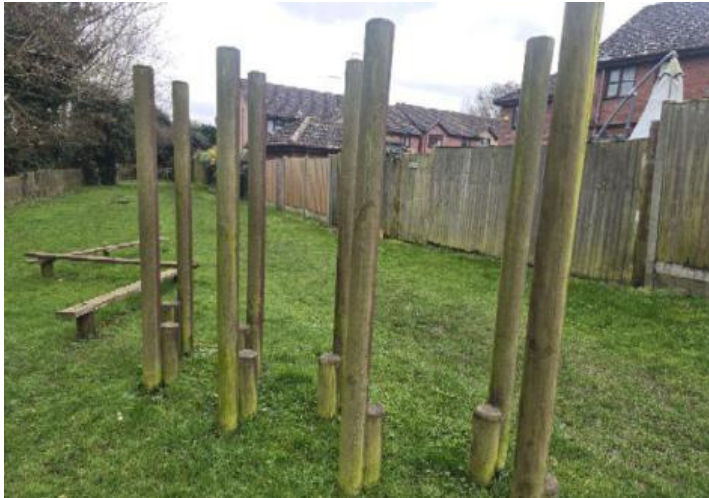
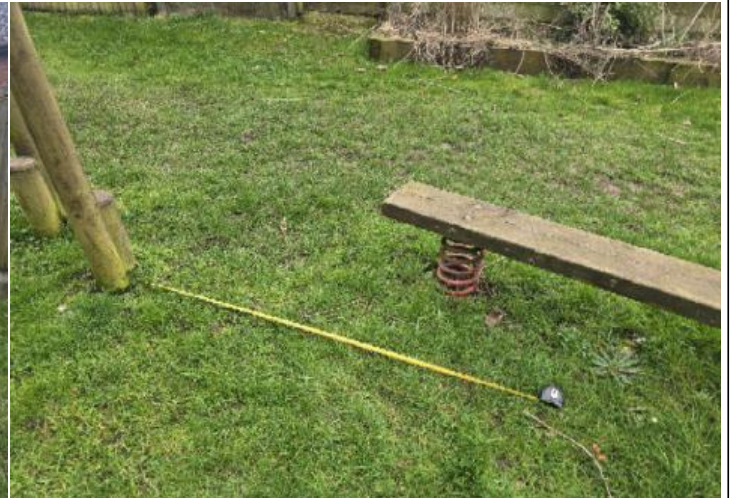
**i** 8 - Low Risk (Finding 1)

**Item:** Activity Equipment - Stilts  
**Manufacturer:** Not Identified

**Finding:** The spring balance beam forms a projecting obstacle / hard object within the falling space of the equipment, in contravention of the requirements of BS EN 1176 Part 1

**Action:** Monitor - No action given the risk assessment

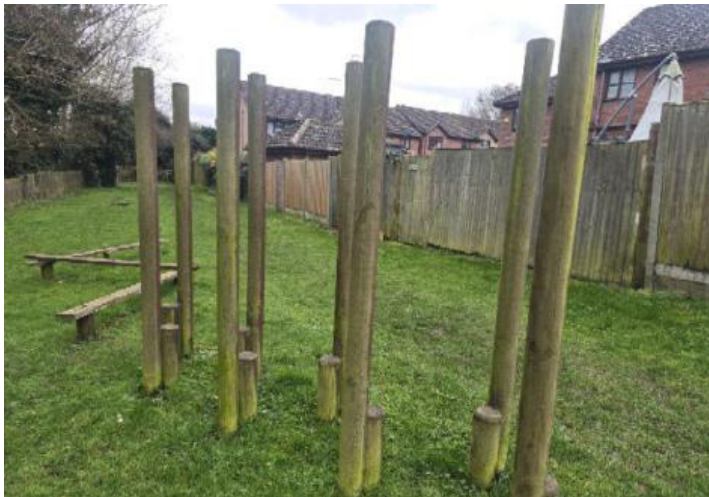
**Item:** Activity Equipment - Stilts  
**Manufacturer:** Not Identified

**Finding:** There is some evidence of rot in the timber

**Action:** Monitor for any further deterioration and replace as required

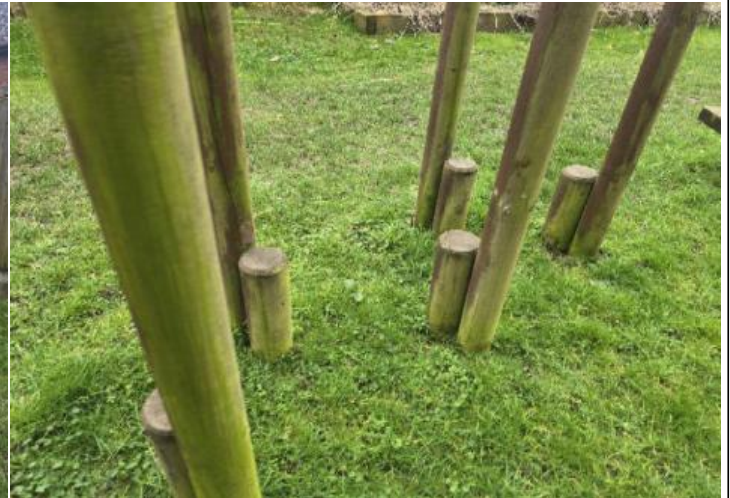
**Item:** Activity Equipment - Stilts  
**Manufacturer:** Not Identified

**Finding:** There is algae or moss on the surface of the equipment

**Action:** Clean and treat appropriately

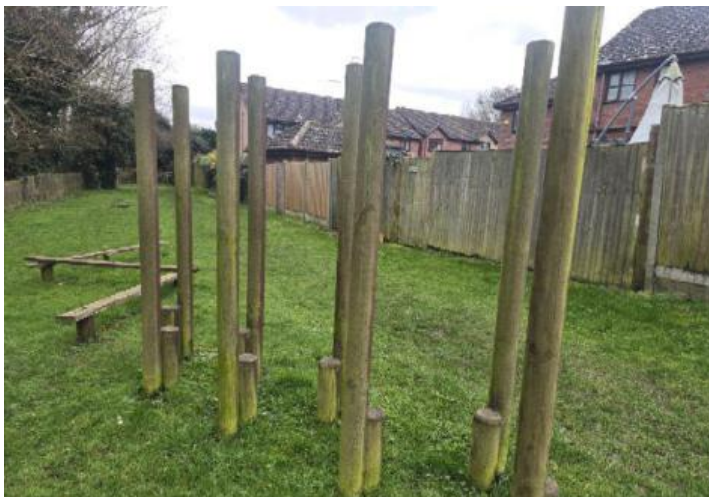
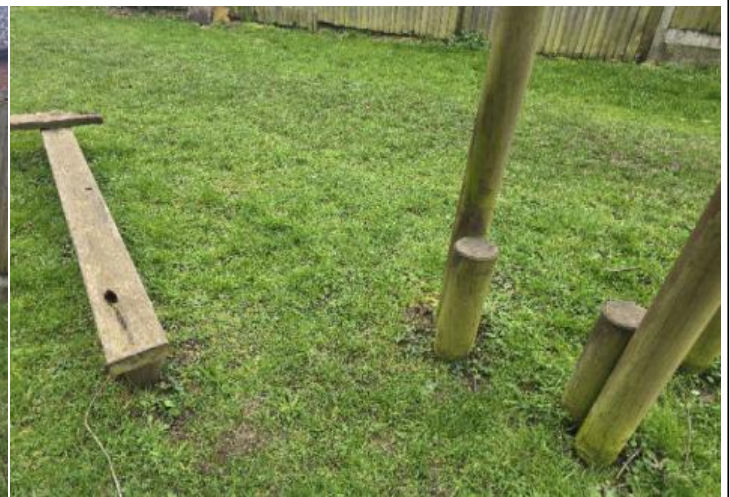
**Item:** Activity Equipment - Stilts  
**Manufacturer:** Not Identified

**Finding:** The step between the items is quite large and users may not be able to complete the step without touching ground, the items could therefore be considered to be within the falling space of each other, however the intention of the play activity continuity is easily apparent and foreseeable to the user

**Action:** Monitor - No action given the risk assessment

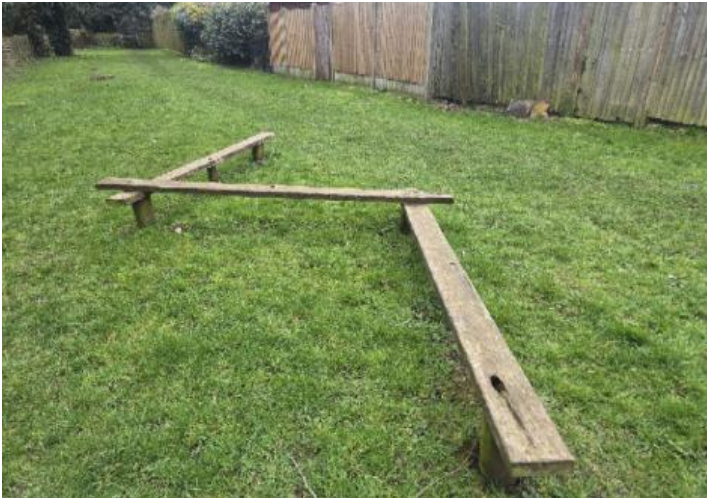
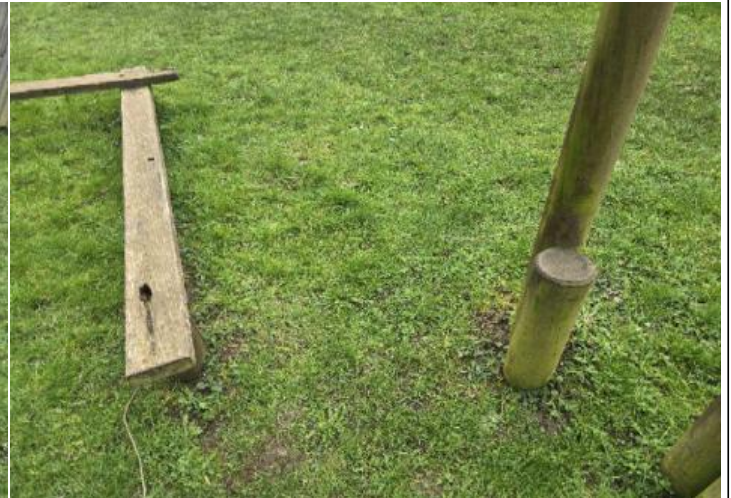
**Item:** Activity Equipment - Balance Beam  
**Manufacturer:** Not Identified

**Finding:** The step between the items is quite large and users may not be able to complete the step without touching ground, the items could therefore be considered to be within the falling space of each other, however the intention of the play activity continuity is easily apparent and foreseeable to the user

**Action:** Monitor - No action given the risk assessment

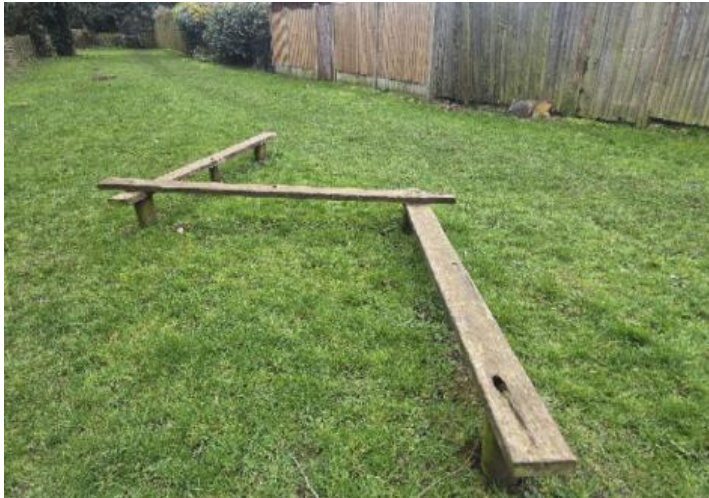
**Item:** Activity Equipment - Balance Beam  
**Manufacturer:** Not Identified

**Finding:** There are areas or parts of the timber on the structure that have rotted

**Action:** Replace all affected timbers

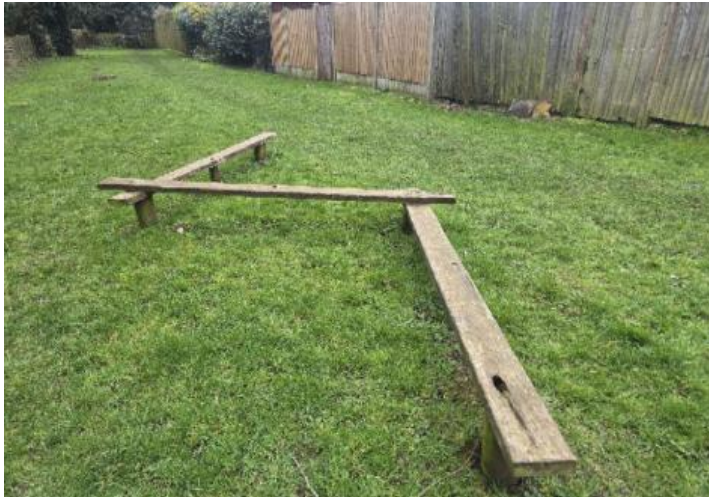
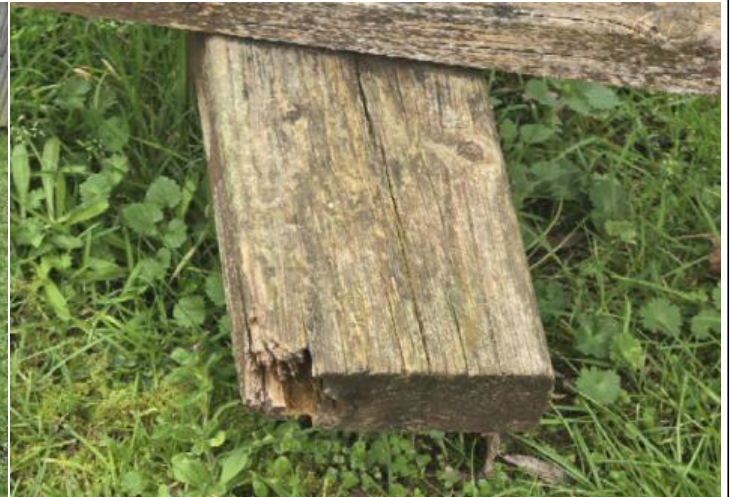
**Item:** Activity Equipment - Balance Beam  
**Manufacturer:** Not Identified

**Finding:** Parts of the timber are rough or splintered

**Action:** Remove all rough or sharp edges

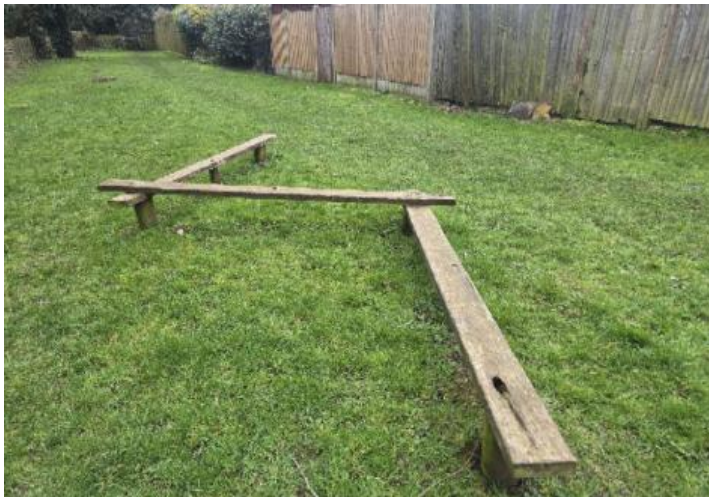
**Item:** Activity Equipment - Balance Beam  
**Manufacturer:** Not Identified

**Finding:** There is/are bolt cap covers missing or damaged on the item

**Action:** Replace missing or damaged bolt cap covers

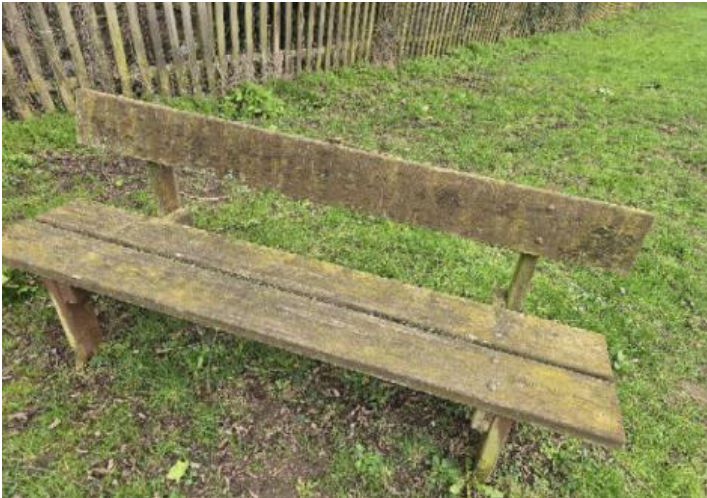
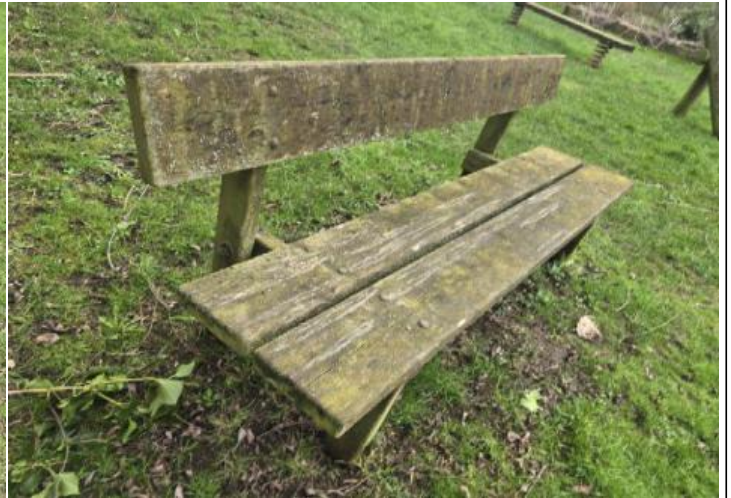
**Item:** Ancillary Items - Bench  
**Manufacturer:** Not Identified

**Finding:** There is algae or moss on the surface of the equipment

**Action:** Clean and treat appropriately

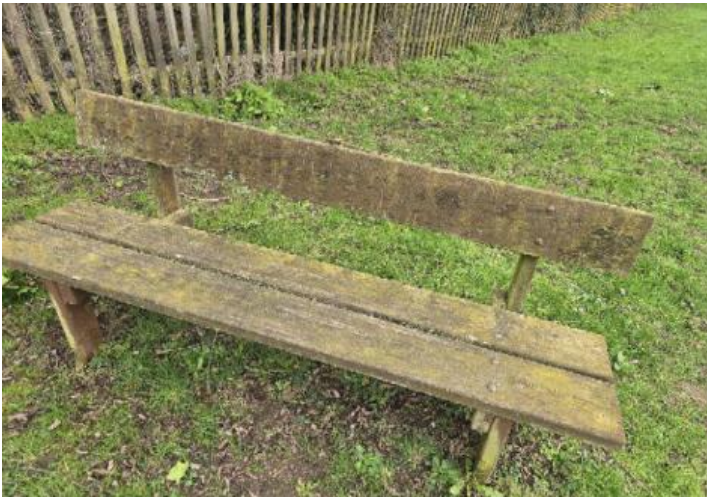
**Item:** Ancillary Items - Bench  
**Manufacturer:** Not Identified

**Finding:** There is some strimmer / machinery damage apparent on the posts, this can penetrate the preservative applied to the timber and accelerate the rotting process

**Action:** Monitor for any deterioration (rot) and replace as required

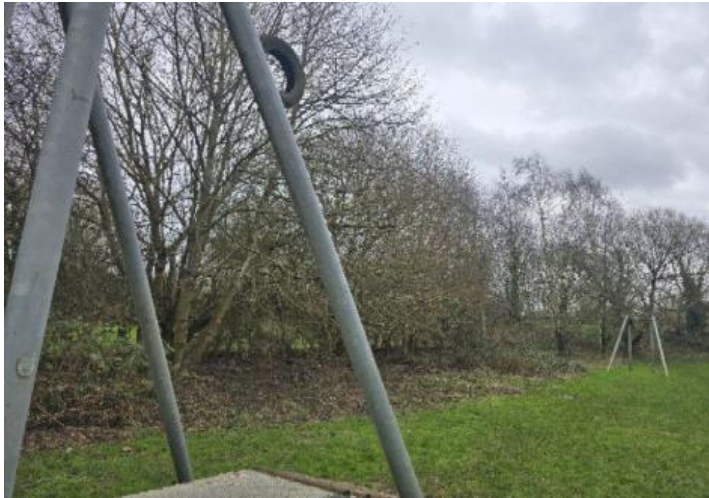
**Item:** Other - Cable Runway  
**Manufacturer:** Not Identified

**Finding:** We have completed a visual inspection of the suspension links, cable and fixing points from ground level, however it is not possible to fully inspect these areas without either hiring equipment to gain access or removing the cable and suspension and inspecting at ground level. We recommend that the main cable and fixing security is thoroughly inspected at least in accordance with the manufacturers recommendations to check for wear, damage, security or internal rusting; this will help to ensure the continued safe use of the equipment

**Action:** Inspect in accordance with the manufacturers recommendations

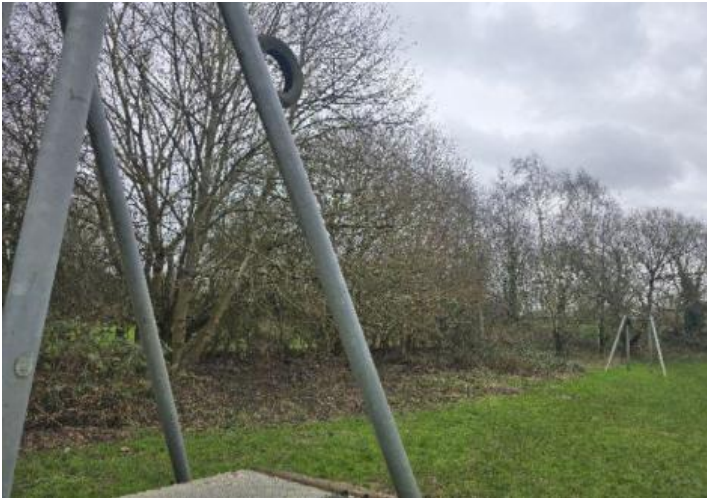
**Item:** Other - Cable Runway  
**Manufacturer:** Not Identified

**Finding:** There are ramp treads missing

**Action:** Replace

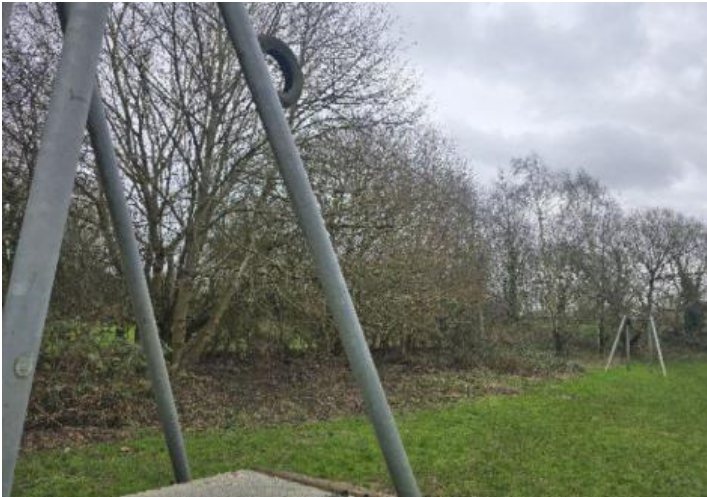
**Item:** Other - Cable Runway  
**Manufacturer:** Not Identified

**Finding:** There is/are bolt cap covers missing or damaged on the item

**Action:** Replace missing or damaged bolt cap covers

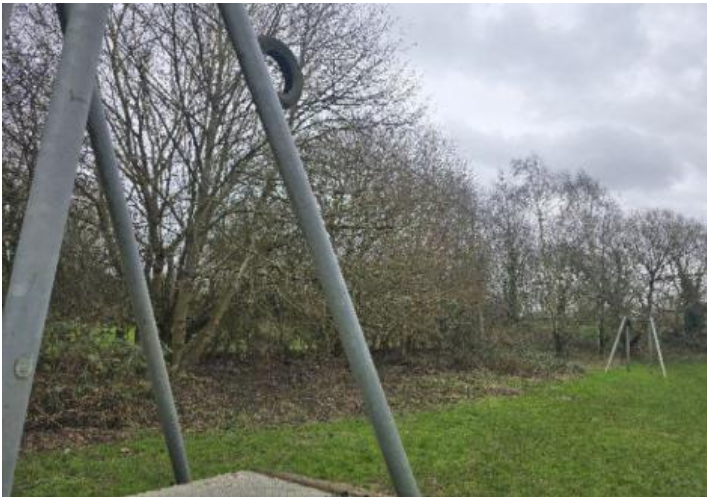
**Item:** Other - Cable Runway  
**Manufacturer:** Not Identified

**Finding:** The seat connection cannot be inspected without dismantling the seat

**Action:** Dismantle the seat to inspect the seat connection for wear

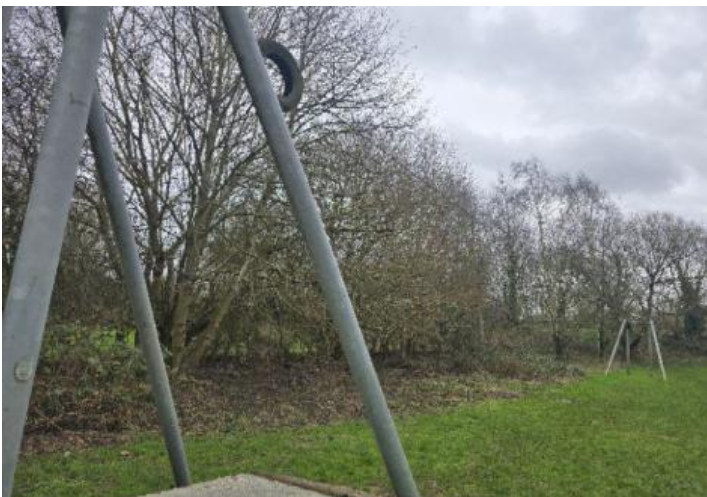
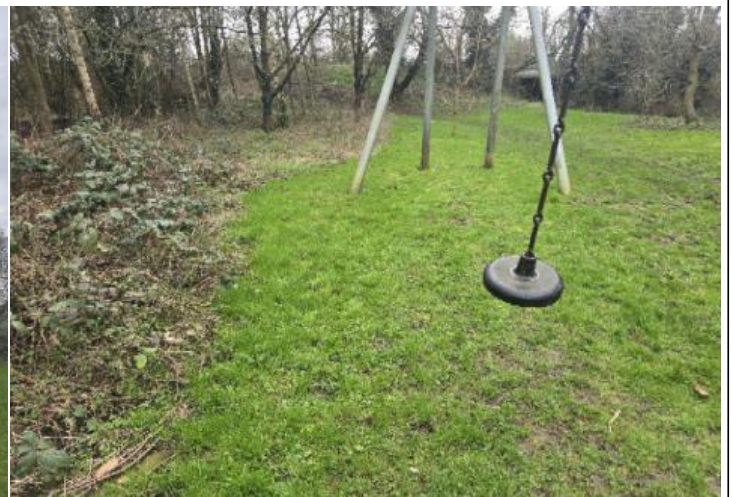
**Item:** Other - Cable Runway  
**Manufacturer:** Not Identified

**Finding:** The adjacent foliage is overhanging into the falling space of the equipment

**Action:** Cut back and maintain 2m falling space

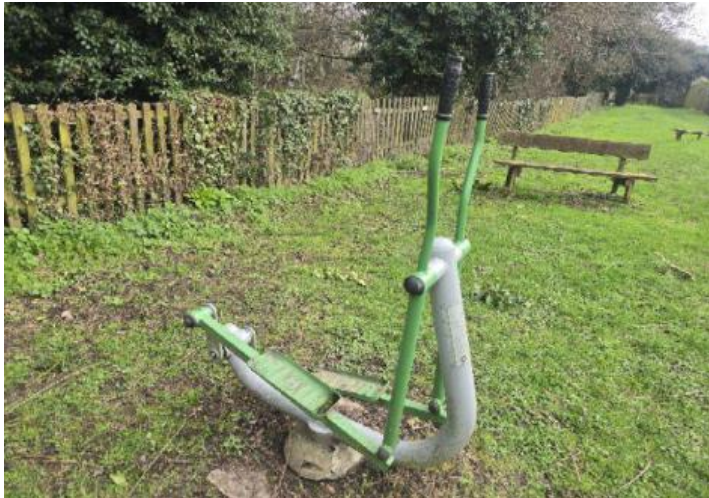
**Item:** Outdoor Fitness Equipment - Cross Rider  
**Manufacturer:** Caloo

**Finding:** The surface has eroded and the foundations are exposed

**Action:** Reinstate surrounding surfaces to cover the foundations

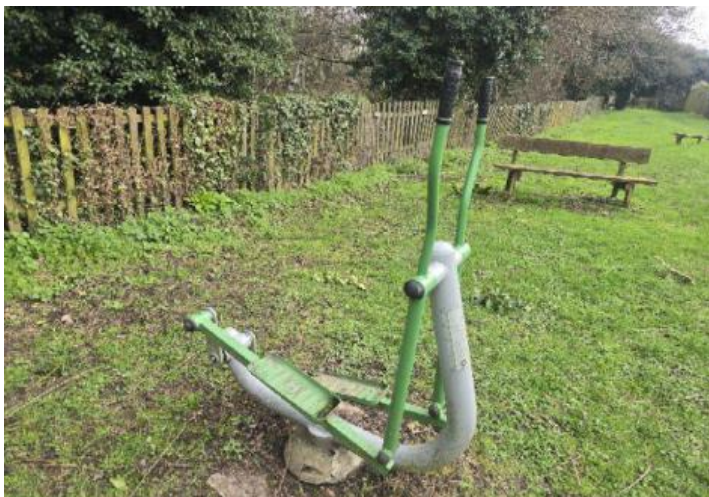
**Item:** Outdoor Fitness Equipment - Cross Rider  
**Manufacturer:** Caloo

**Finding:** There is surface corrosion / rust present on the item

**Action:** Consider treating the item

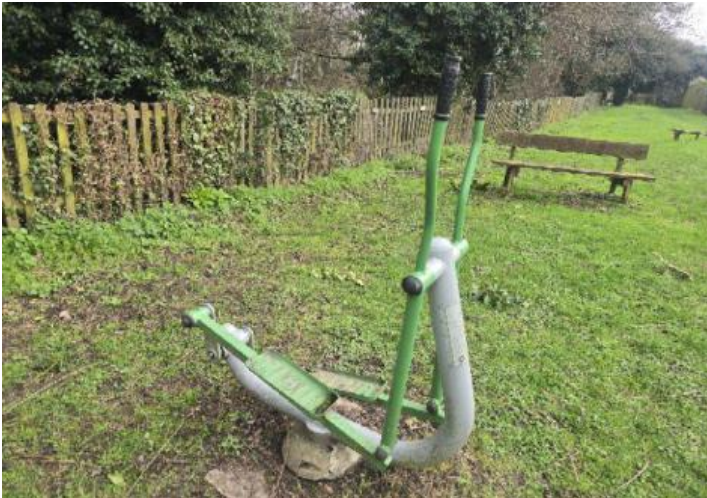
**Item:** Outdoor Fitness Equipment - Cross Rider  
**Manufacturer:** Caloo

**Finding:** There is/are bolt cap covers missing or damaged on the cross rider

**Action:** Replace missing or damaged bolt cap covers
